# Feature: Risks of Undersized Bonding/Grounding Wires – Editorial: You Have Enemies?

## **Risks of Undersized Bonding/Grounding Wires**

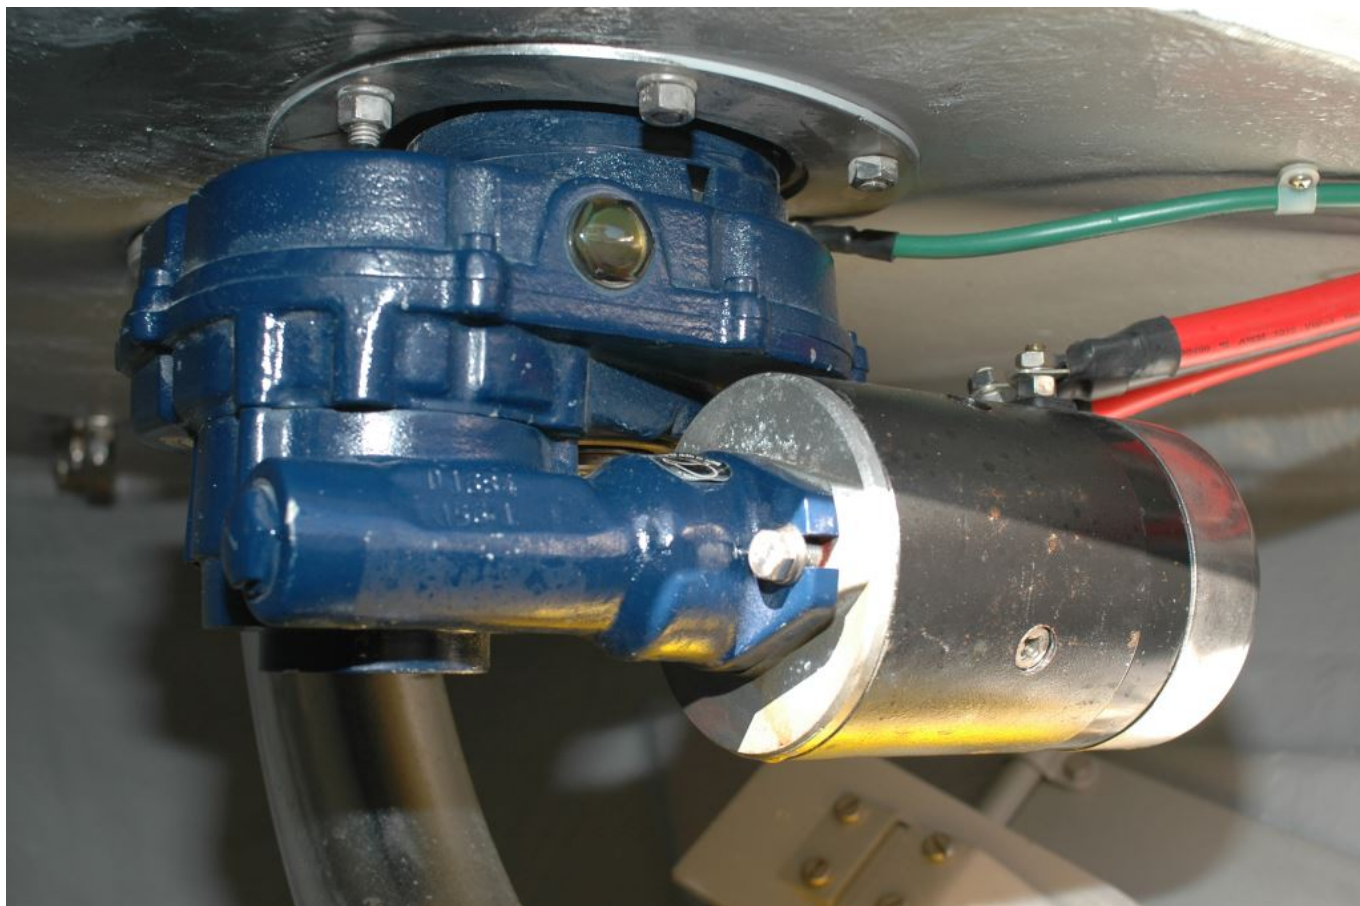
While optional, grounding deck equipment like windlasses is common. If that approach is taken, the grounding wire must be large enough to carry fault current from the windlasses' DC positive cable. This one is undersized.

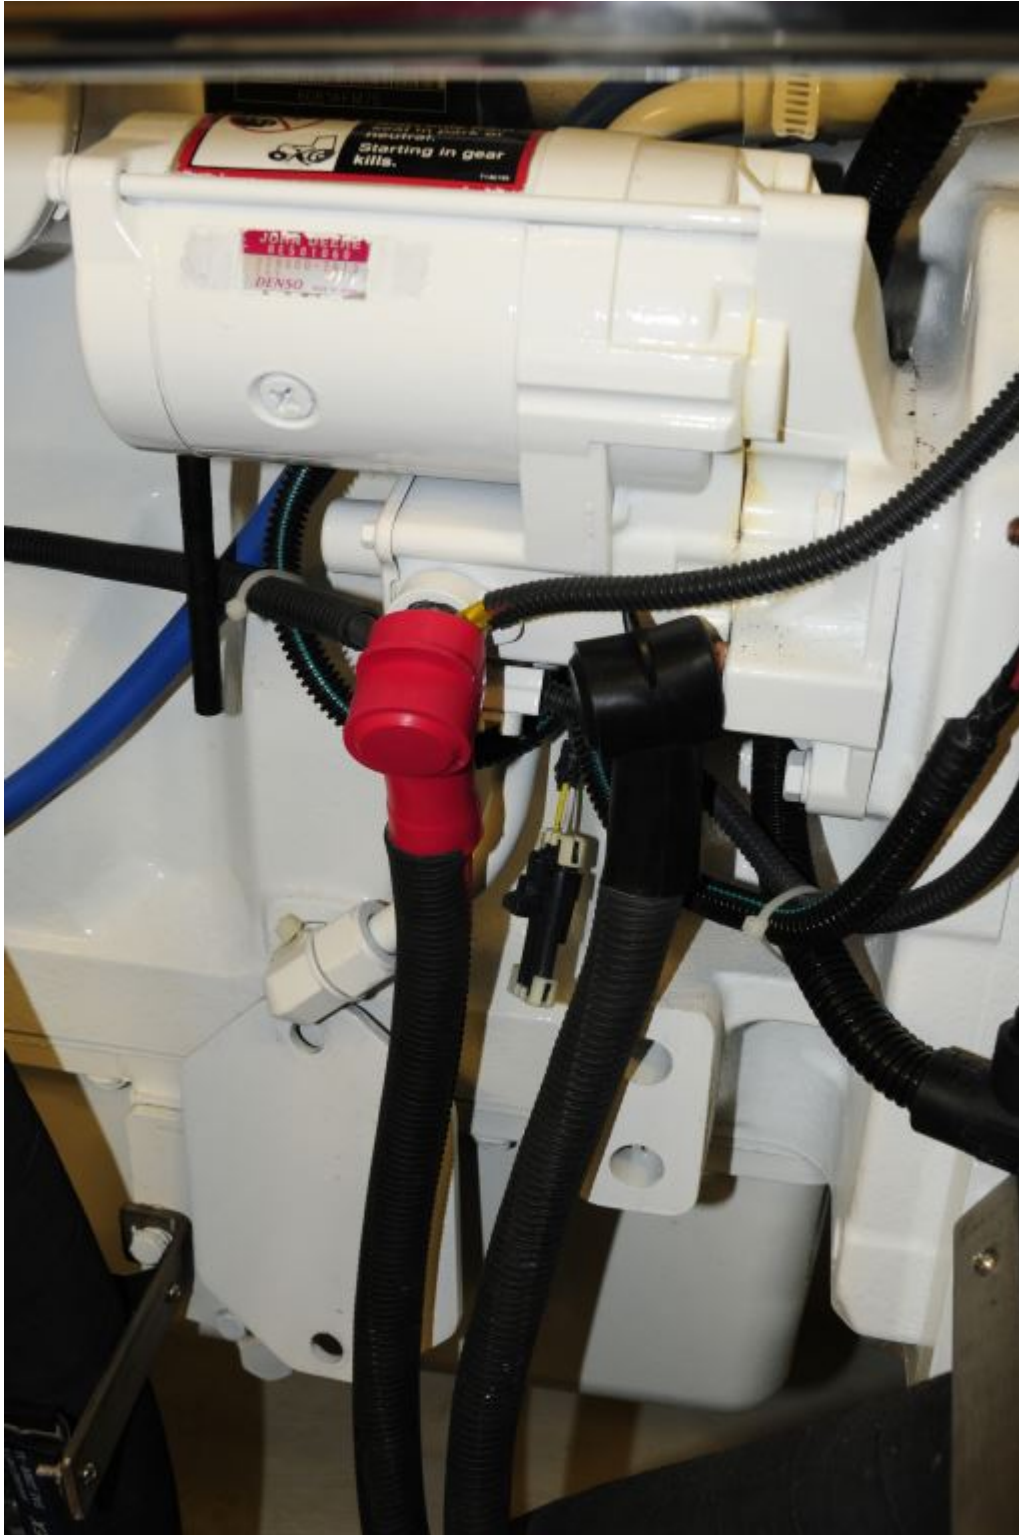
When isolated ground starters and alternators are used, the engine block is non-current-carrying, which means it can therefore be DC grounded. The grounding cable used must be large enough to carry full fault current from the largest DC positive conductor, which is usually the one supplying the starter, which is also typically not protected by over-current protection (a fuse); it is the only conductor which is exempt

**from this ABYC rule, making the prospect of a short to the block even more dire.**
