# February 2024 Newsletter – Stainless Washer in Current Path

## Photo Essay: Stainless Washer in Current Path

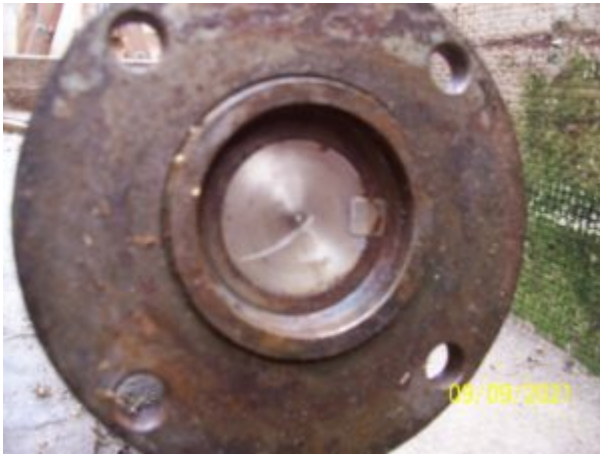
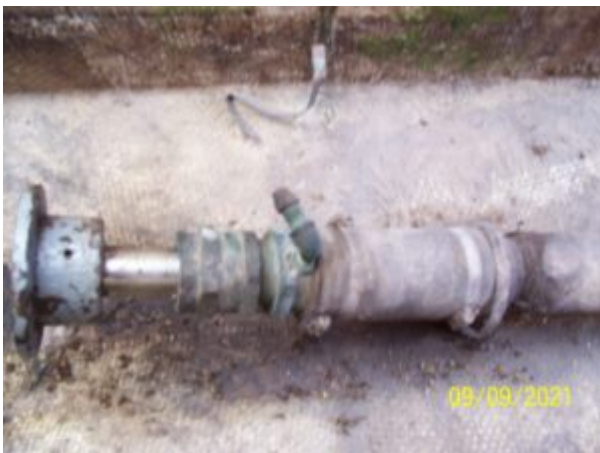
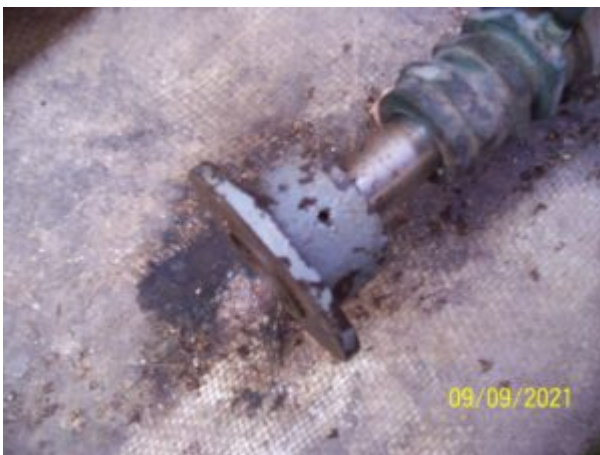
I am having trouble with the drive system and write you for advice (or possibly direction where I can read info), I have attached pictures of the coupler end at the engine. I have been unable to remove this coupler despite several attempts with lots of PB Blaster. I think I need to remove the shaft to at least replace the stuffing box. I also think I need to replace the cutlass bearings at both ends. I can't imagine that they might still be good. That is something that scares me a bit. I am going to try to remove the shaft by removing the propeller and then removing the shaft forward. Any thoughts you might have, ideas, directions, or information sources would be appreciated.

I'm afraid all of your photos are out of focus, so I am unable to discern much detail. There appears to be a set screw or drift pin in the coupling; I assume that's been removed? The coupling pilot bushing also appears to be dinged, that will need to be cleaned up by a machine shop. Once separated, the coupling should be fit to the shaft and faced before it is

There are proprietary coupling press tools, one is available from Durant Machine. However, you can make your own coupling puller using a set of grade 8 bolts, a piece of 3/8" steel plate and a drift (you can use a socket). The plate is drilled with a hole pattern to match the coupling, and the bolts passed through both sets of holes, with the socket against the shaft. Lubricate the bolt threads and tighten the nuts evenly, this should push the shaft out of the coupling bore, some heat applied to the coupling may accelerate the process.
