Flooding vs. Siphoning

Know the difference and avoid both

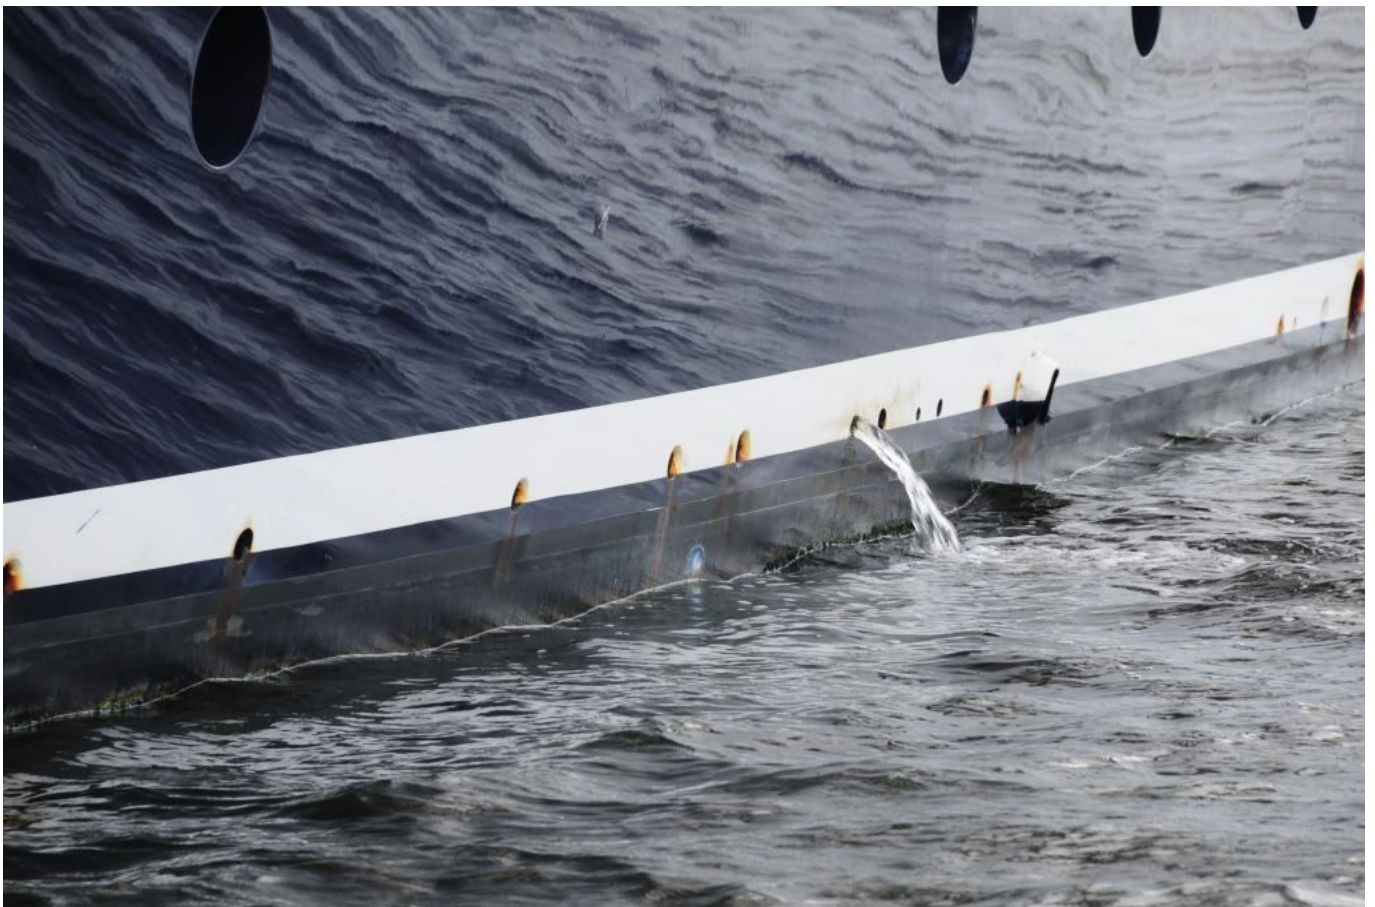
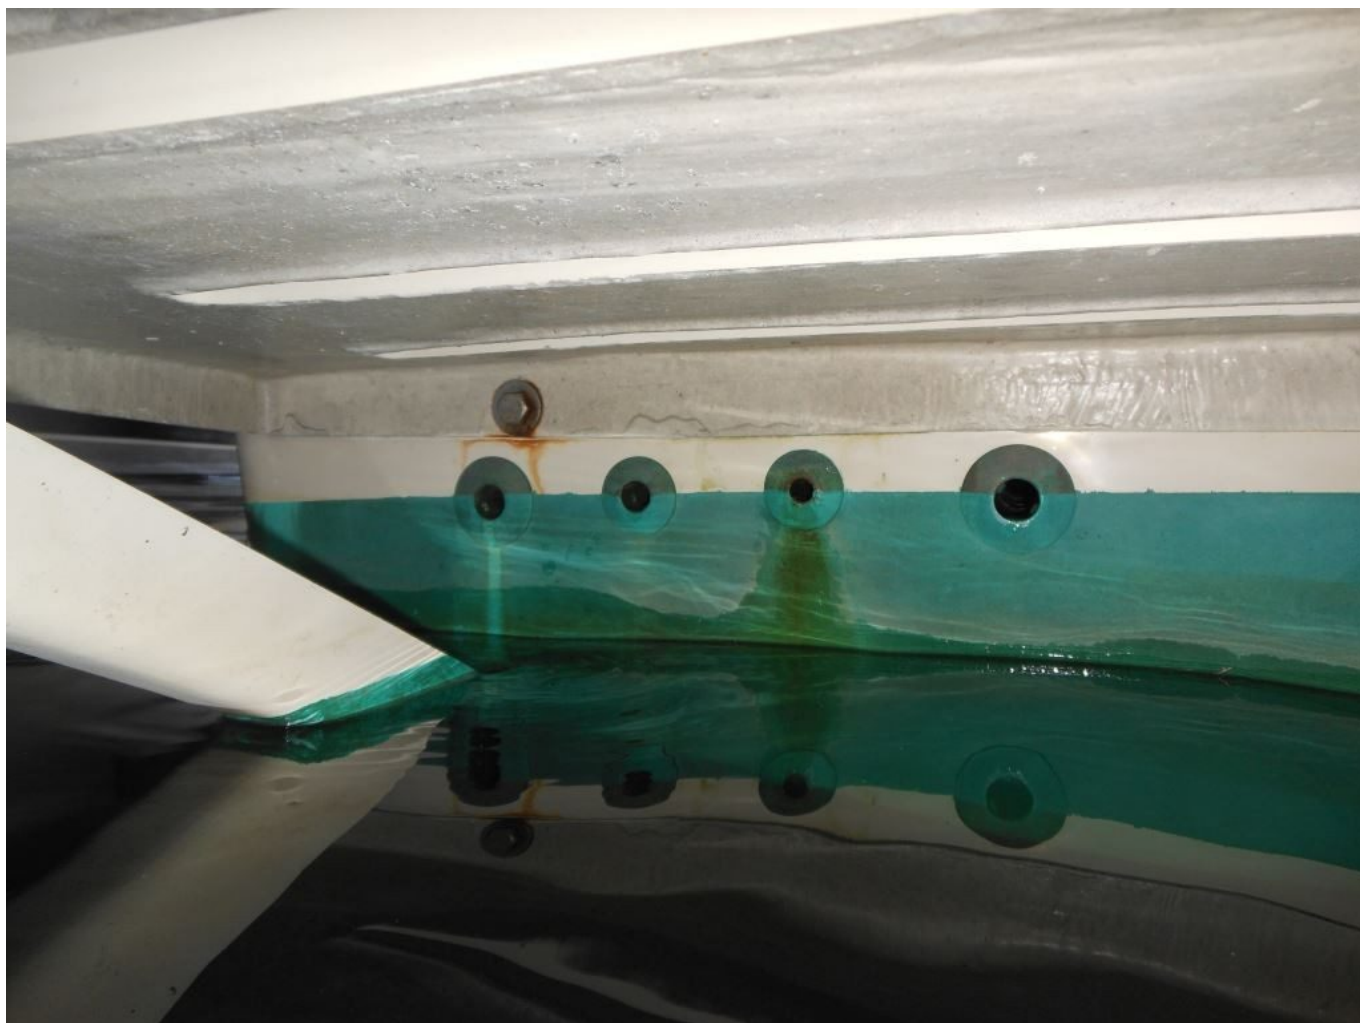
Engine, pump and other discharges that serve equipment that is open to the hull interior, which are close to the waterline, and which will be submerged if the vessel heels or squats, must utilize both an inverted U riser, as well as an anti-siphon valve. The first prevents pressurized flooding, while the second thwarts flooding that is the result of a siphon.

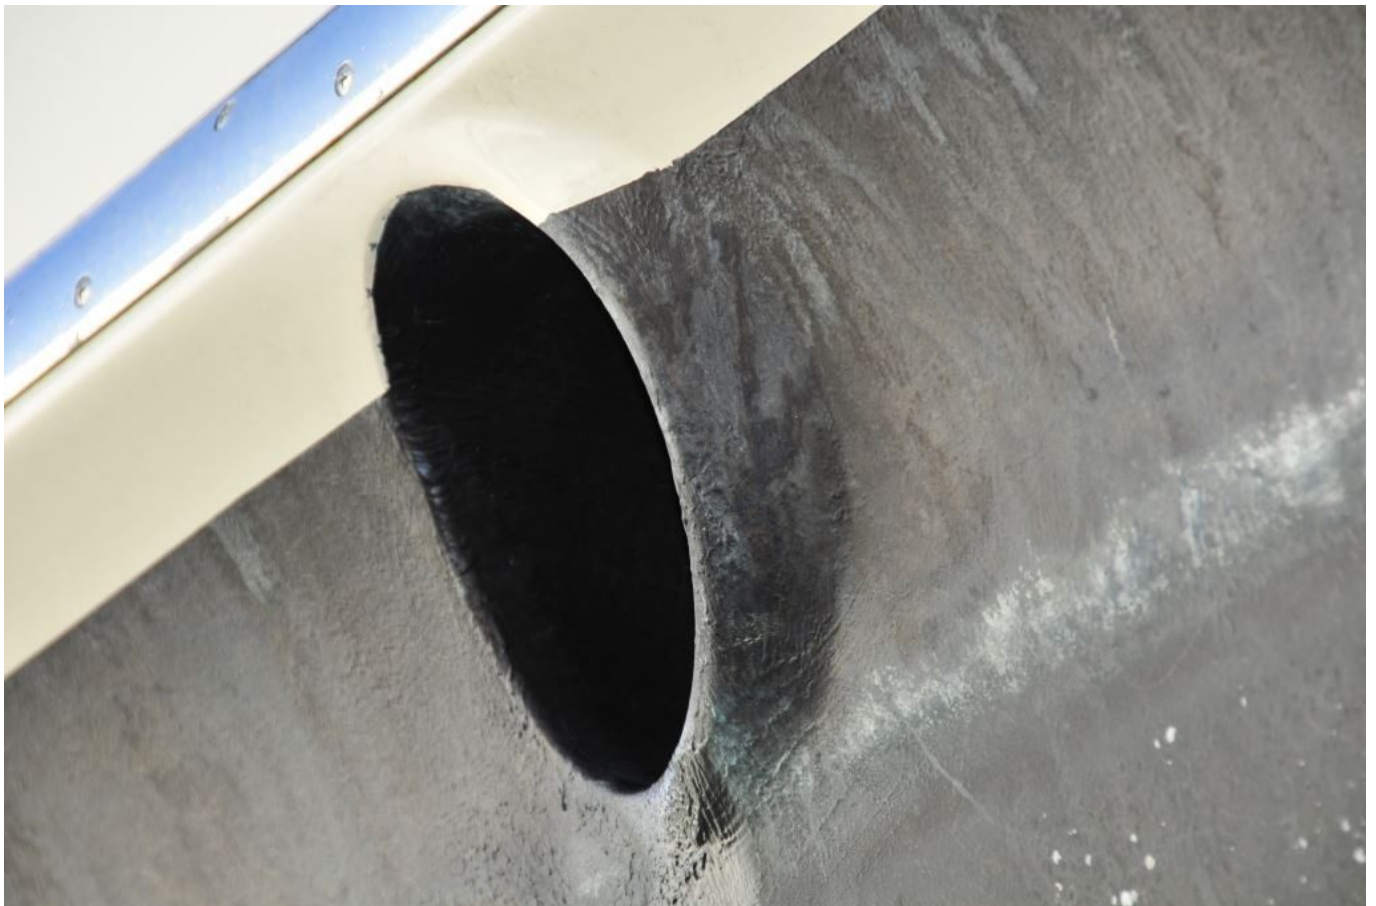
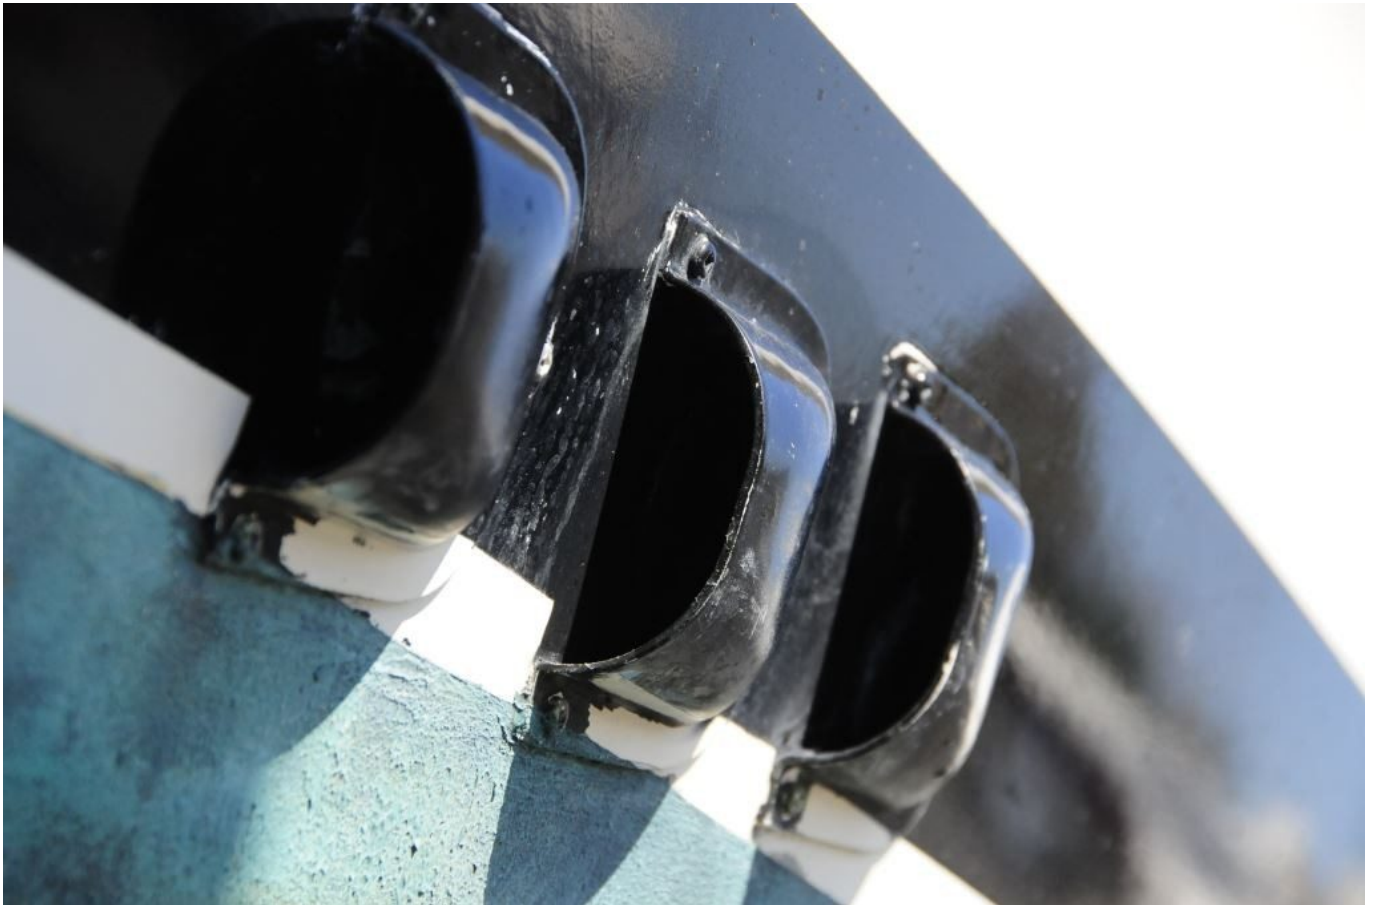
Deflectors located directly ahead of hull-side exhaust outlets (top) are among the most effective means of preventing bow wave-induced flooding. Clamshells (above), on the other hand, can be used to prevent ordinary wave action from forcing water into through hulls for engines, gensets and bilge pumps. These can, however, restrict flow, and when used they should face aft, like the ones shown here, or be angled down and aft at 45°. Under no circumstances should they ever face directly down, as that creates a funneling effect for beam to waves.

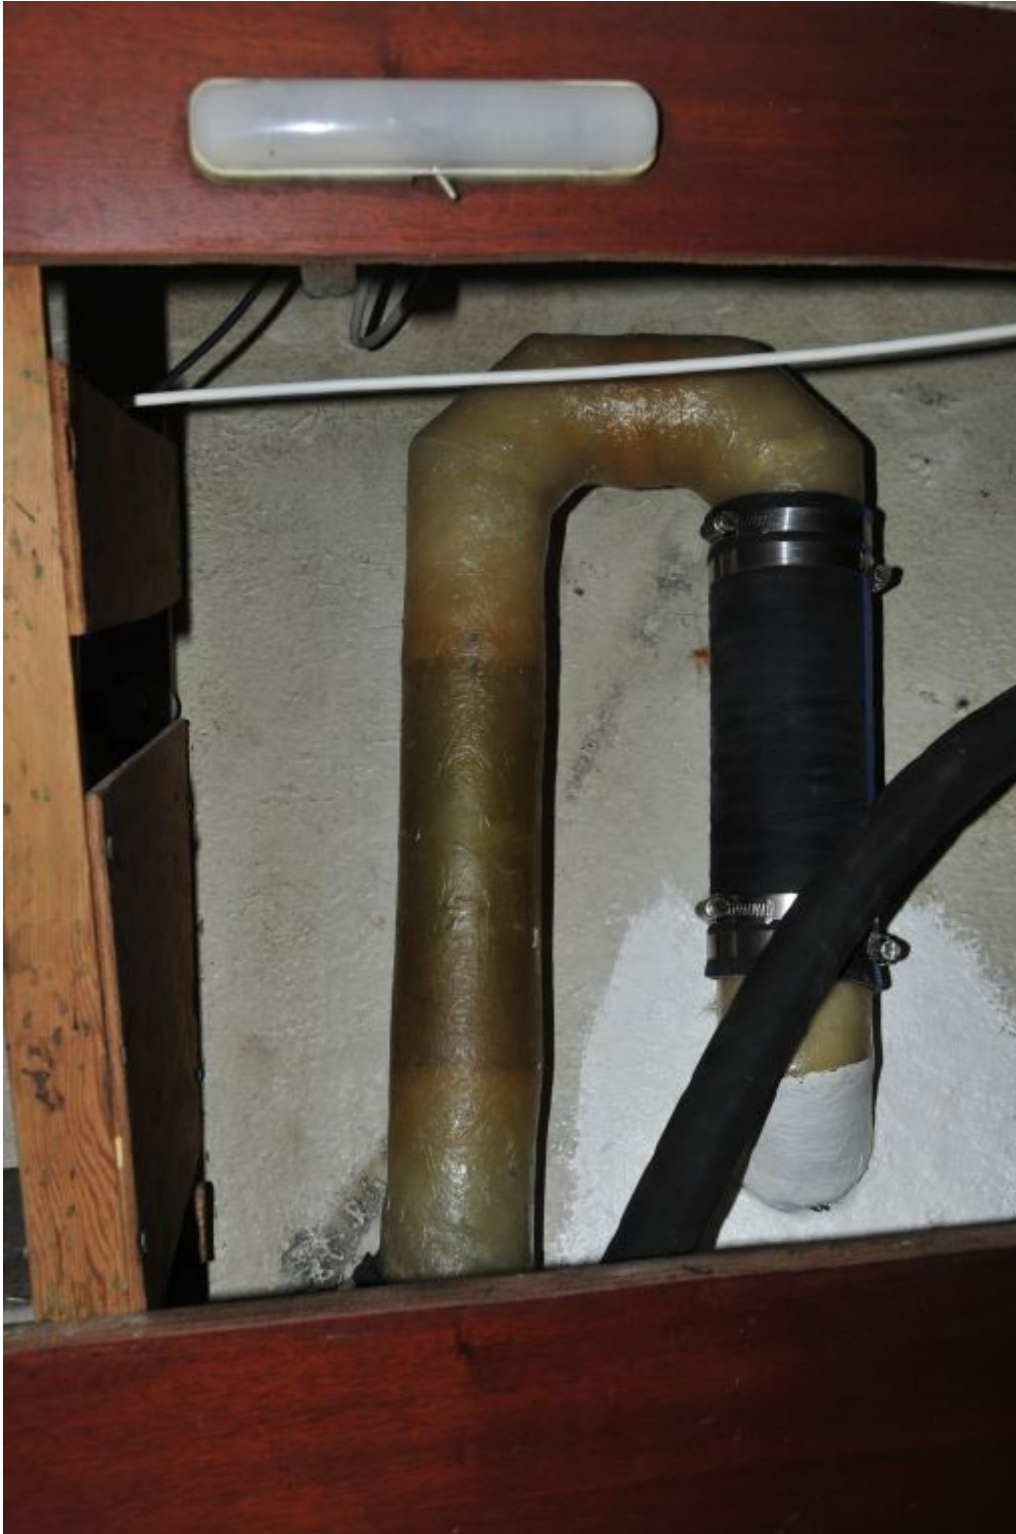
Wet exhaust system inverted U's are effective in preventing water from backing up into engines and gensets. However, if enough pressure is present, even a riser's height can be overcome. This is especially problematic on engines that may not be running while a vessel is underway, such as gensets and

sailing vessel propulsion engines.

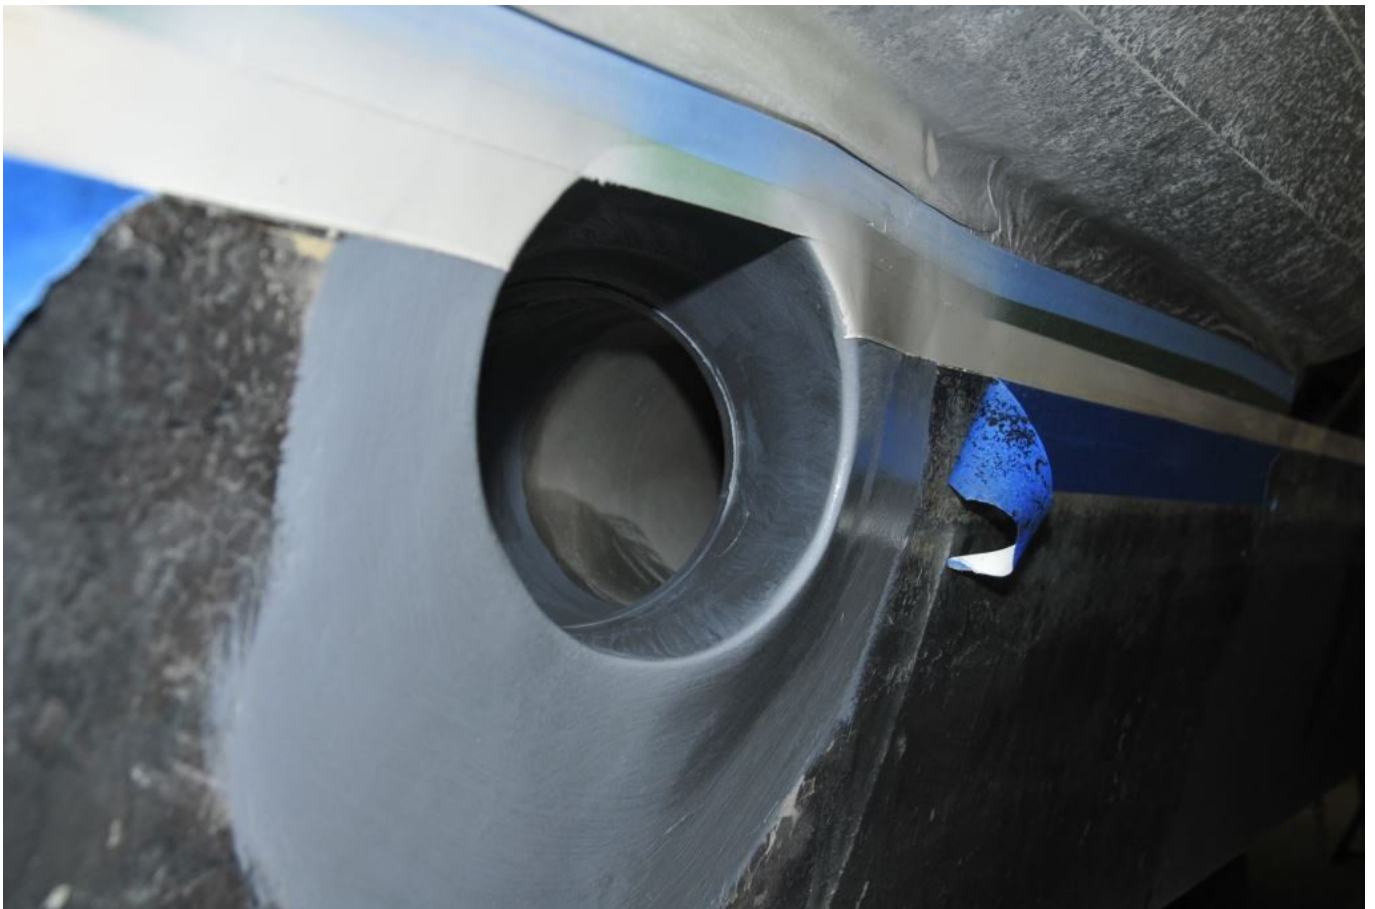
A deflector was added to this exhaust, to prevent pressurized water entry, created by the vessel's bow wave at the point of transition from displacement to planing speed.

The solution was an interesting one, and the very essence of simplicity; a small semicircular wedge of prefabricated fiberglass was attached to the hull immediately forward of the exhaust discharge a spoiler of sorts, which effectively deflected the slip stream of water away from the hull before it could enter the exhaust outlet and hose. Several sea trials under varying conditions proved the design sound, under no condition could water be made to enter the exhaust system.

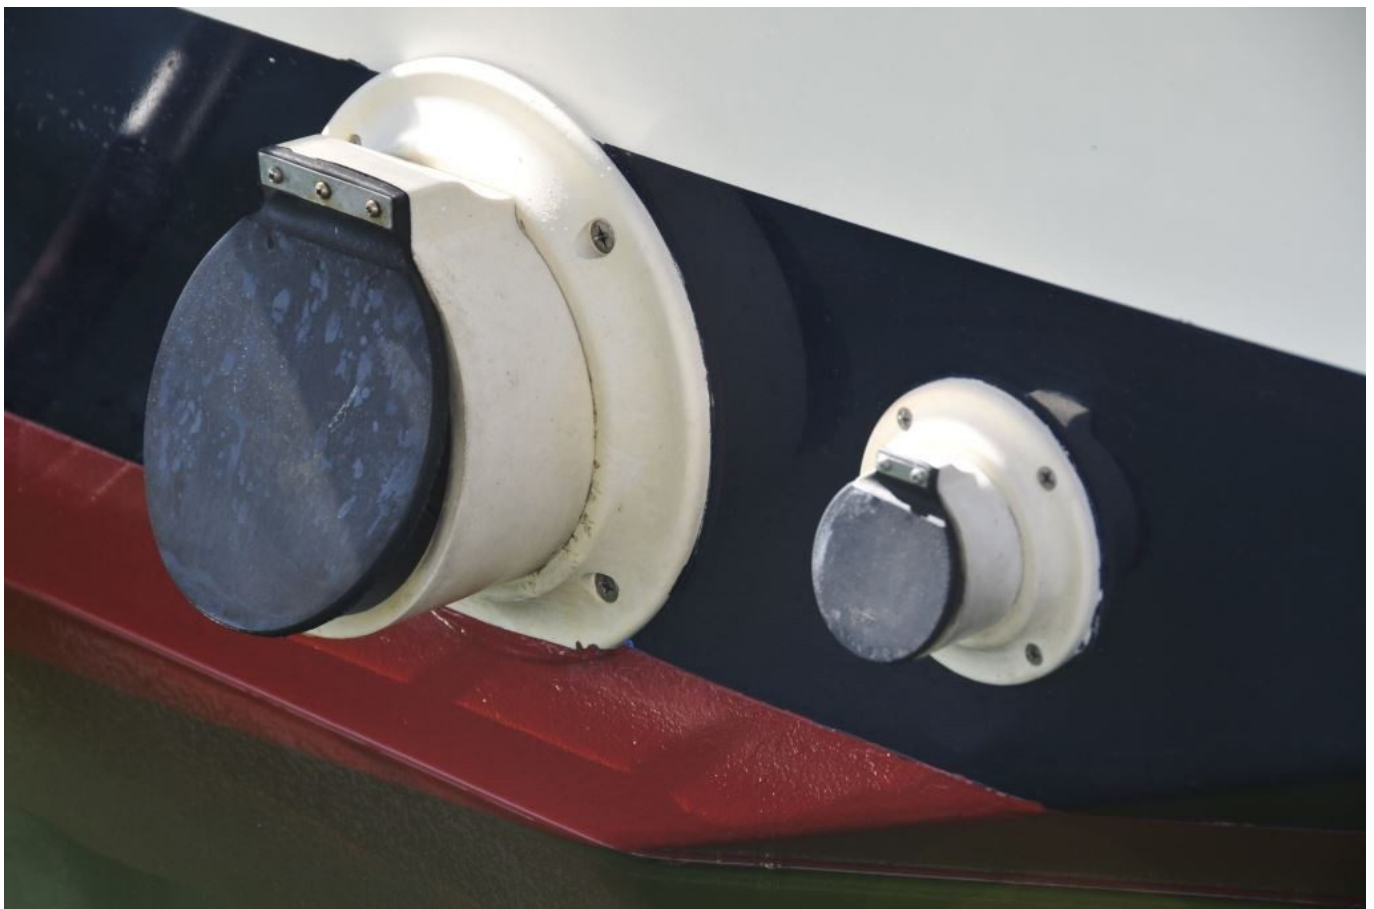
Flappers can be an effective means of preventing water from traveling the wrong direction into a transom-mounted exhaust discharge outlet. They do, however, wear out and often fall off without the owner's knowledge. If your vessel is equipped with these, be sure to check them regularly.

While a rubber flap is sometimes used to prevent back-flow, they are more effective for transom rather than side exhausts, in the latter application they are frequently dislodged and lost. Yet another alternative involves the use of a proprietary exhaust check valve, available from marine exhaust

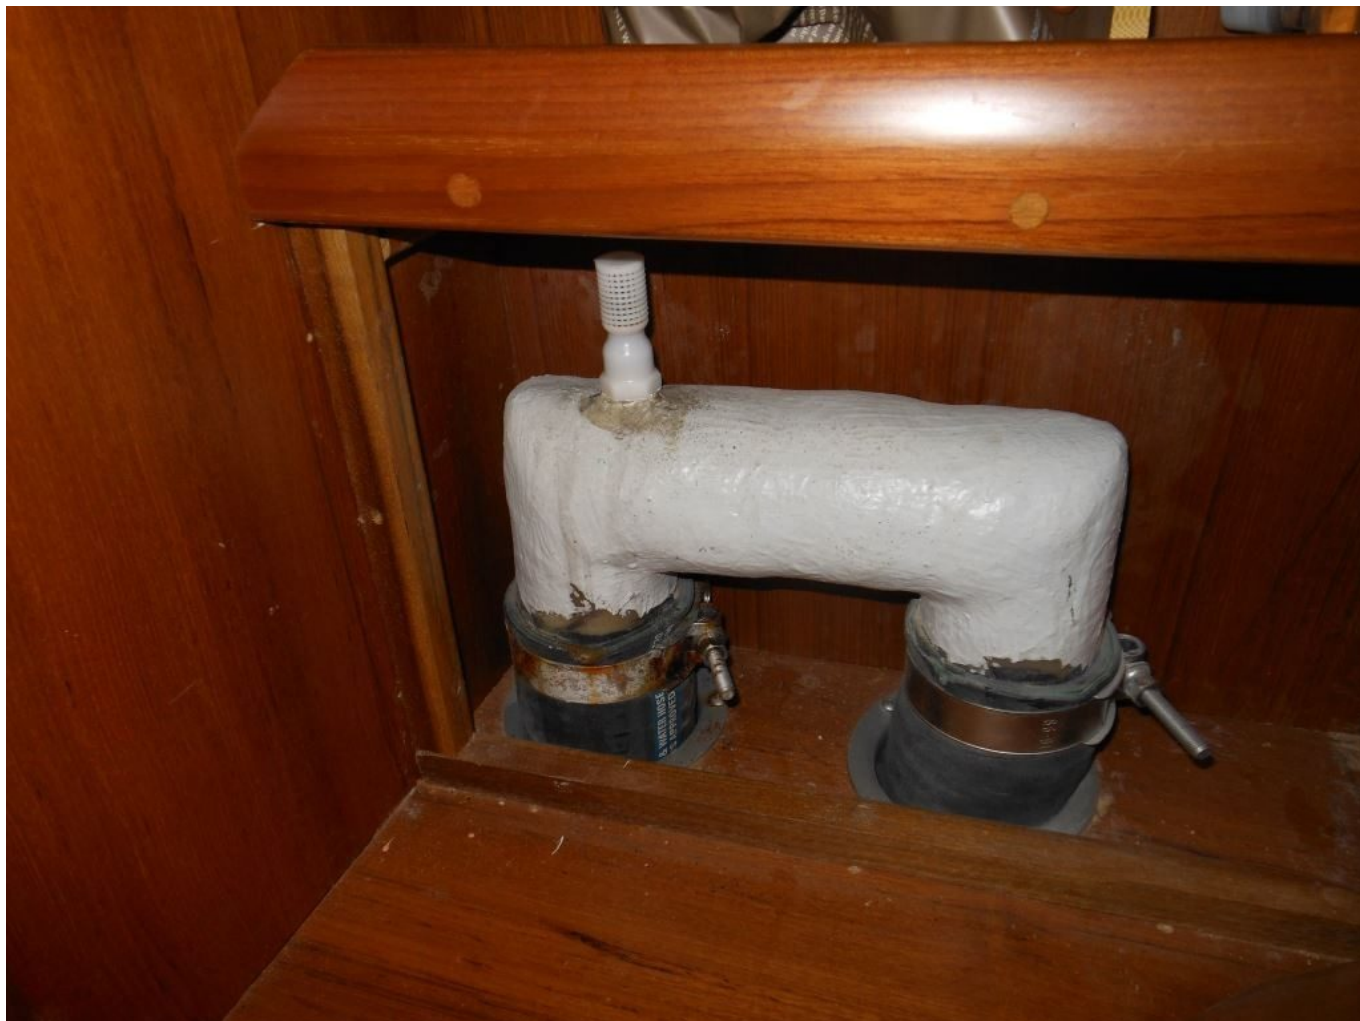
Because it is filled with a mixture of gas and liquid, the likelihood of a siphon being established within a wet exhaust is very low. While there's no harm installing an anti-siphon valve in such an exhaust system, like the one shown here, it's unnecessary. More importantly, it will not prevent pressurized flooding.
