Flooding vs. Siphoning

Know the difference and avoid both

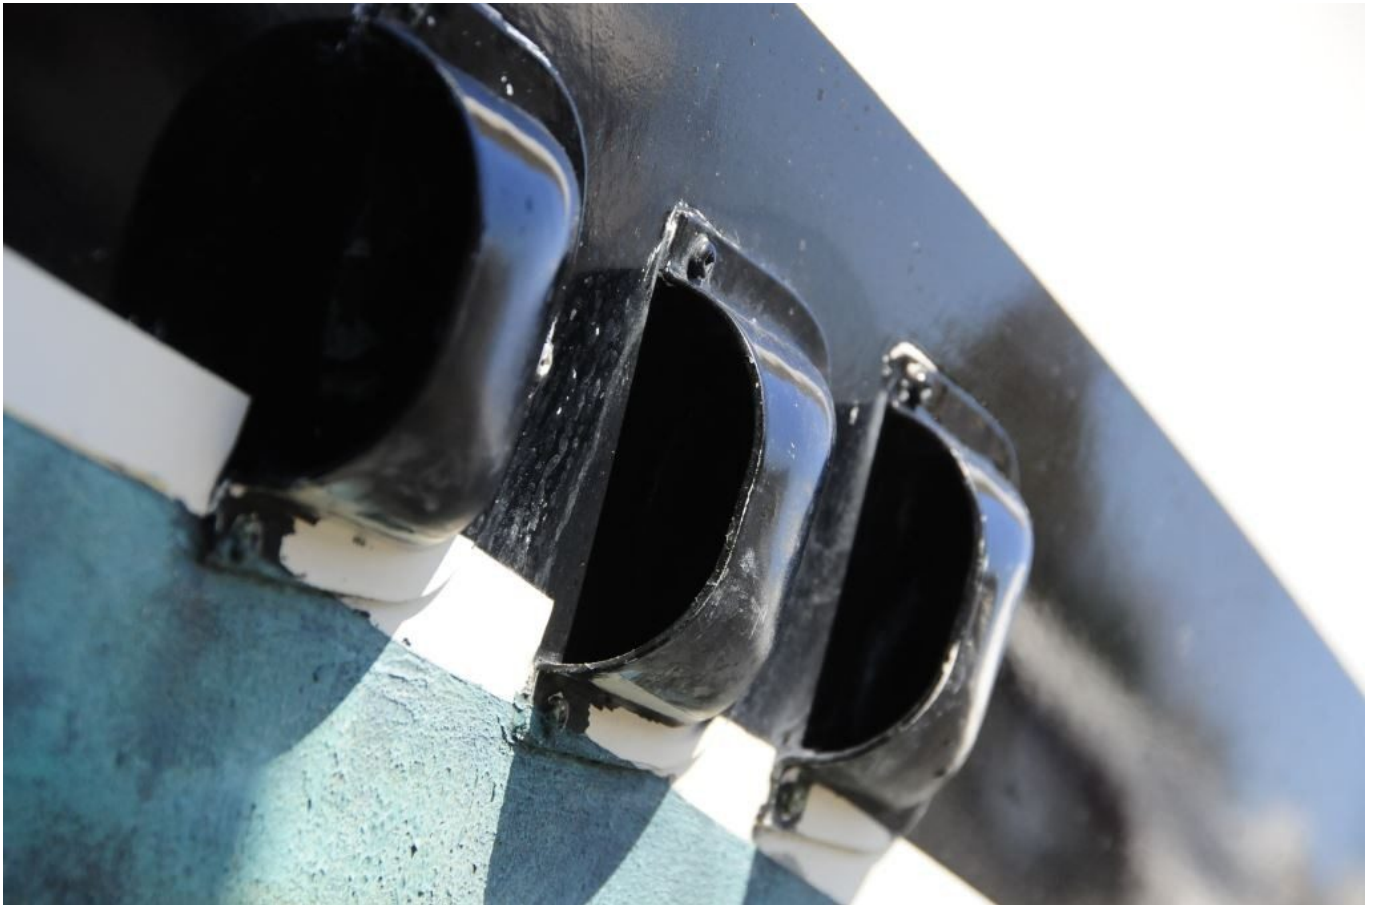
Deflectors located directly ahead of hull-side exhaust outlets (top) are among the most effective means of preventing bow wave-induced flooding. Clamshells (above), on the other hand, can be used to prevent ordinary wave action from forcing water into through hulls for engines, gensets and bilge pumps. These can, however, restrict flow, and when used they should face aft, like the ones shown here, or be angled down and aft at 45°. Under no circumstances should they ever face directly down, as that creates a funneling effect for beam to waves.
