Flooding vs. Siphoning

Know the difference and avoid both

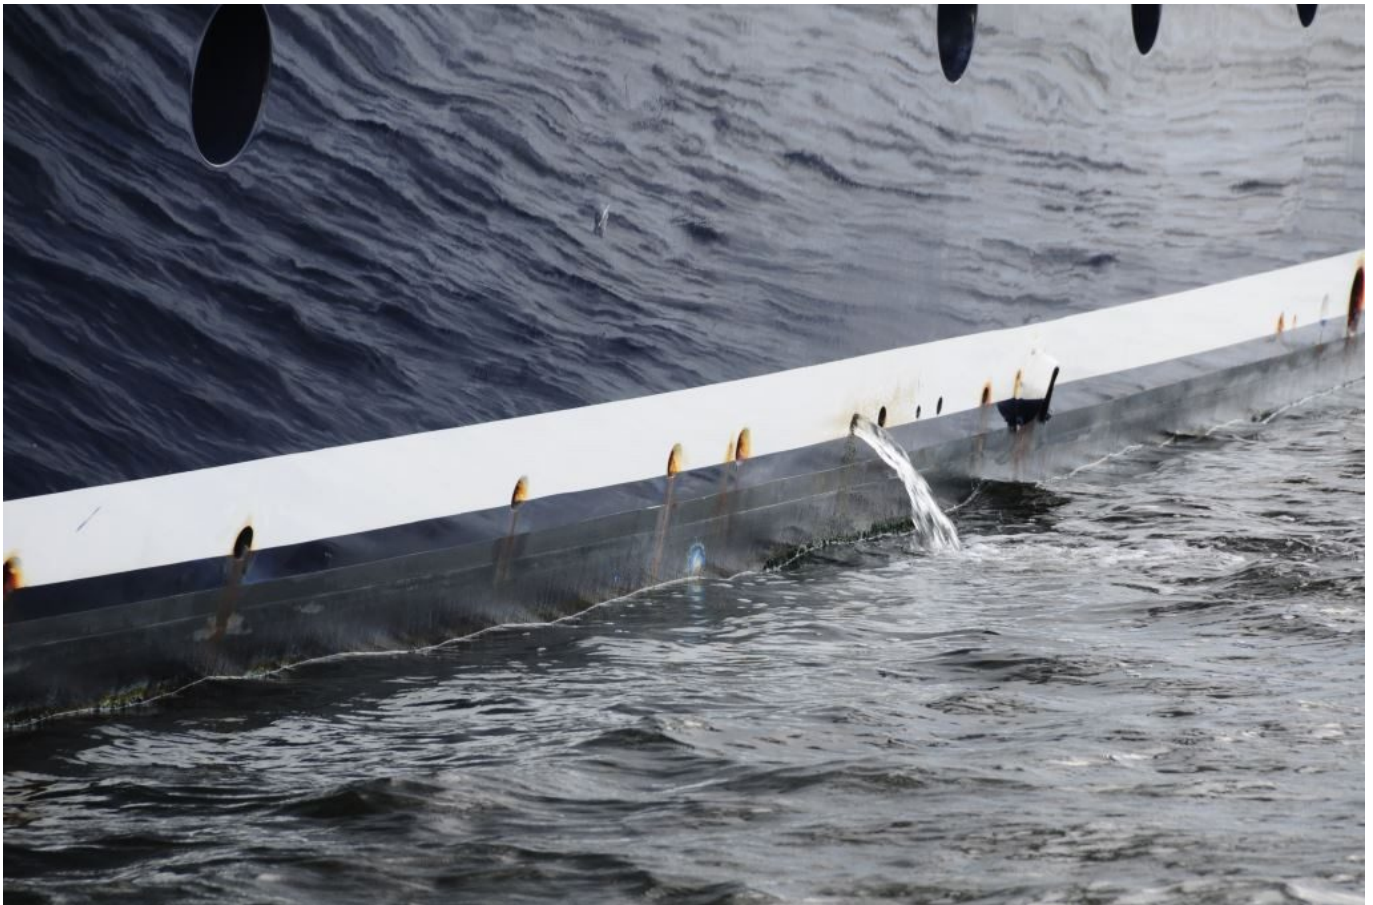
Engine, pump and other discharges that serve equipment that is open to the hull interior, which are close to the waterline, and which will be submerged if the vessel heels or squats, must utilize both an inverted U riser, as well as an anti-siphon valve. The first prevents pressurized flooding, while the second thwarts flooding that is the result of a siphon.

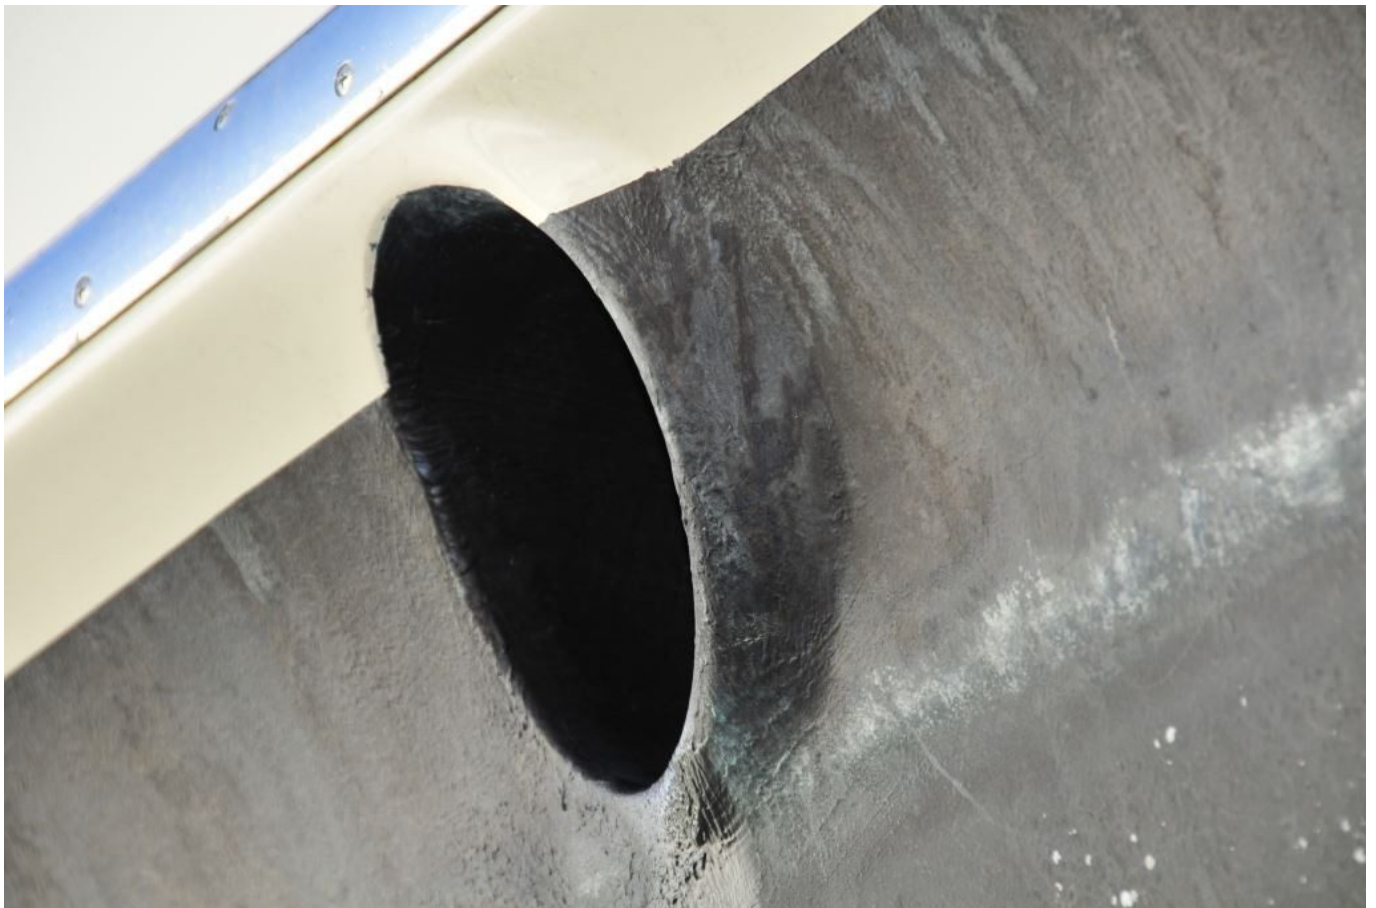
Deflectors located directly ahead of hull-side exhaust outlets (top) are among the most effective means of preventing bow wave-induced flooding. Clamshells (above), on the other hand, can be used to prevent ordinary wave action from forcing water into through hulls for engines, gensets and bilge pumps. These can, however, restrict flow, and when used they should face aft, like the ones shown here, or be angled down and aft at 45°. Under no circumstances should they ever face directly down, as that creates a funneling effect for beam to waves.

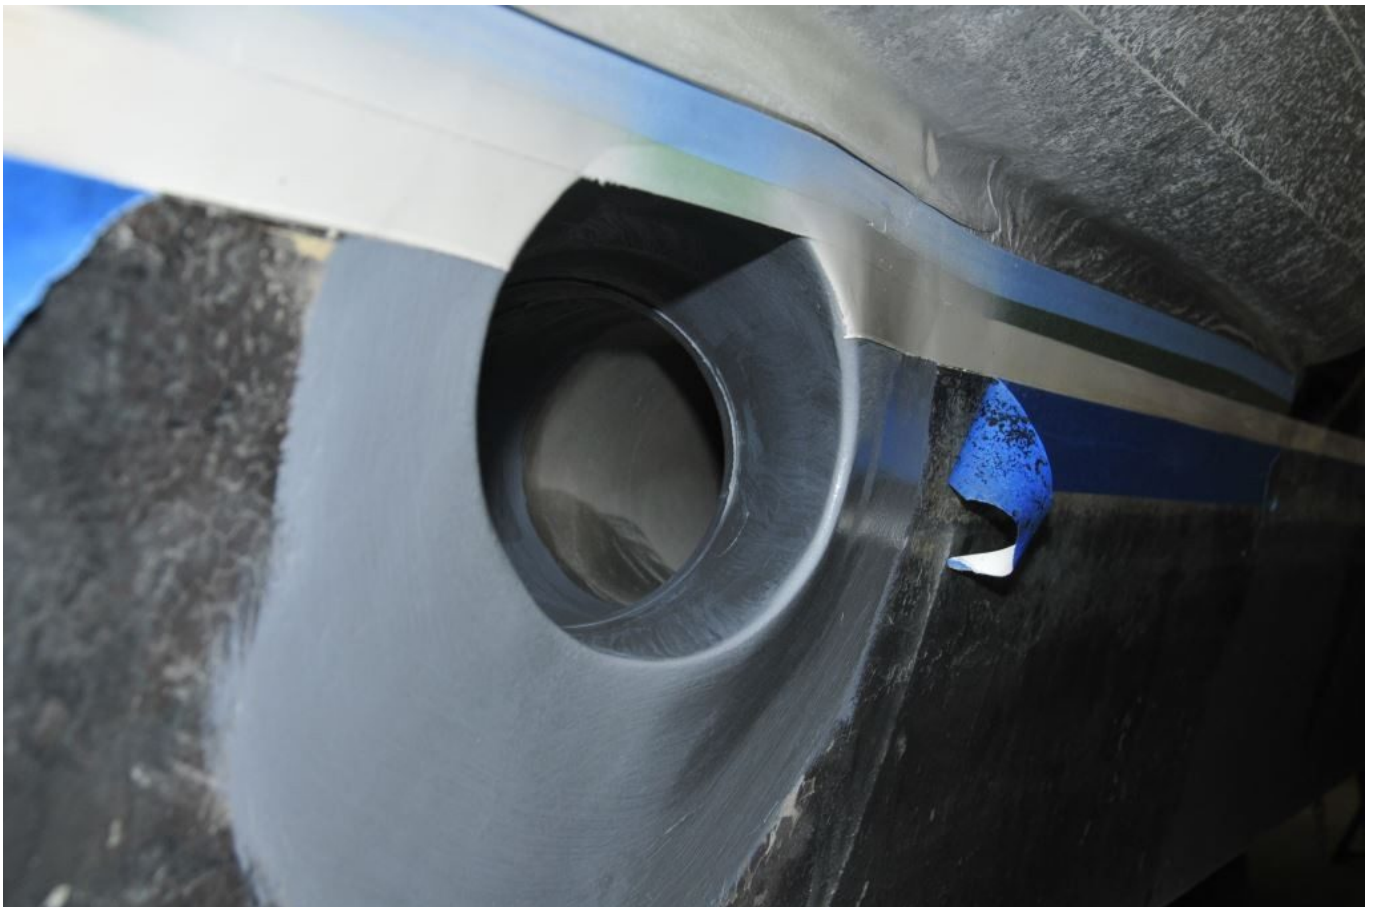
A deflector was added to this exhaust, to prevent pressurized water entry, created by the vessel's bow wave at the point of transition from displacement to planing speed.

The solution was an interesting one, and the very essence of simplicity; a small semicircular wedge of prefabricated fiberglass was attached to the hull immediately forward of the exhaust discharge a spoiler of sorts, which effectively deflected the slip stream of water away from the hull before it could enter the exhaust outlet and hose. Several sea trials under varying conditions proved the design sound, under no condition could water be made to enter the exhaust system.
