# Flooding vs. Siphoning

## Flooding vs. Siphoning

*Know the difference and avoid both*

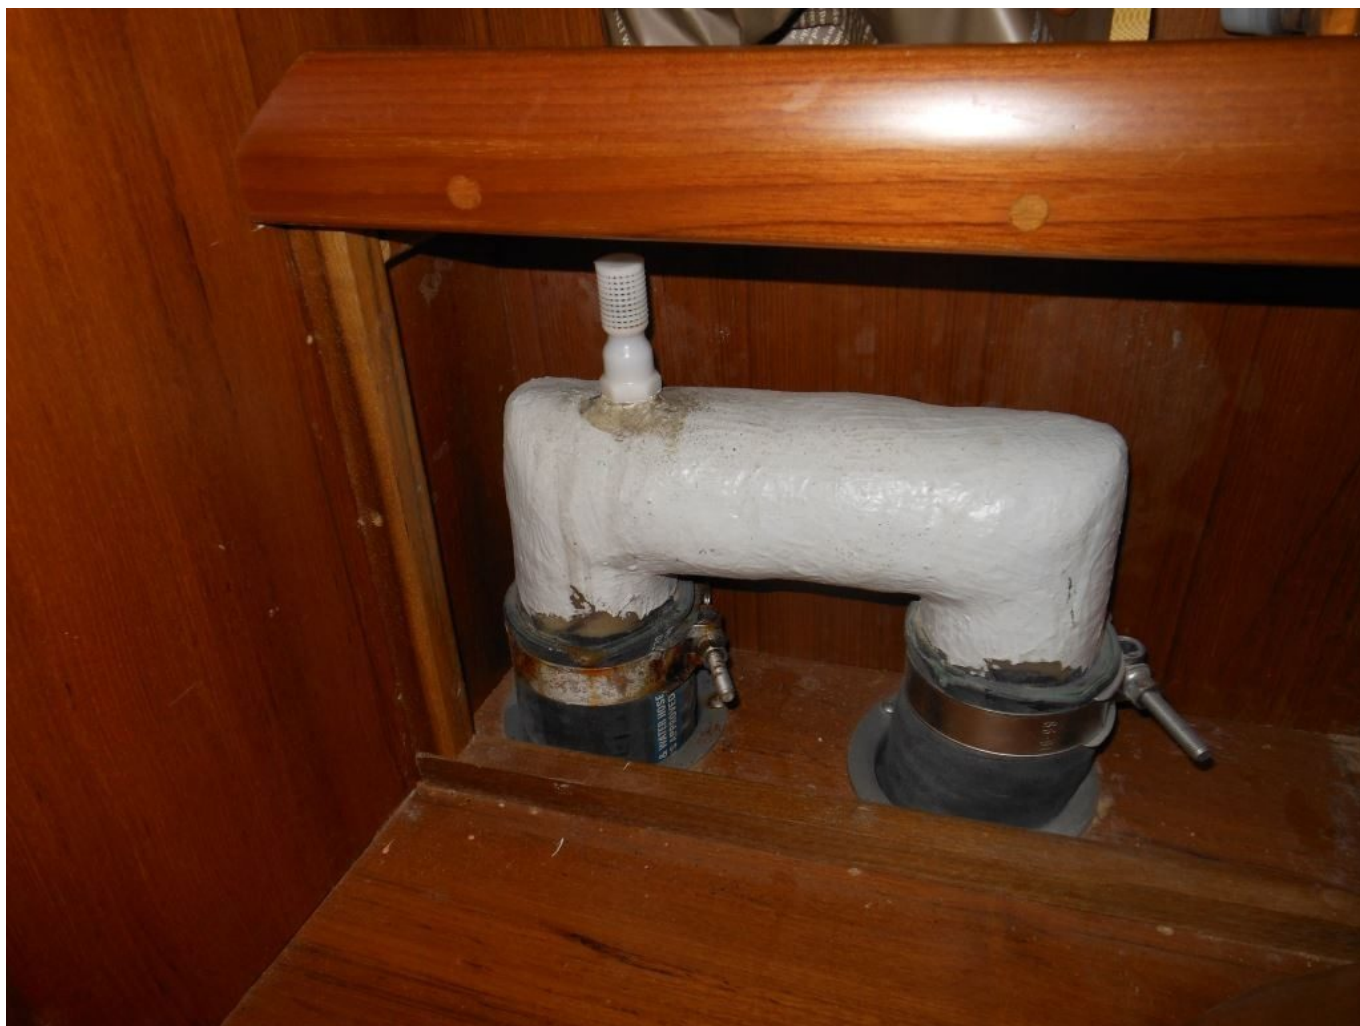
**Because it is filled with a mixture of gas and liquid, the likelihood of a siphon being established within a wet exhaust is very low. While there's no harm installing an anti-siphon valve in such an exhaust system, like the one shown here, it's unnecessary. More importantly, it will not prevent pressurized flooding.**
