# Flooding vs. Siphoning

Text and photos © 2019 Steve D'Antonio Marine Consulting, Inc.

## **Flooding vs. Siphoning**

*Know the difference and avoid both*

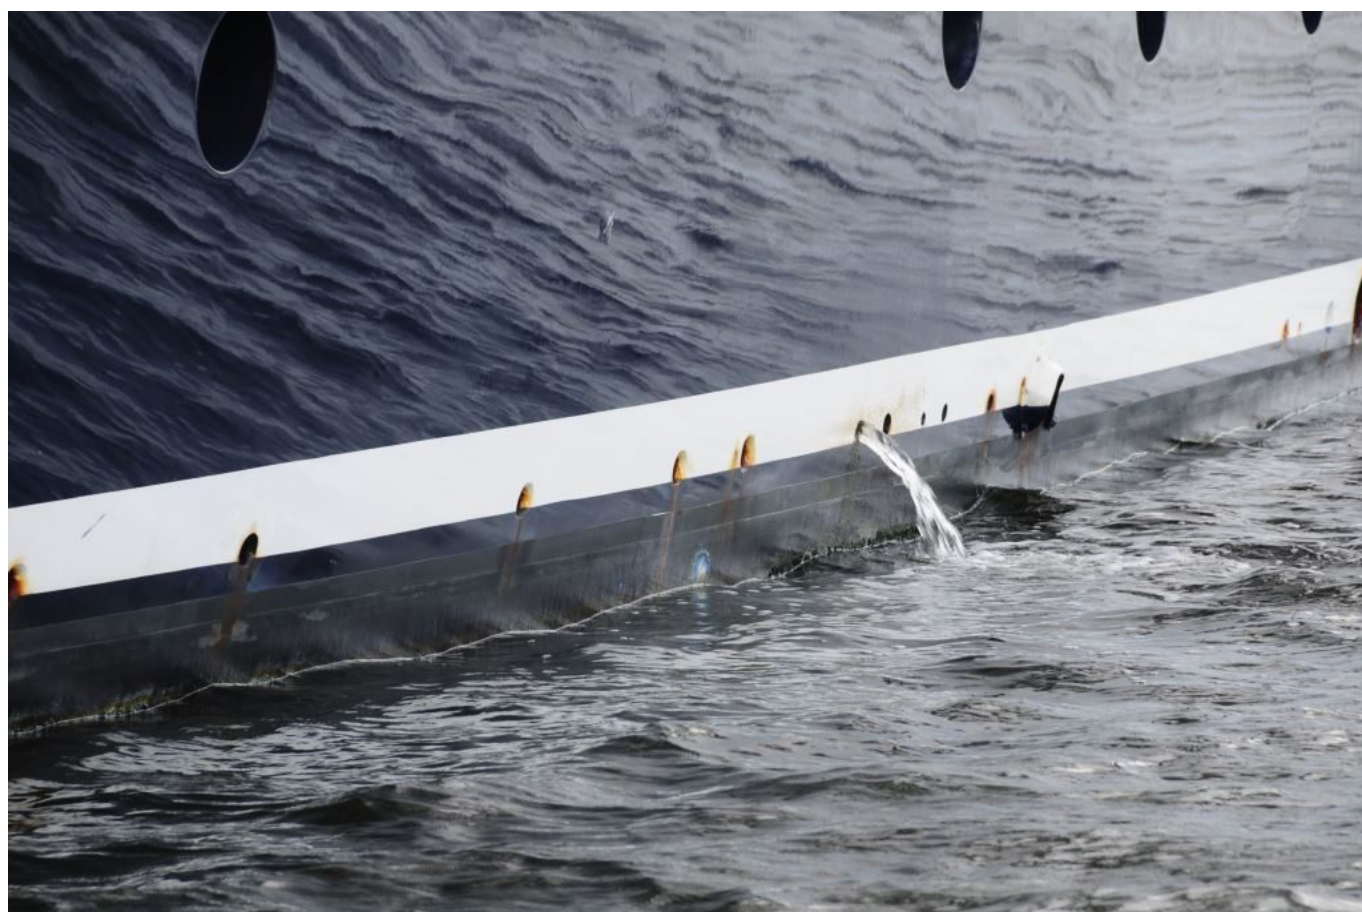
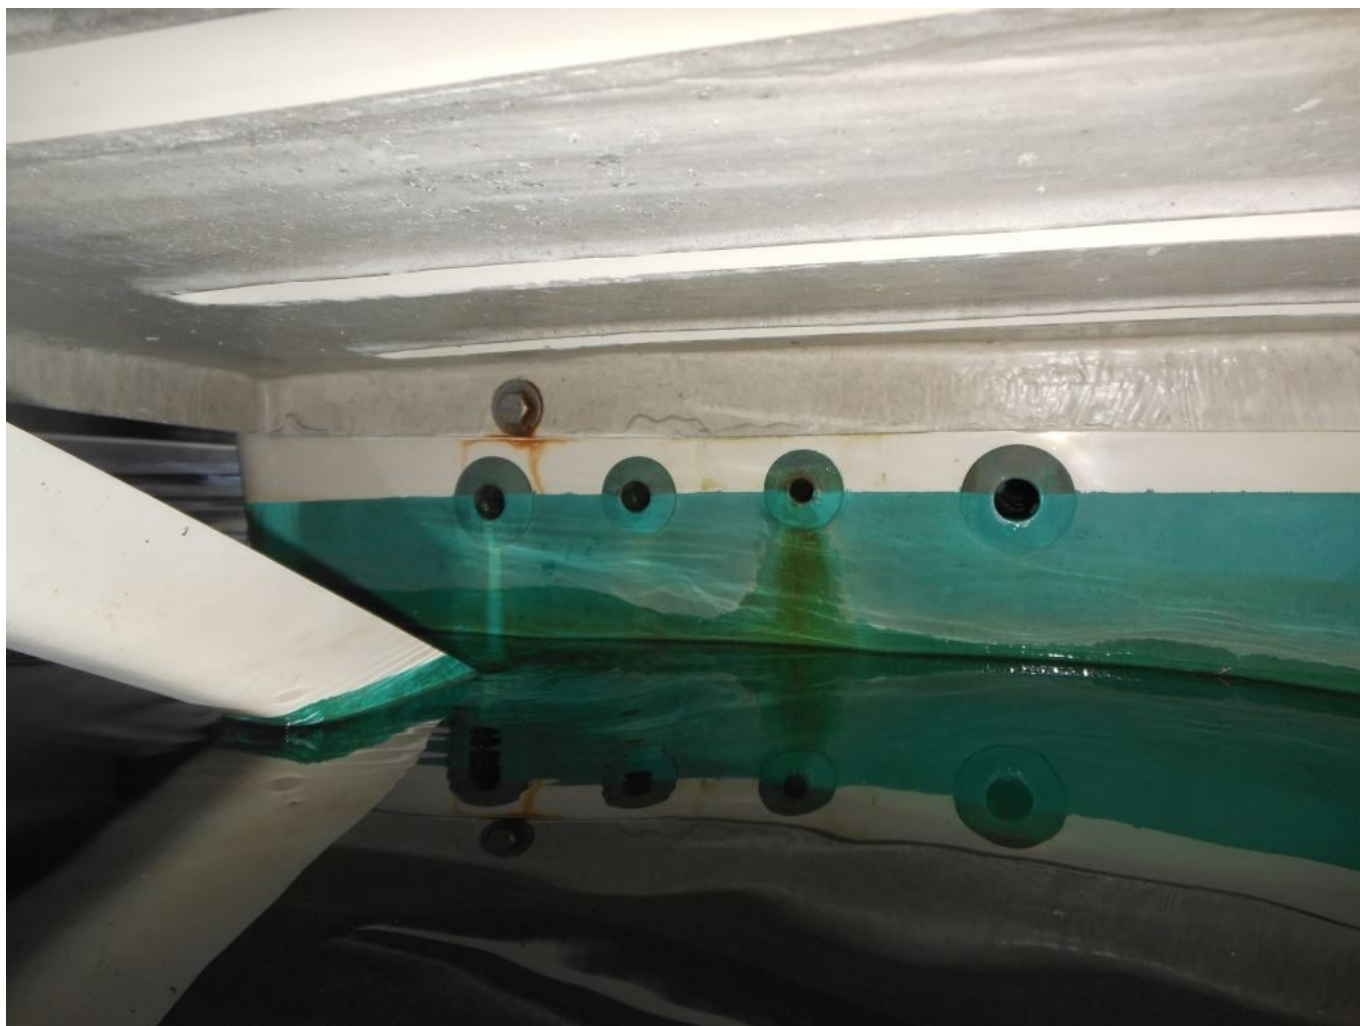
**Engine, pump and other discharges that serve equipment that is open to the hull interior, which are close to the waterline, and which will be submerged if the vessel heels or squats, must utilize both an inverted U riser, as well as an anti-siphon valve. The first prevents pressurized flooding, while the second thwarts flooding that is the result of a siphon.**

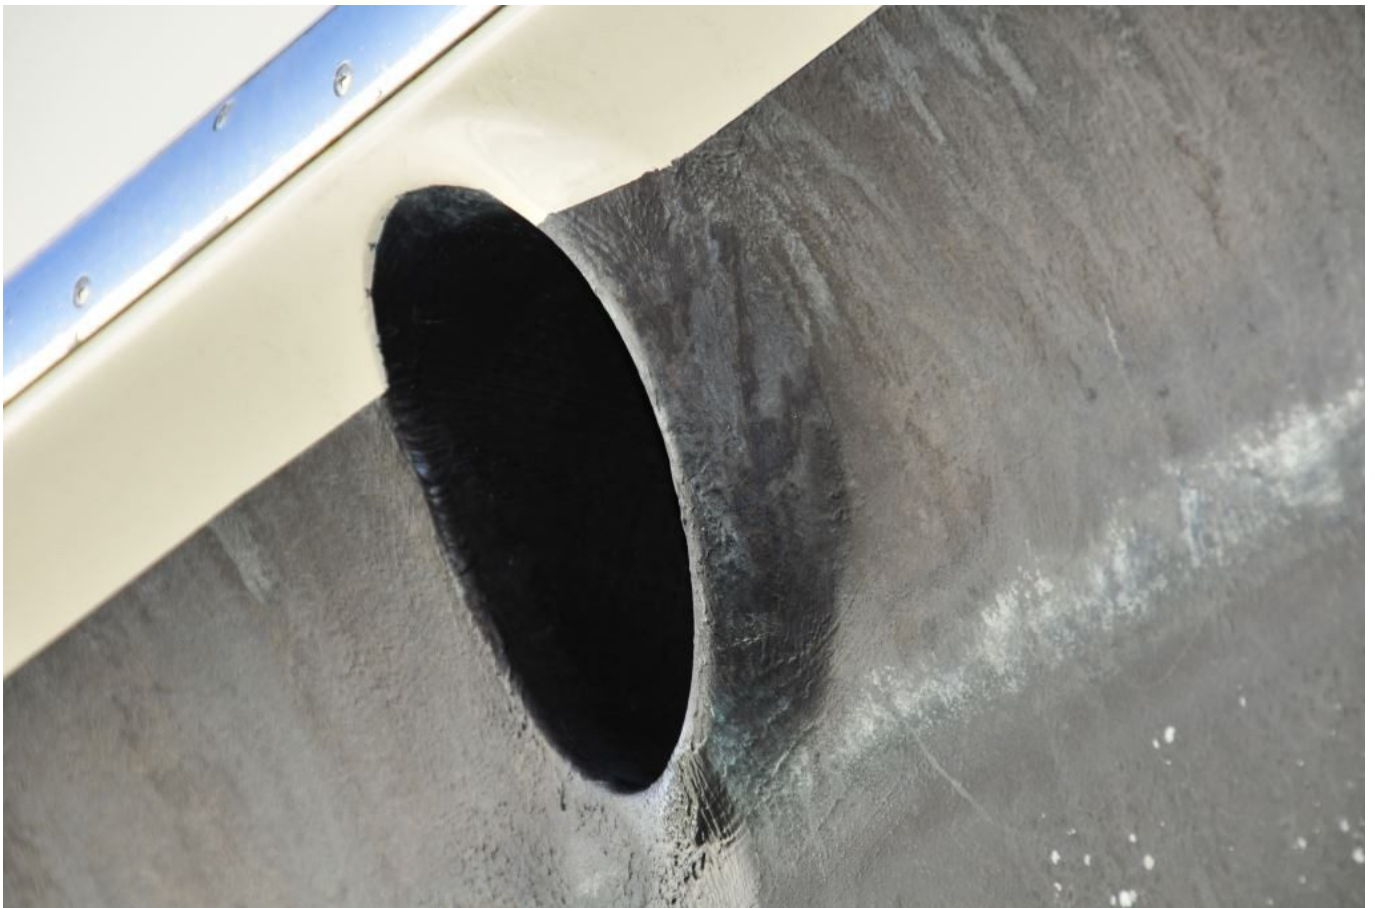
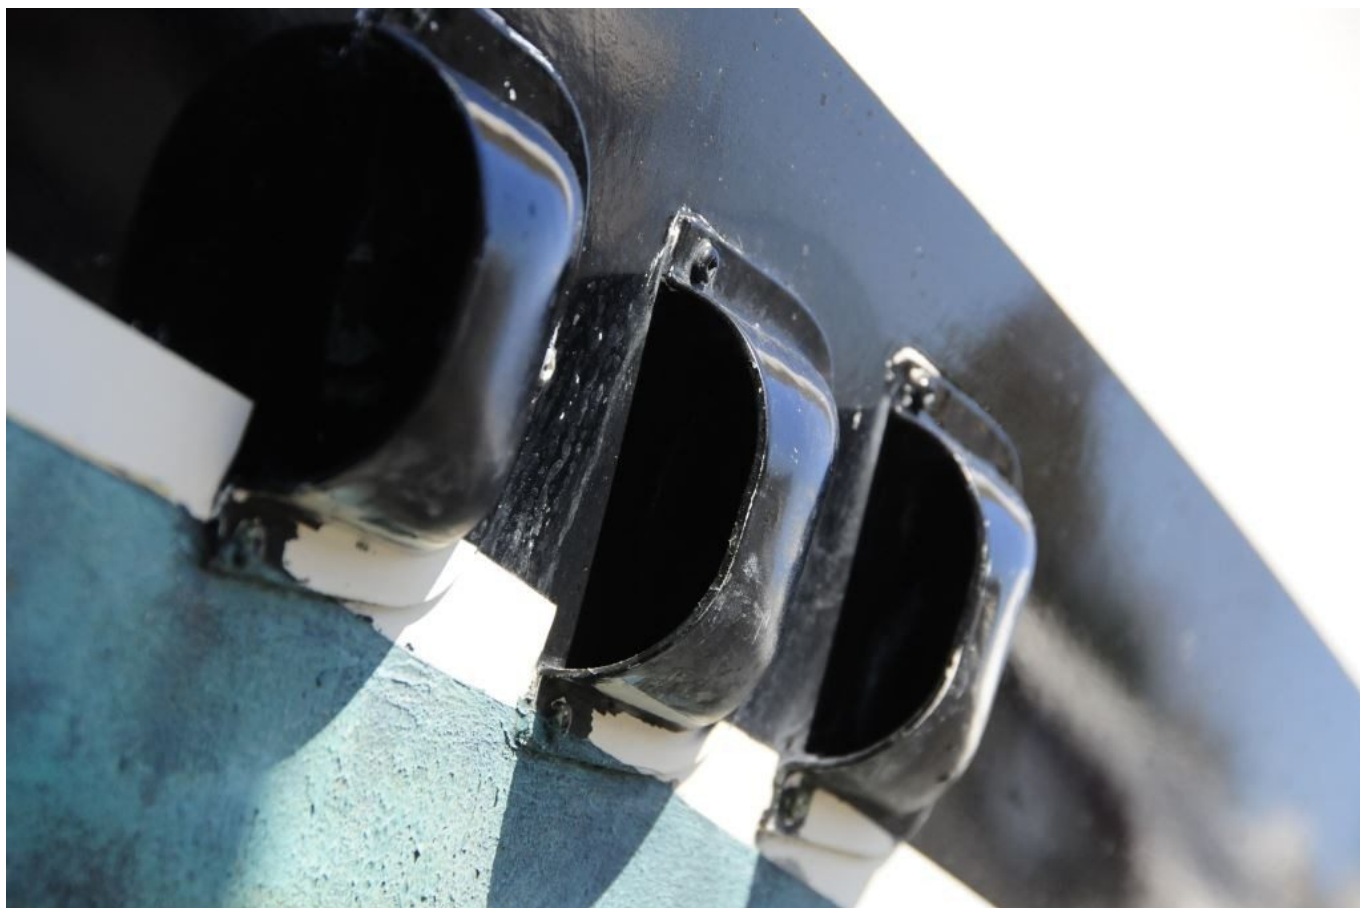
**Deflectors located directly ahead of hull-side exhaust outlets (top) are among the most effective means of preventing bow wave-induced flooding. Clamshells (above), on the other hand, can be used to prevent ordinary wave action from forcing water into through hulls for engines, gensets and bilge pumps.**

**These can, however, restrict flow, and when used they should face aft, like the ones shown here, or be angled down and aft at 45°. Under no circumstances should they ever face directly down, as that creates a funneling effect for beam to waves.**

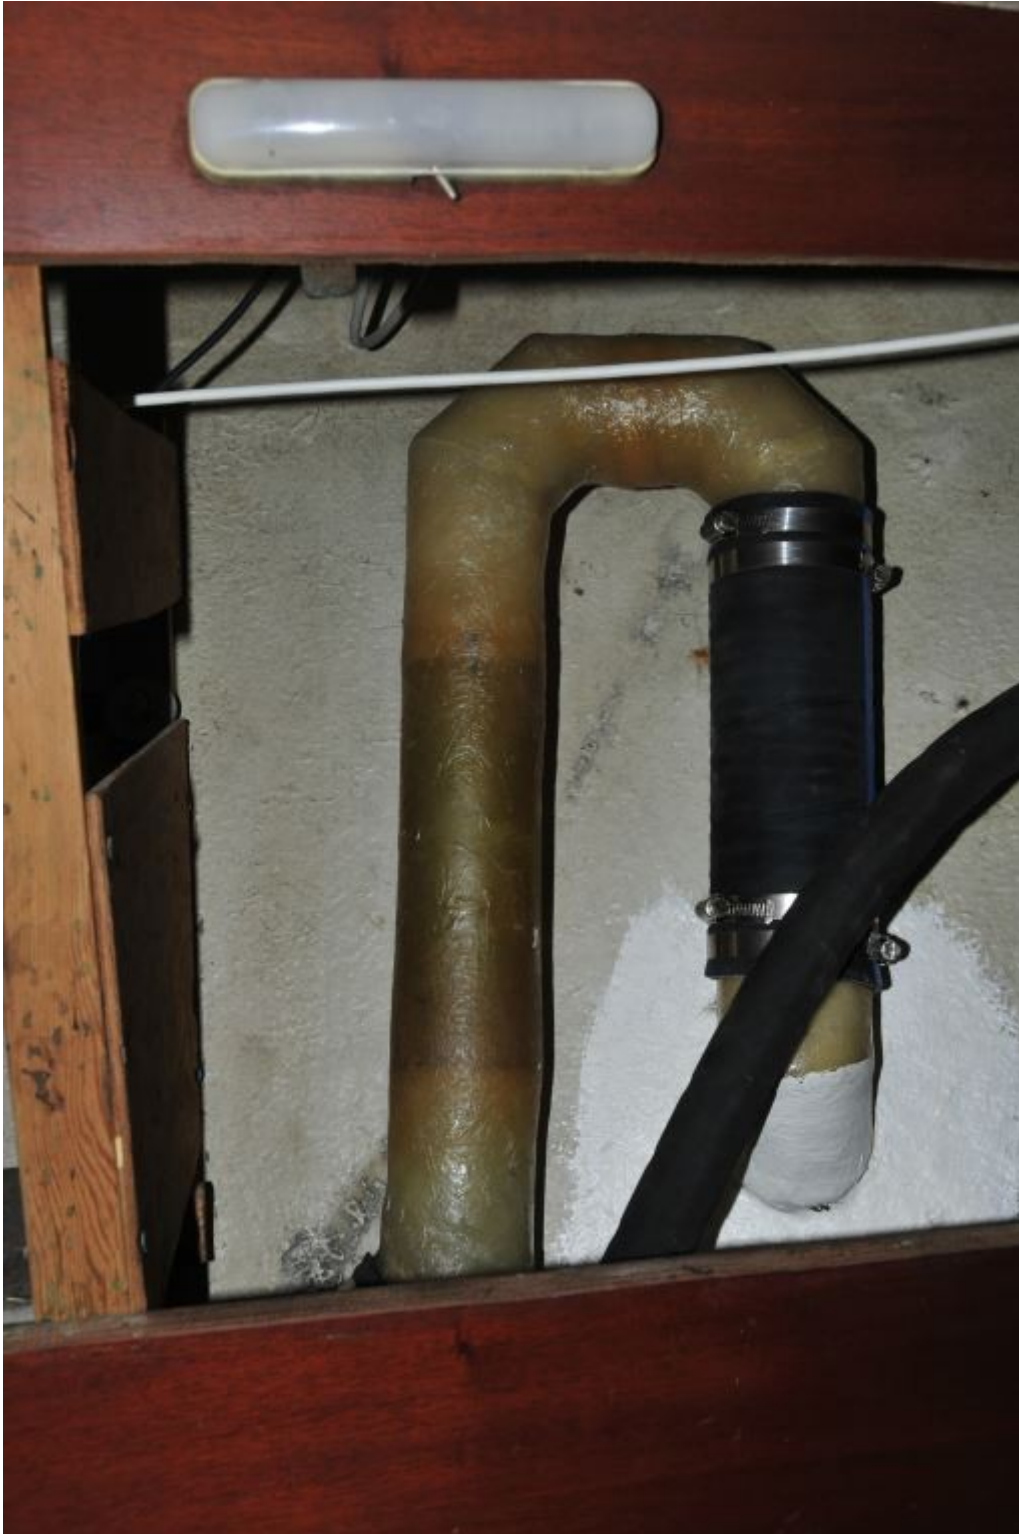
Wet exhaust system inverted U's are effective in preventing water from backing up into engines and gensets. However, if enough pressure is present, even a riser's height can be overcome. This is especially problematic on engines that may not be running while a vessel is underway, such as gensets and

## **sailing vessel propulsion engines.**

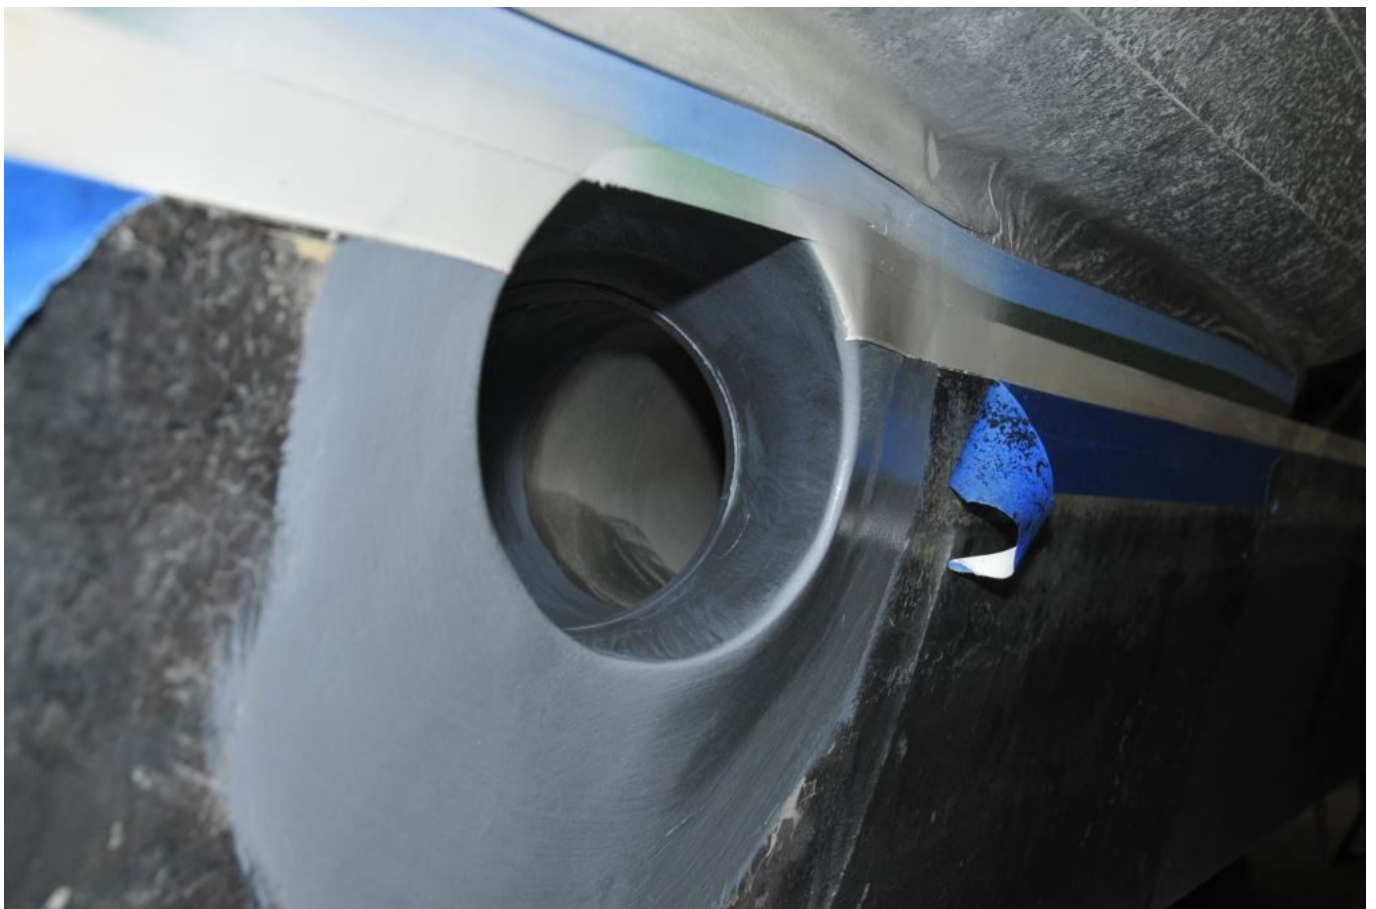
**A deflector was added to this exhaust, to prevent pressurized water entry, created by the vessel's bow wave at the point of transition from displacement to planing speed.**

The solution was an interesting one, and the very essence of simplicity; a small semicircular wedge of prefabricated fiberglass was attached to the hull immediately forward of the exhaust discharge a spoiler of sorts, which effectively deflected the slip stream of water away from the hull before it could enter the exhaust outlet and hose. Several sea trials under varying conditions proved the design sound, under no condition could water be made to enter the exhaust system.

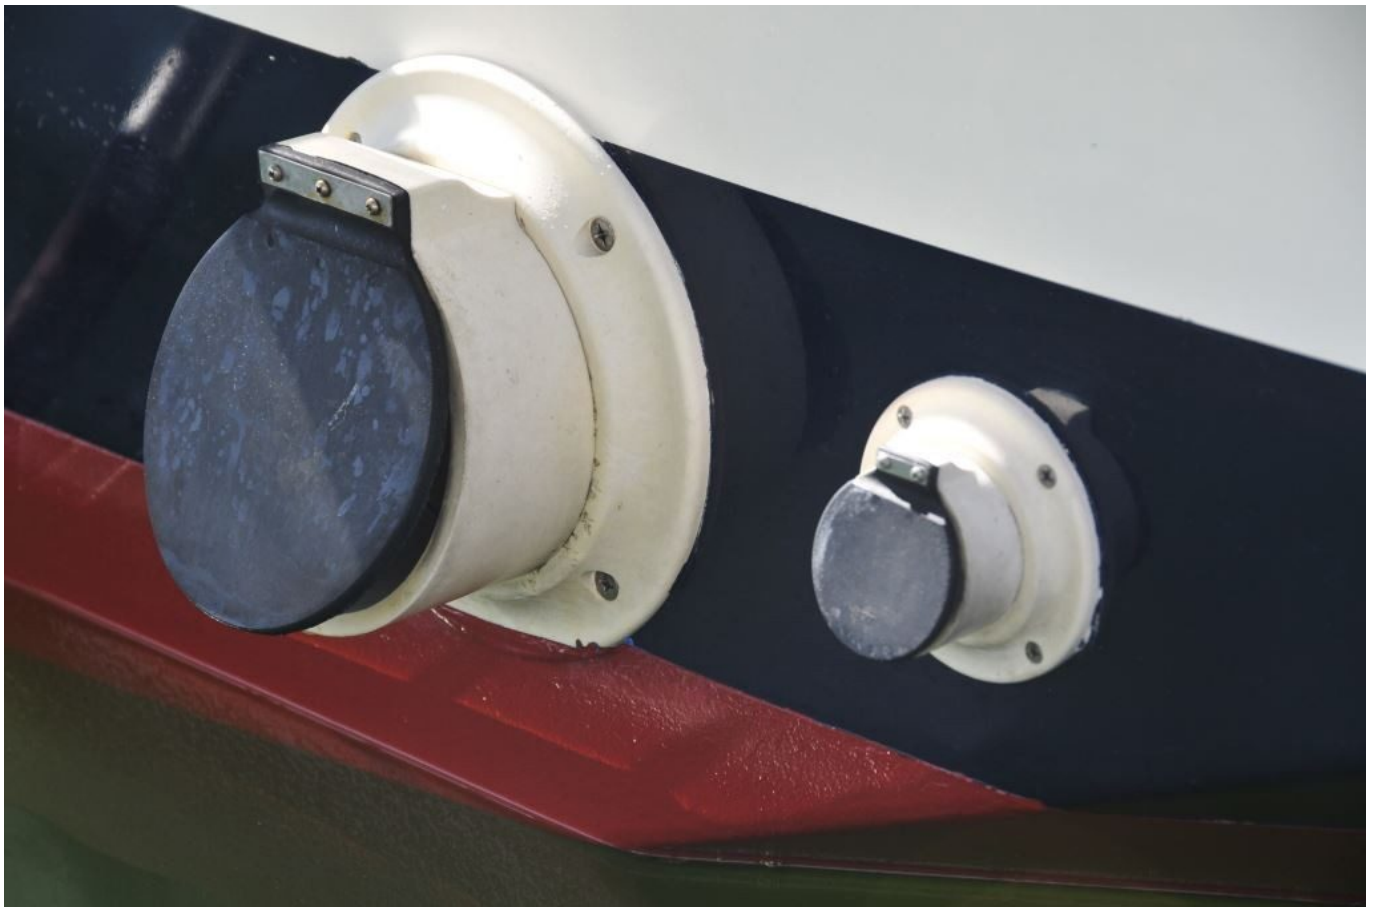
**Flappers can be an effective means of preventing water from traveling the wrong direction into a transom-mounted exhaust discharge outlet. They do, however, wear out and often fall off without the owner's knowledge. If your vessel is equipped with these, be sure to check them regularly.**

While a rubber flap is sometimes used to prevent back-flow, they are more effective for transom rather than side exhausts, in the latter application they are frequently dislodged and lost. Yet another alternative involves the use of a proprietary exhaust check valve, available from marine exhaust

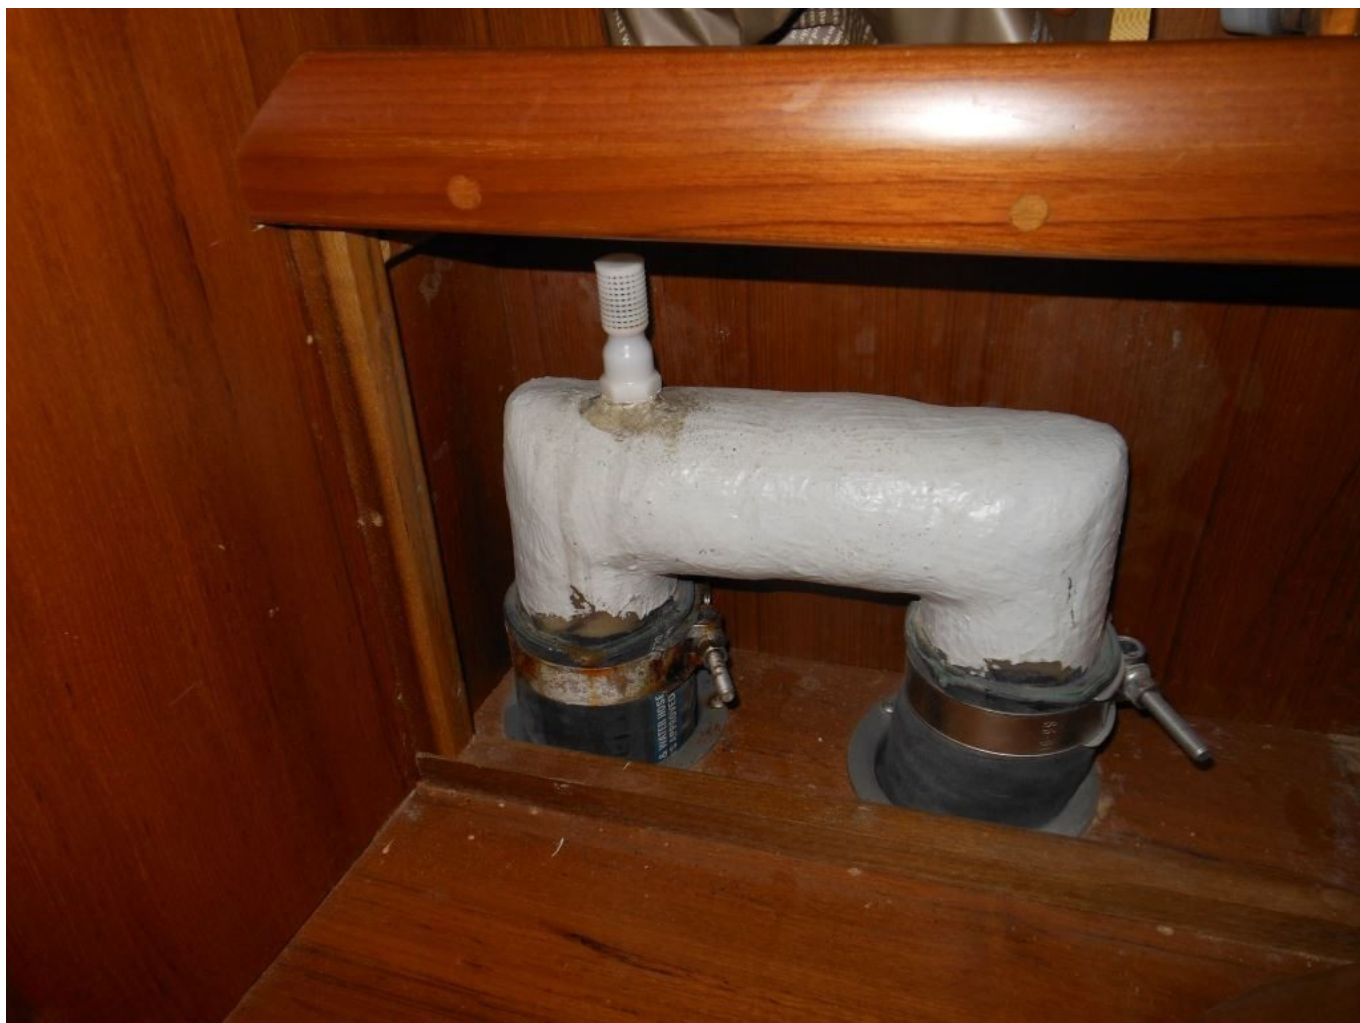
**Because it is filled with a mixture of gas and liquid, the likelihood of a siphon being established within a wet exhaust is very low. While there's no harm installing an anti-siphon valve in such an exhaust system, like the one shown here, it's unnecessary. More importantly, it will not prevent pressurized flooding.**
