Flooding vs. Siphoning

Know the difference and avoid both

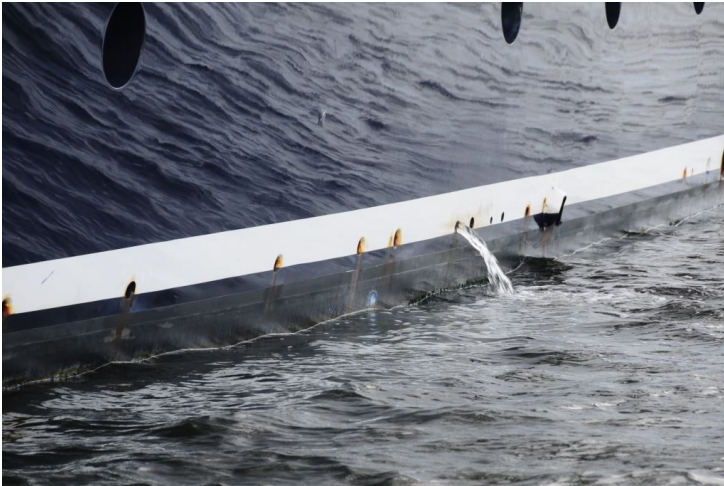
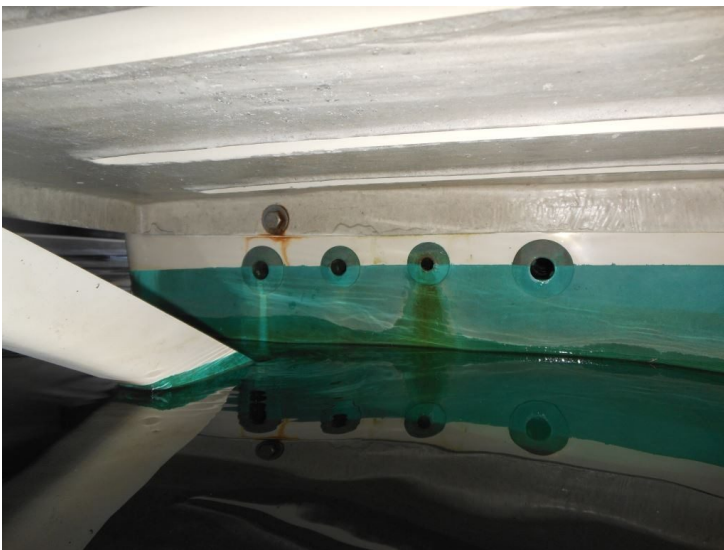
Engine, pump and other discharges that serve equipment that is open to the hull interior, which are close to the waterline,

and which will be submerged if the vessel heels or squats, must utilize both an inverted U riser, as well as an anti-siphon valve. The first prevents pressurized flooding, while the second thwarts flooding that is the result of a siphon.

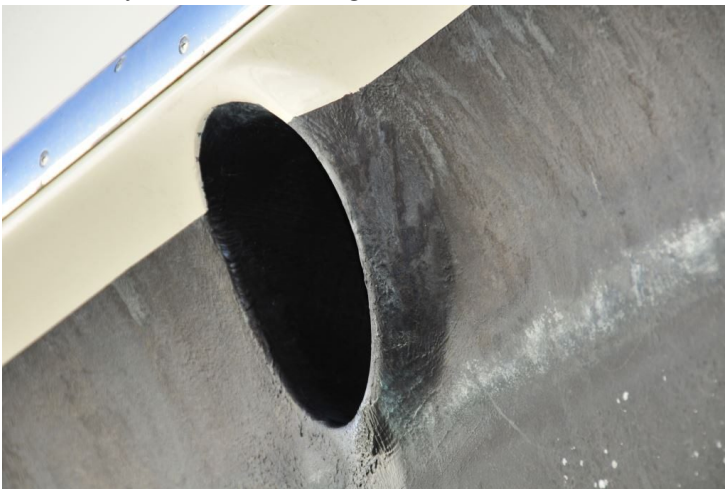
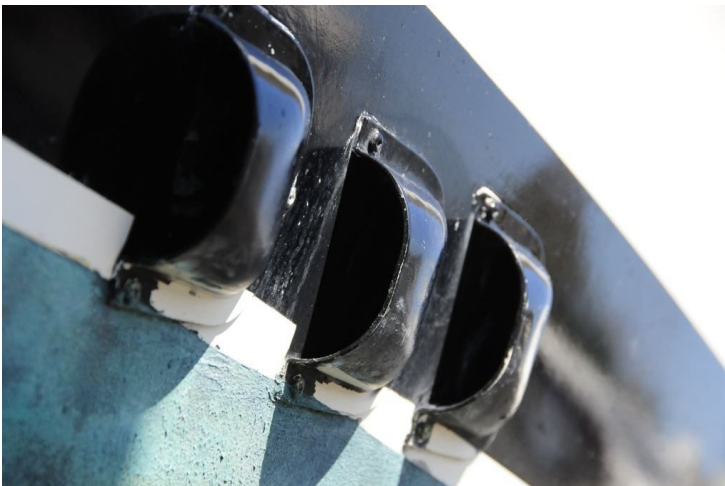
Deflectors located directly ahead of hull-side exhaust outlets (top) are among the most effective means of preventing bow wave-induced flooding. Clamshells (above), on the other hand, can be used to prevent ordinary wave action from forcing water into through hulls for engines, gensets and bilge pumps. These can, however, restrict flow, and when used they should face aft, like the ones shown here, or be angled down and aft at 45°. Under no circumstances should they ever face directly down, as that creates a funneling effect for beam to waves.

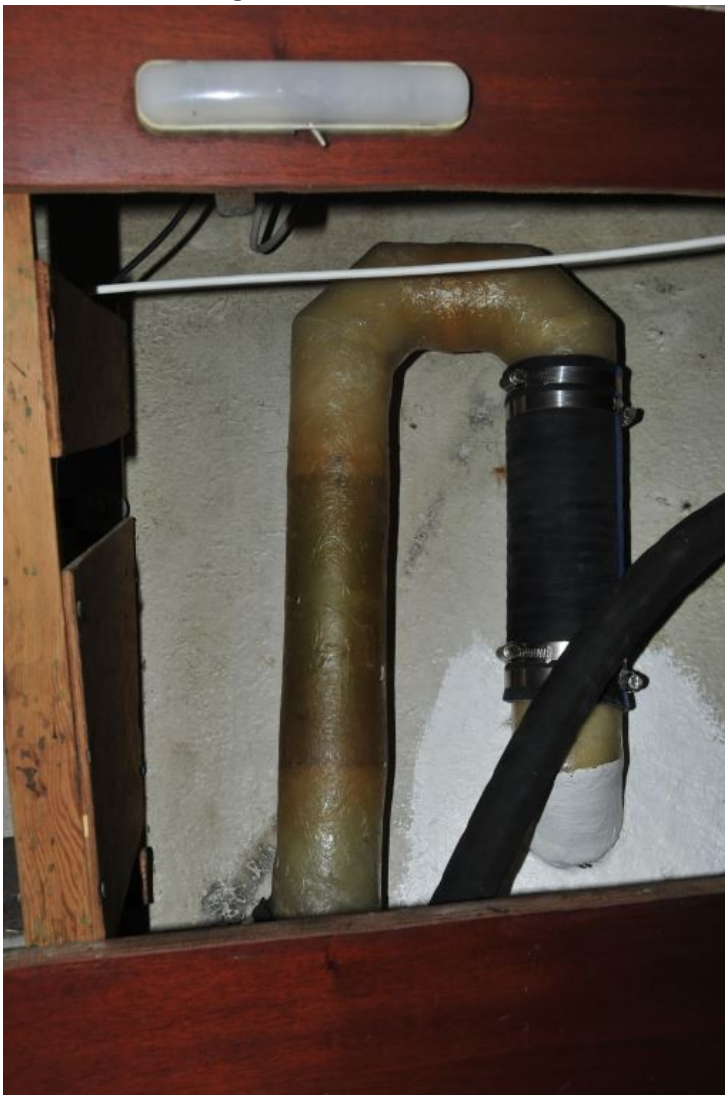
Wet exhaust system inverted Us are effective in preventing water from backing up into engines and gensets. However, if enough pressure is present, even a riser's height can be overcome. This is especially problematic on engines that may not be running while a vessel is underway, such as gensets and sailing vessel propulsion engines.

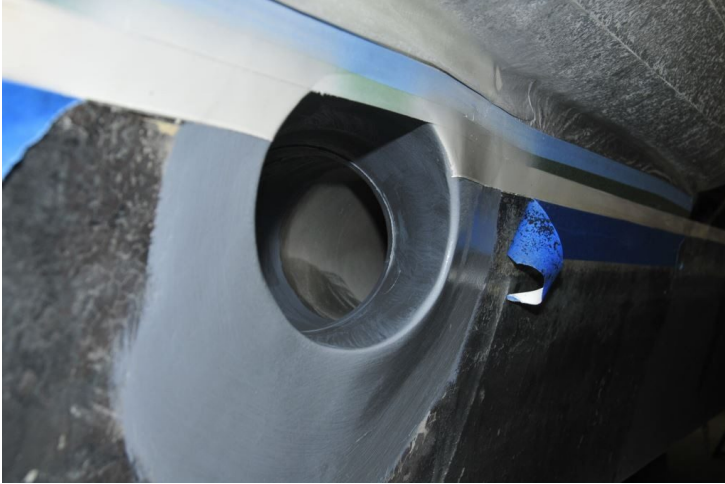
A deflector was added to this exhaust, to prevent pressurized water entry, created by the vessel's bow wave at the point of transition from displacement to planing speed.

The solution was an interesting one, and the very essence of simplicity; a small semicircular wedge of prefabricated fiberglass was attached to the hull immediately forward of the exhaust discharge a spoiler of sorts, which effectively deflected the slip stream of water away from the hull before it could enter the exhaust outlet and hose. Several sea trials under varying conditions proved the design sound, under no condition could water be made to enter the exhaust system.

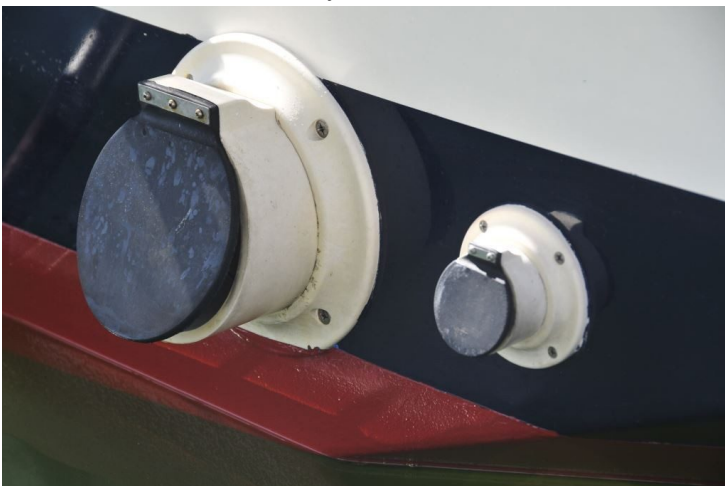
Flappers can be an effective means of preventing water from traveling the wrong direction into a transom-mounted exhaust discharge outlet. They do, however, wear out and often fall off without the owner's knowledge. If your vessel is equipped with these, be sure to check them regularly.

While a rubber flap is sometimes used to prevent back-flow, they are more effective for transom rather than side exhausts, in the latter application they are frequently dislodged and lost. Yet another alternative involves the use of a proprietary exhaust check valve, available from marine exhaust manufacturers. While these are viable and effective at preventing water from being driven up and into exhaust systems, they are difficult to inspect once installed, users have no way of readily knowing if the check flap remains intact, or is even there at all. Instead, my goal was to prevent water from entering any part of the exhaust system beginning at the hull outlet. Because water only entered under a narrow set of conditions, upsetting that scenario was all that was needed.

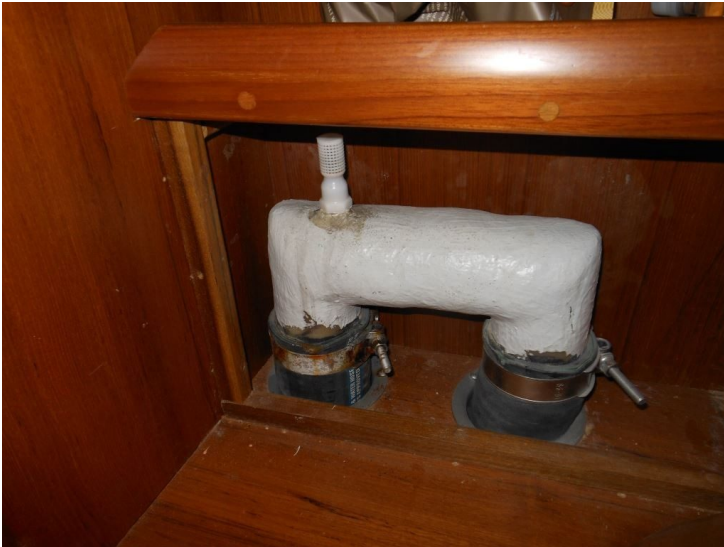
Because it is filled with a mixture of gas and liquid, the likelihood of a siphon being established within a wet exhaust is very low. While there's no harm installing an anti-siphon valve in such an exhaust system, like the one shown here, it's unnecessary. More importantly, it will not prevent pressurized flooding.
