# Flooding vs. Siphoning

## **Flooding vs. Siphoning**

*Know the difference and avoid both*

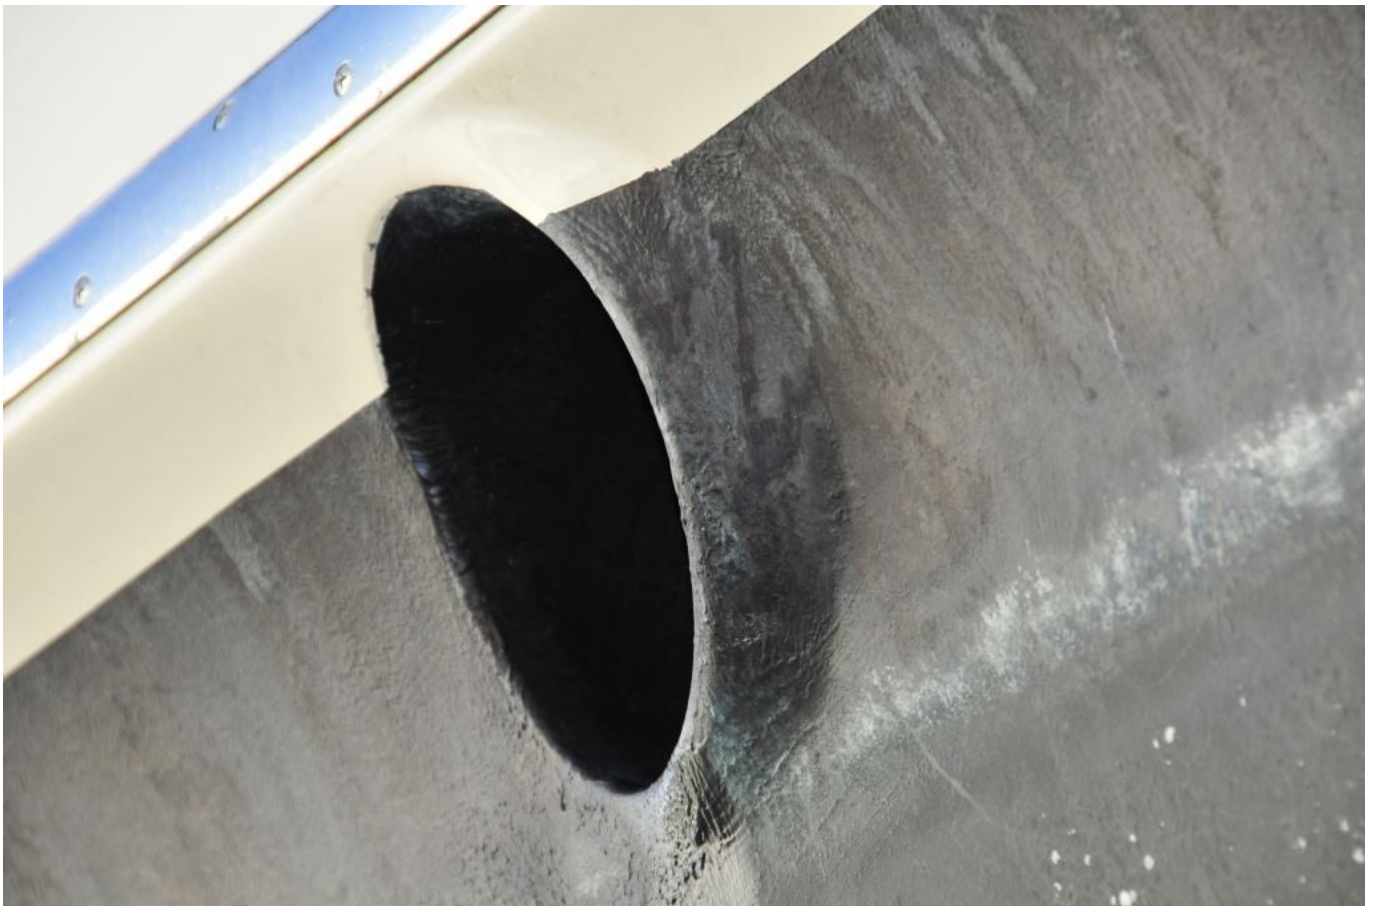
**Deflectors located directly ahead of hull-side exhaust outlets (top) are among the most effective means of preventing bow wave-induced flooding. Clamshells (above), on the other hand, can be used to prevent ordinary wave action from forcing water into through hulls for engines, gensets and bilge pumps. These can, however, restrict flow, and when used they should face aft, like the ones shown here, or be angled down and aft at 45°. Under no circumstances should they ever face directly down, as that creates a funneling effect for beam to waves.**

The solution was an interesting one, and the very essence of simplicity; a small semicircular wedge of prefabricated fiberglass was attached to the hull immediately forward of the exhaust discharge a spoiler of sorts, which effectively deflected the slip stream of water away from the hull before it could enter the exhaust outlet and hose. Several sea trials under varying conditions proved the design sound, under no condition could water be made to enter the exhaust system.

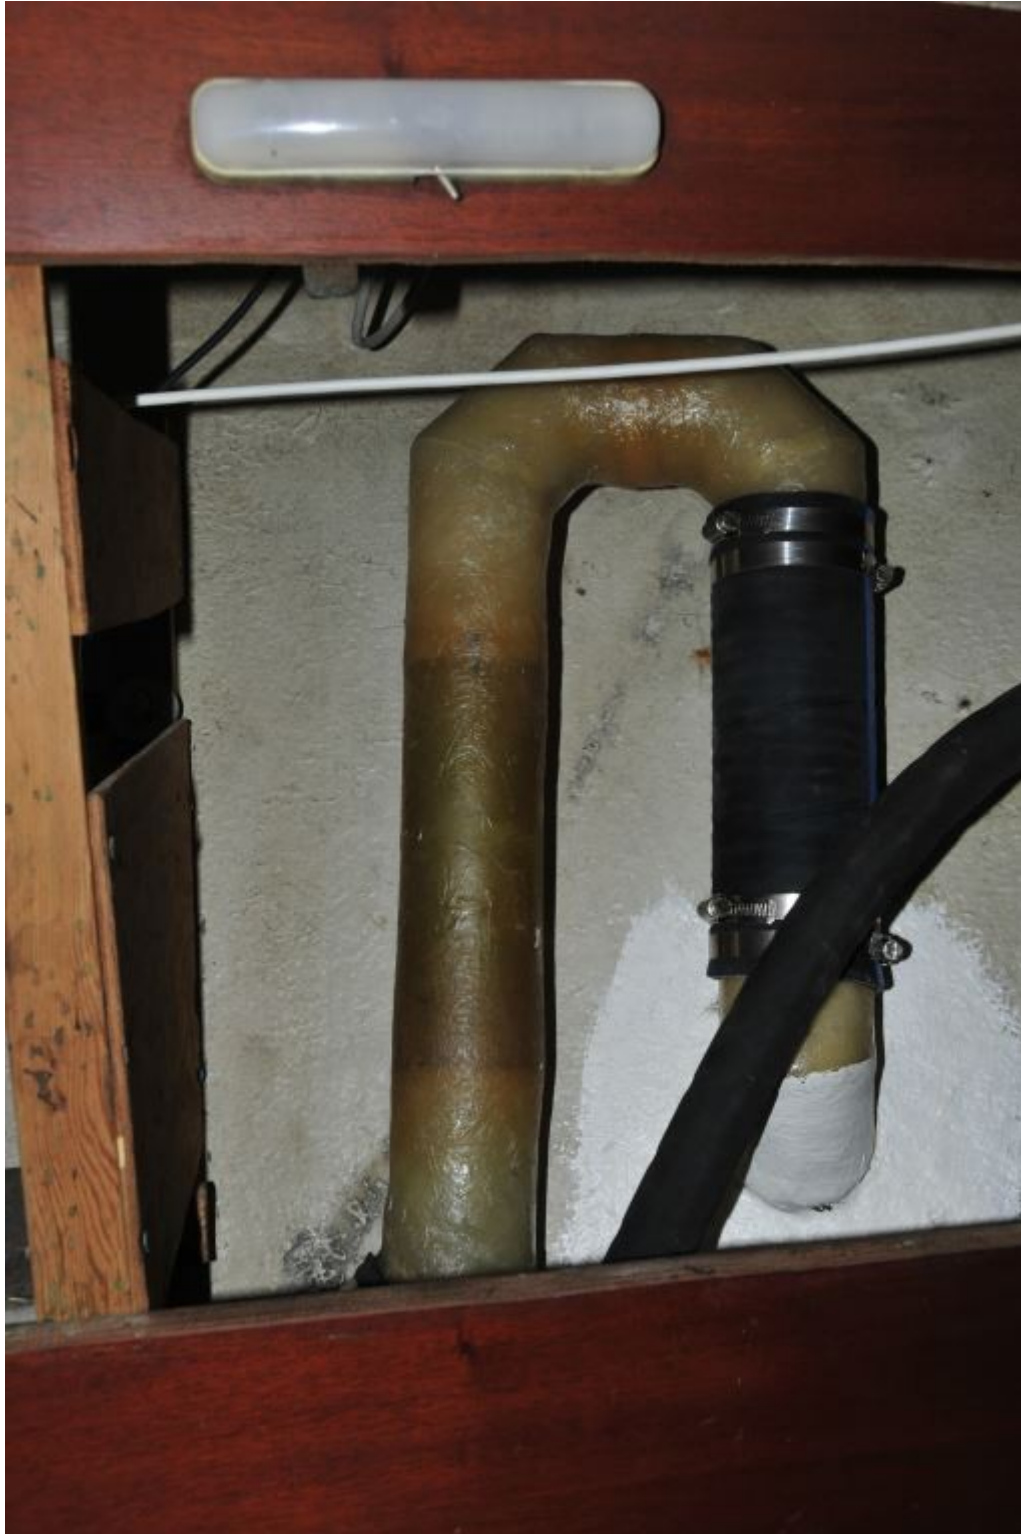
Wet exhaust system inverted U's are effective in preventing water from backing up into engines and gensets. However, if enough pressure is present, even a riser's height can be overcome. This is especially problematic on engines that may not be running while a vessel is underway, such as gensets and

## **sailing vessel propulsion engines.**
