# Flooding vs. Siphoning

## Flooding vs. Siphoning

*Know the difference and avoid both*

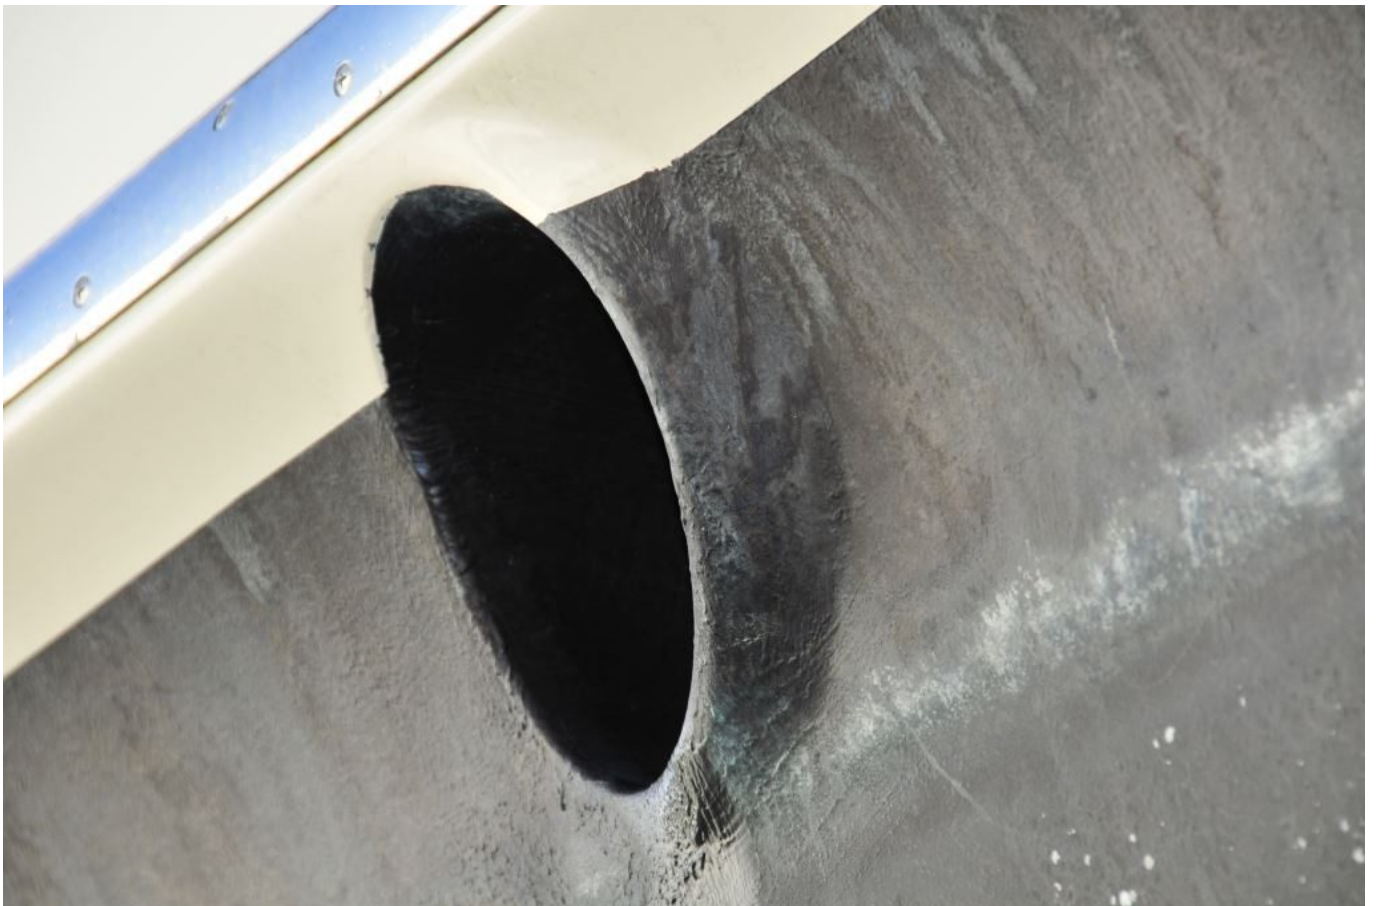
**Deflectors located directly ahead of hull-side exhaust outlets (top) are among the most effective means of preventing bow wave-induced flooding. Clamshells (above), on the other hand, can be used to prevent ordinary wave action from forcing water into through hulls for engines, gensets and bilge pumps. These can, however, restrict flow, and when used they should face aft, like the ones shown here, or be angled down and aft at 45°. Under no circumstances should they ever face directly down, as that creates a funneling effect for beam to waves.**

The solution was an interesting one, and the very essence of simplicity; a small semicircular wedge of prefabricated fiberglass was attached to the hull immediately forward of the exhaust discharge a spoiler of sorts, which effectively deflected the slip stream of water away from the hull before it could enter the exhaust outlet and hose. Several sea trials under varying conditions proved the design sound, under no condition could water be made to enter the exhaust system.

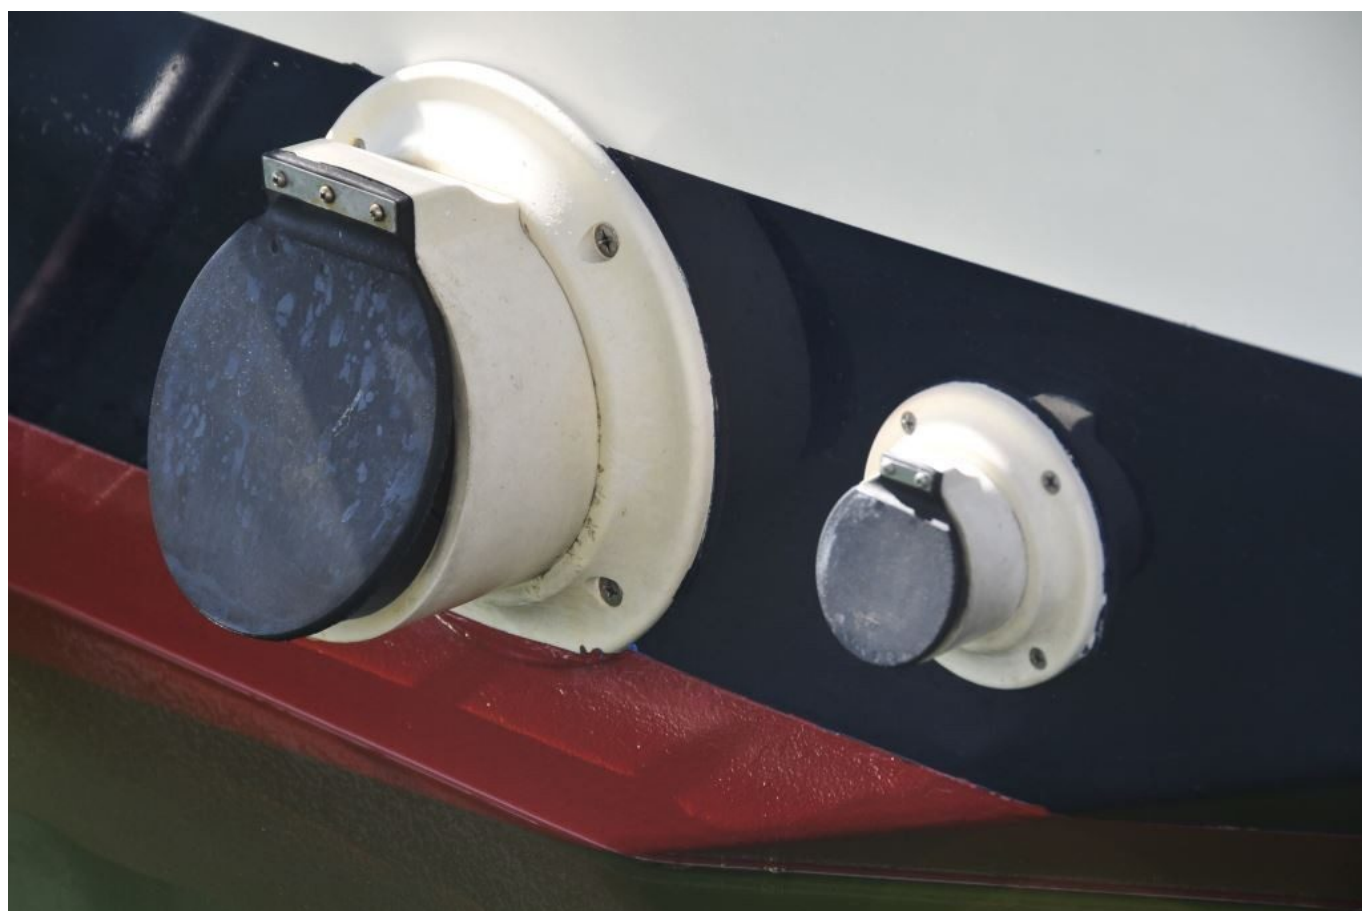
**Flappers can be an effective means of preventing water from traveling the wrong direction into a transom-mounted exhaust discharge outlet. They do, however, wear out and often fall off without the owner's knowledge. If your vessel is equipped with these, be sure to check them regularly.**

While a rubber flap is sometimes used to prevent back-flow, they are more effective for transom rather than side exhausts, in the latter application they are frequently dislodged and lost. Yet another alternative involves the use of a proprietary exhaust check valve, available from marine exhaust
