# **Fuel Tank Installation**

## **There's More to it than Meets the Eye**

Text and Photos by Steve D'Antonio

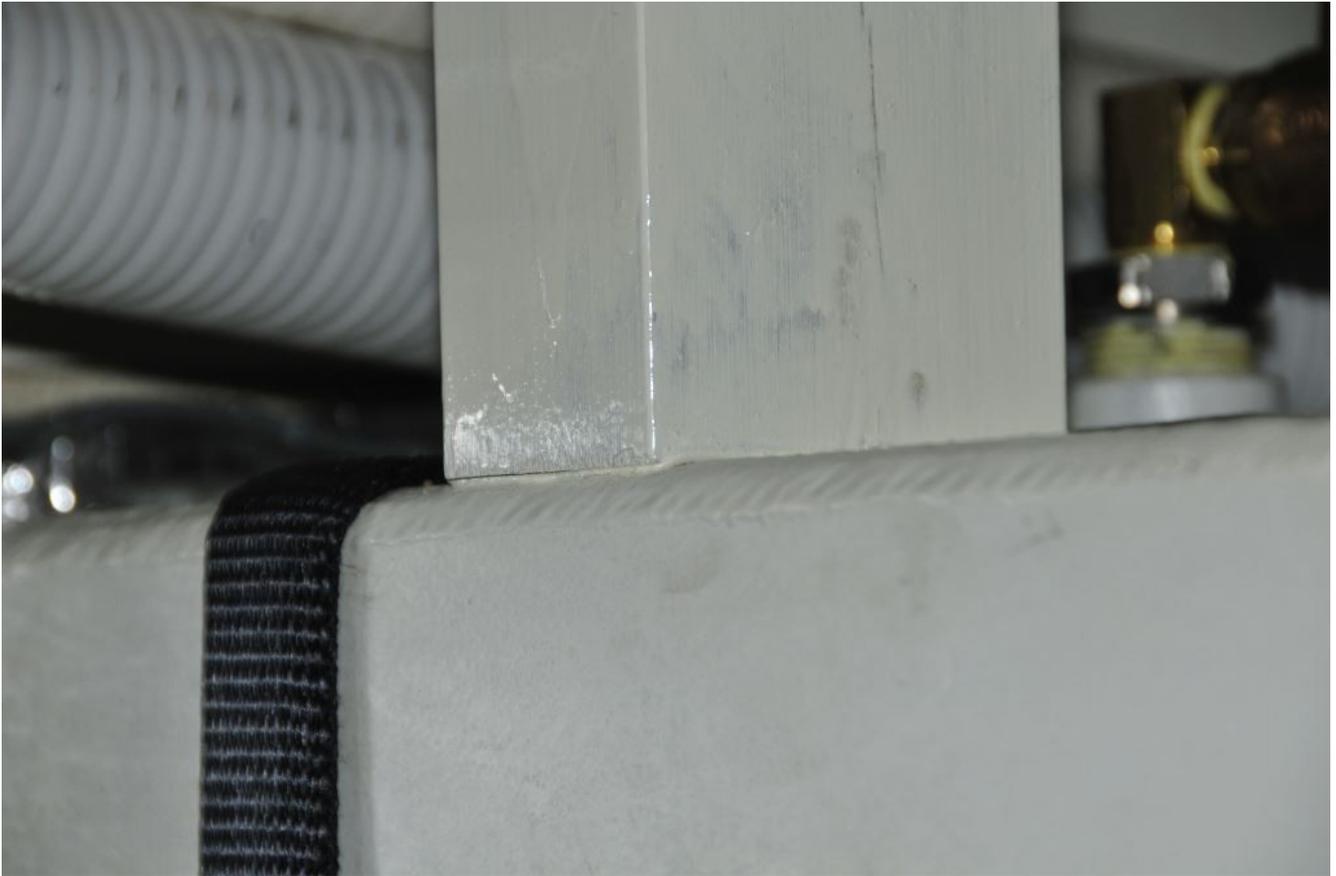
**Fuel tanks must never be used as a supporting structure, to support a sole for instance as is the case in this image, unless they are specifically designed for this purpose. Most tanks are not designed to support anything other than themselves and the fuel they contain.**

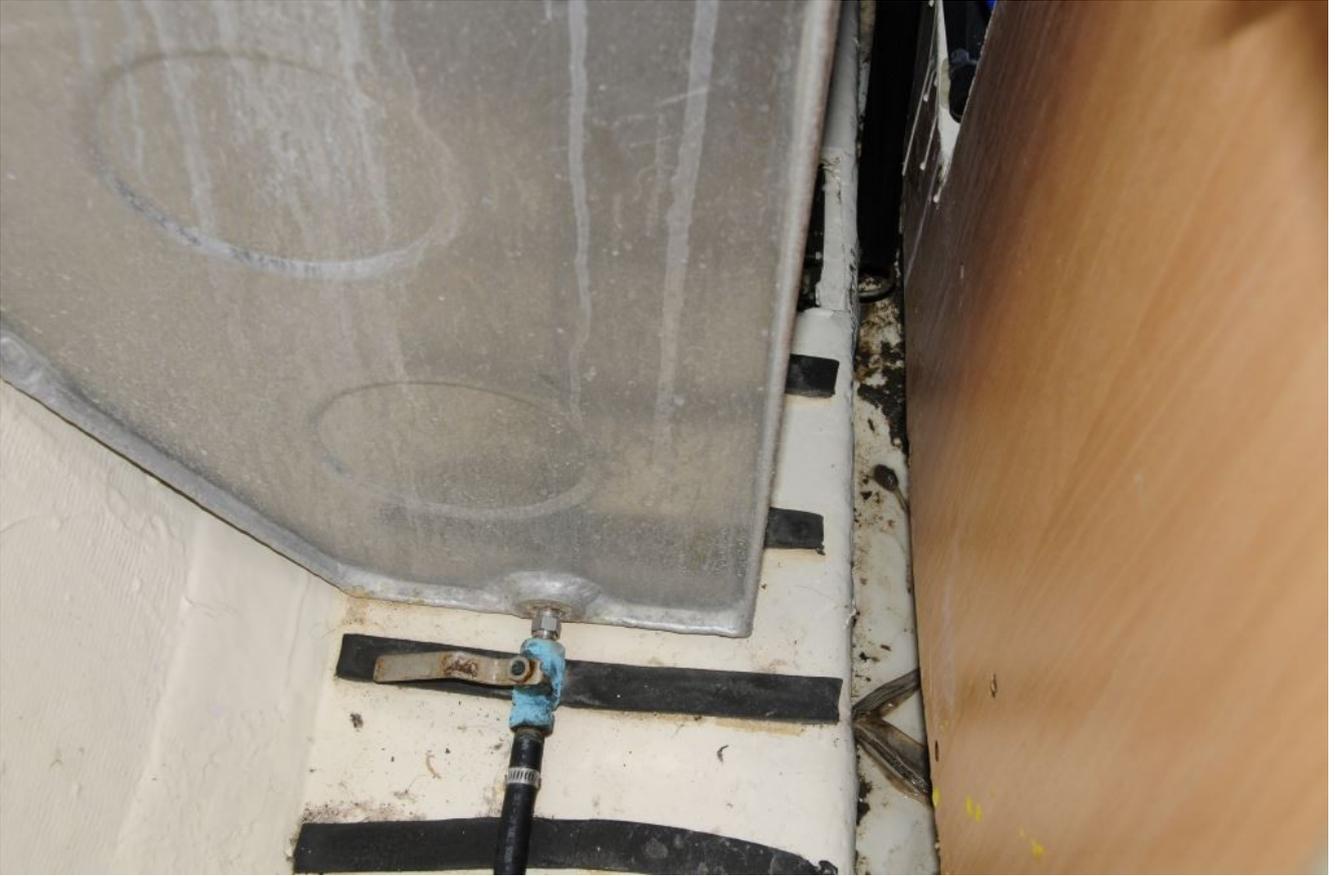
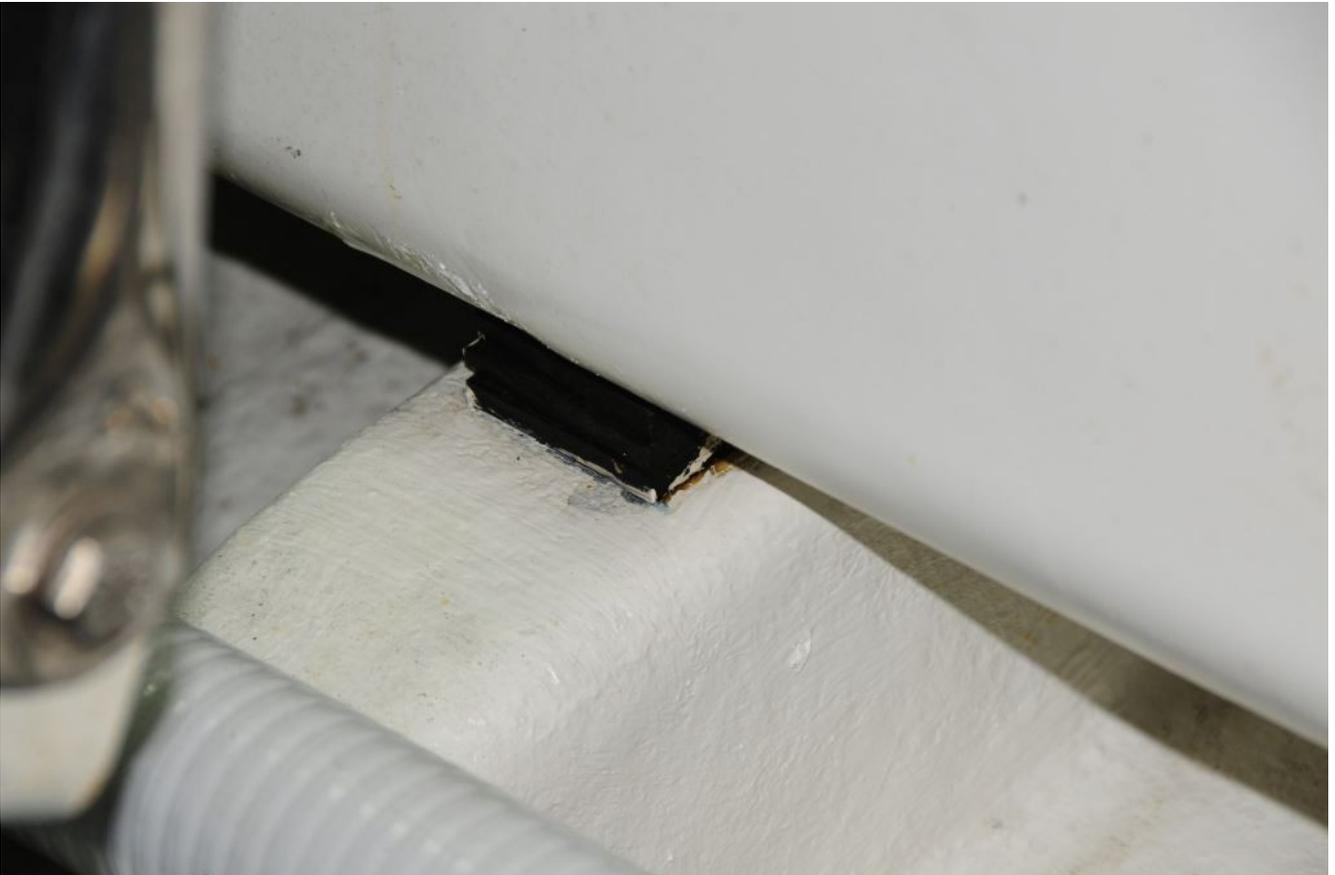
**Tanks, especially metallic tanks, should be elevated above a self or deck to allow for water drainage. Often this is accomplished with thin strips of rubber material, which often compress, and in turn fail to fulfill their intended purpose. Whatever material is used as this spacer, it must be resistant to compression, decay and water absorption.**

Ideally, unless designed and built to be self supporting (this would include internal reinforcement), tanks should rest on continuous shelf-like structures rather than stringers or beams of any sort. When supported in this manner, flexing is minimized if not eliminated. In order to promote drainage and prevent corrosion to a metallic tank's bottom, one to two inch wide,  $\frac{1}{4}$  inch thick spacers made of non-hygroscopic material

(prefabricated fiberglass or GP03 works well) should be *bedded* athwartships to the tank bottom on four to six inch centers, using a polyurethane bedding compound. With this approach, the tank can't rest in standing water and water can't migrate between the tank and the spacers, either of which will lead to corrosion.

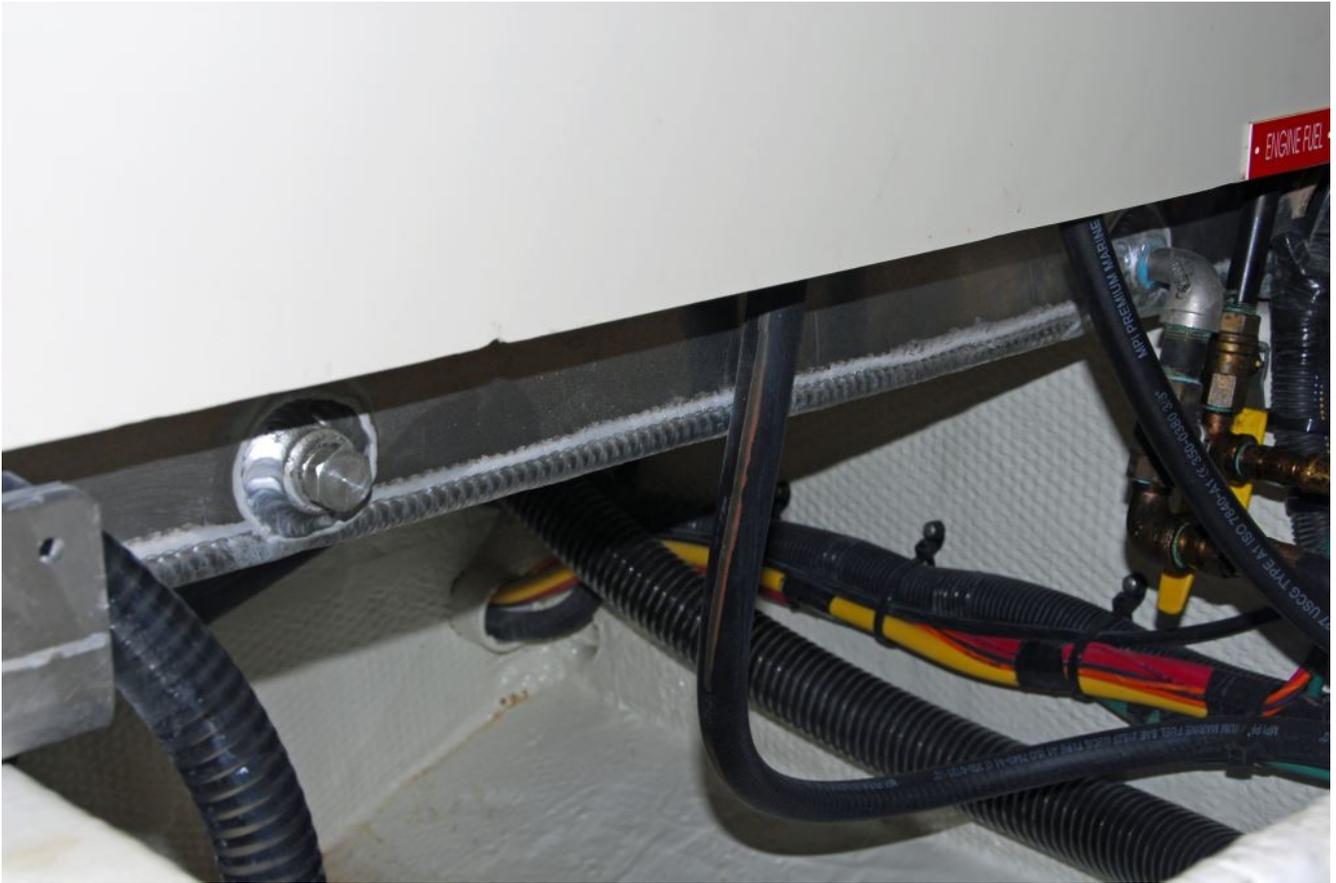
**Large tanks that span great distances, between stringers like this one for instance, are challenged. Unless the tank is specifically designed and built to support its own weight, as well as the fuel within, and pounding g-force loads, then it should be supported by a shelf.**

In another similar flex-induced failure, a large tank, nearly 1000 gallons, spanned the entire beam of a vessel. It was located beneath the cockpit where it rested on a closely spaced set of central stringers as well as on supports located outboard at the tank's extreme beam ends. Once again, when the tank wasn't full it was capable of supporting itself as well as the weight of the fuel. However, once filled the weight of the fuel, over 3.5 tons, caused the beam ends to sag because there was a small gap between the bottom of the tank and these outboard supports, an installation defect if ever there was one. Further exacerbating this problem was the fact that this was a high speed, off shore fishing vessel that was designed to endure slamming loads, as it made its way through tumultuous seas. As the tank absorbed these loads it flexed, initially anyway, which eventually led to its failure at the fulcrum point on the tank's centerline. Interestingly, the crack that developed did so precisely in the middle of a weld bead, indicating that the weld itself, as well as the plate, was sound. The structure simply could not absorb the movement caused by inadequate support.

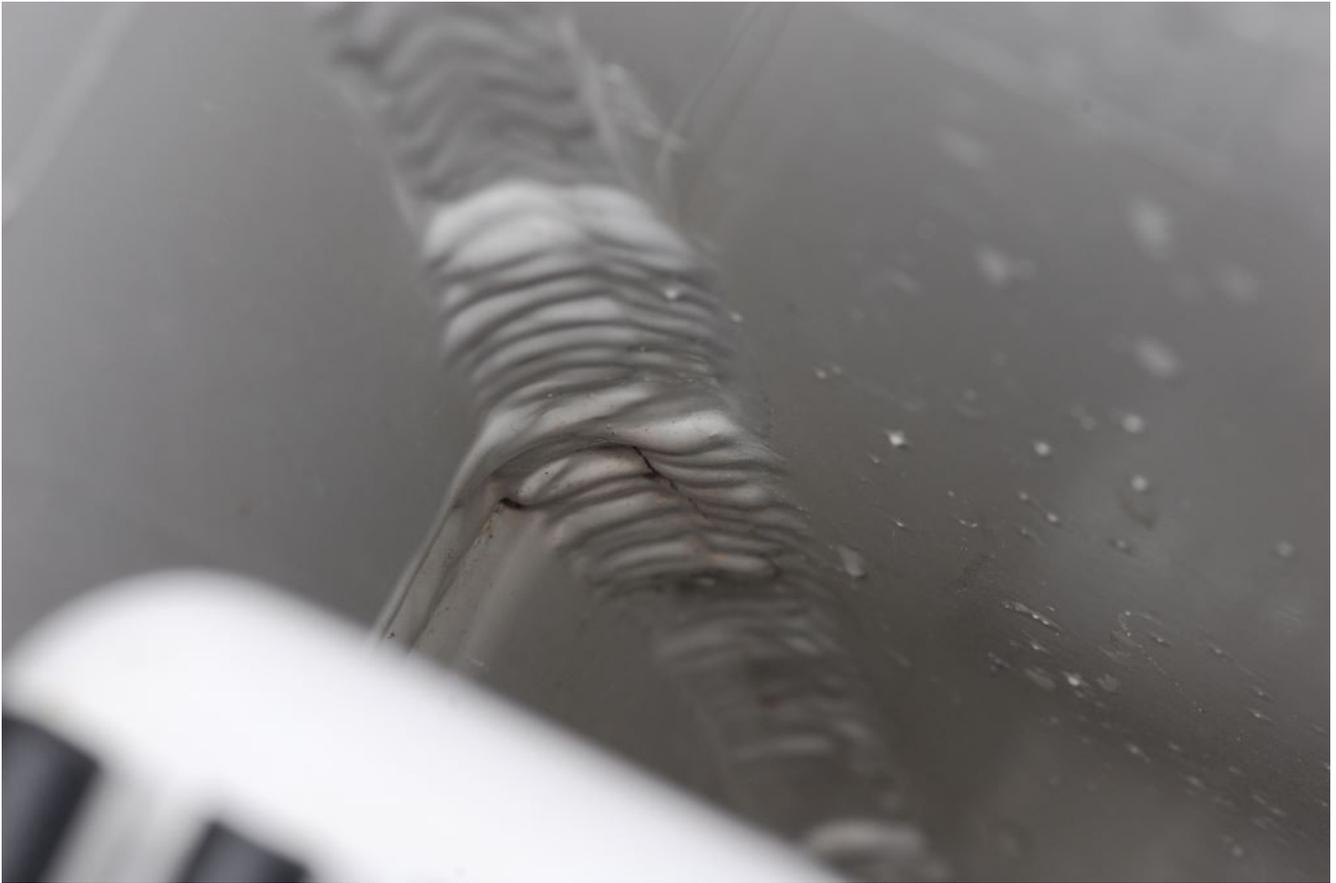
**Tanks should not be allowed to flex or move once installed, they should be fully supported and secured. This large tank, installed in a new vessel, cracked at a weld shortly after the vessel went into service. The tank was not properly supported and as a result, when full, the outboard ends sagged, stressing the center section.**

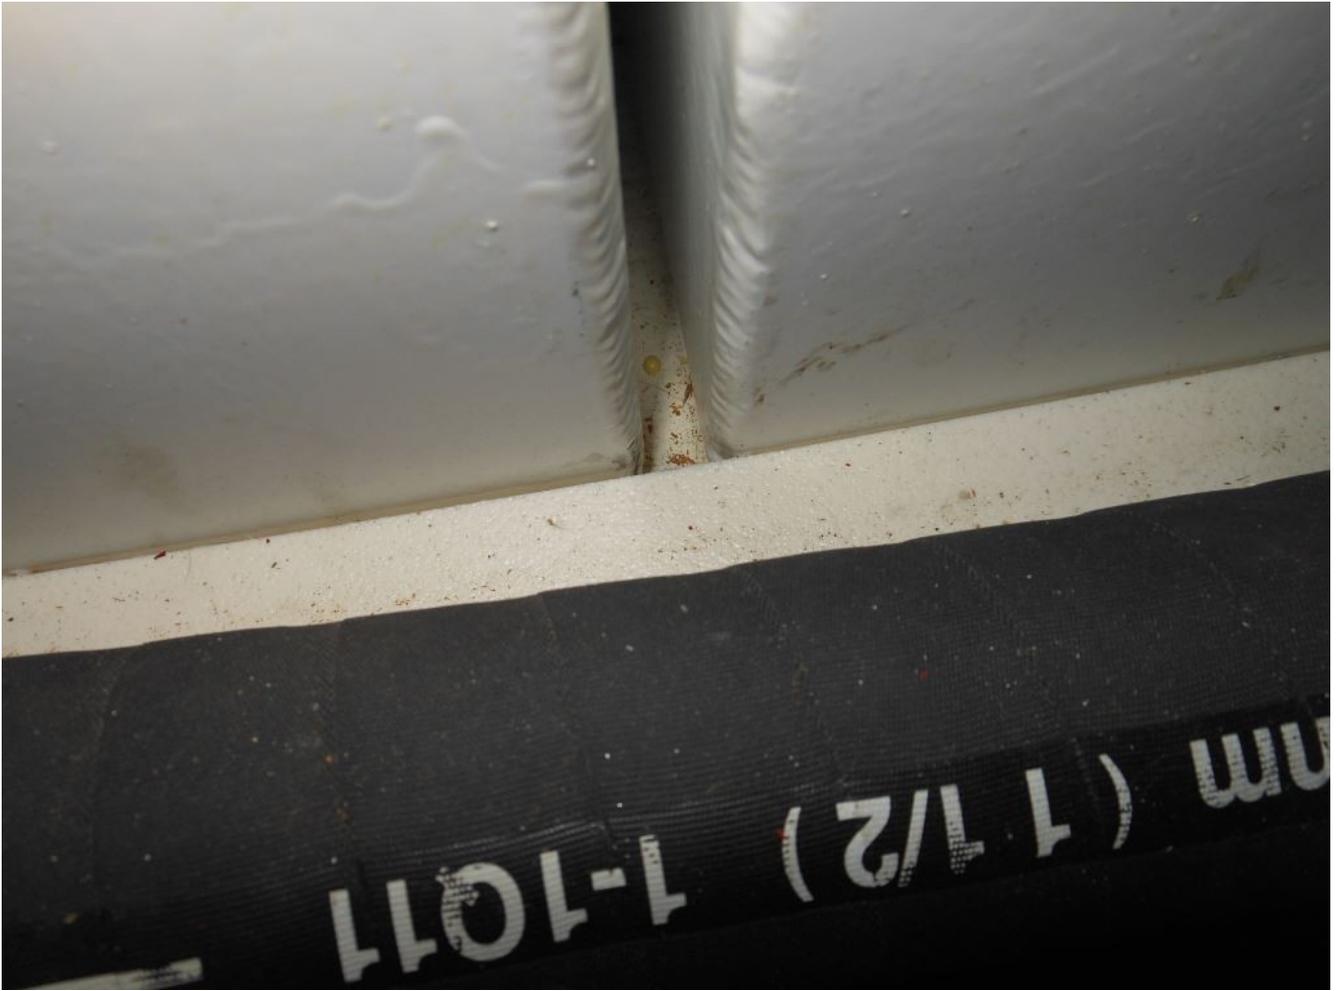
**Water entrapment sounds the death knell for many metallic tanks. Gaps and voids that can retain water allow corrosion and rust to gain a toe hold, which could ultimately lead to tank failure. Tanks should never be installed directly against a surface such as a shelf or cleat like that shown here, as the small gap between the two will retain water. Tank installations should be self-draining, avoiding traps like the one shown here.**

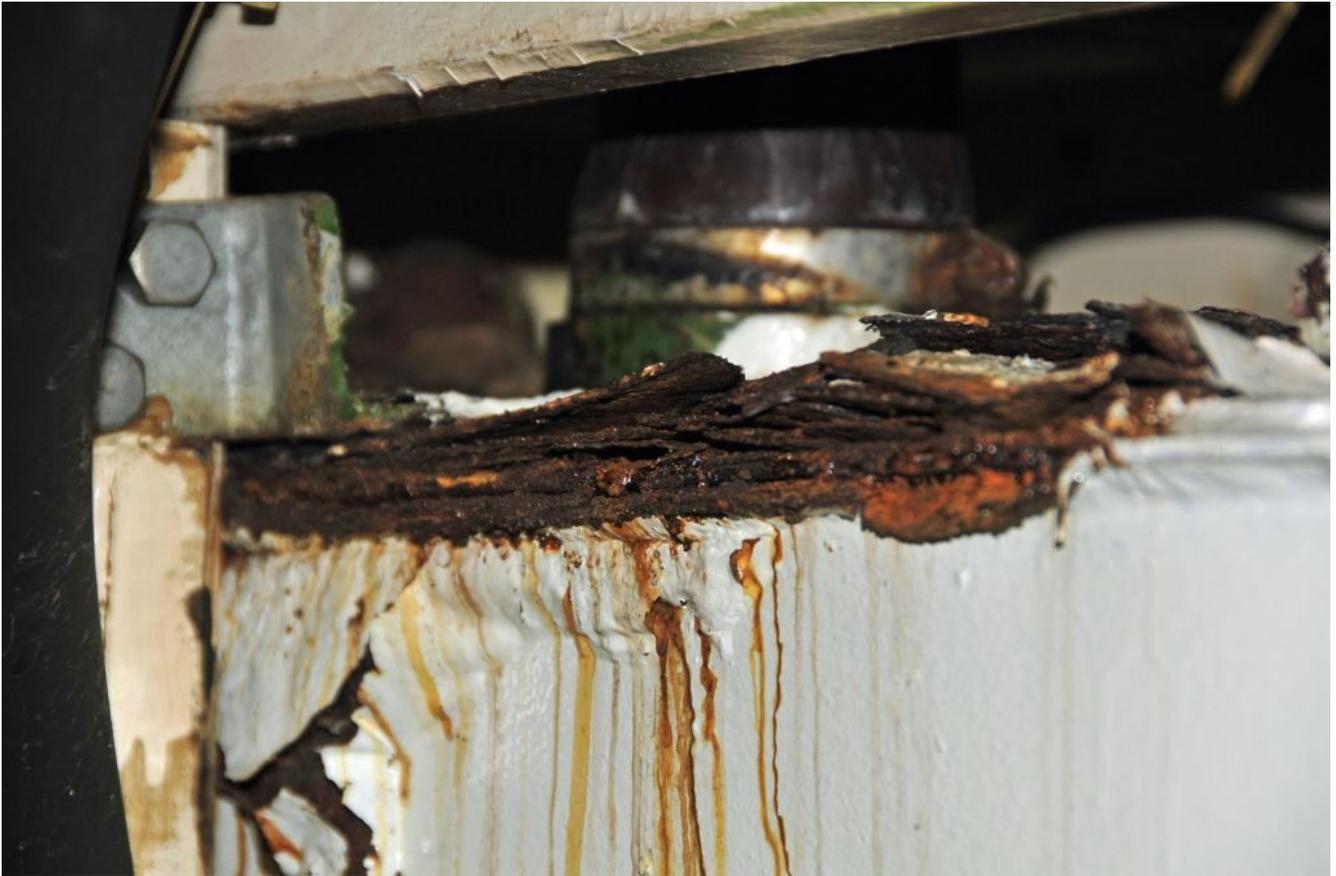
These steel tanks suffer from the classic, deck leak-induced rust and failure scenario. If the tank tops were angled they may have shed water, giving users a clue as to the impending failure. Tanks should be installed in such a way as to enable easy, casual inspection, i.e. they should remain exposed.

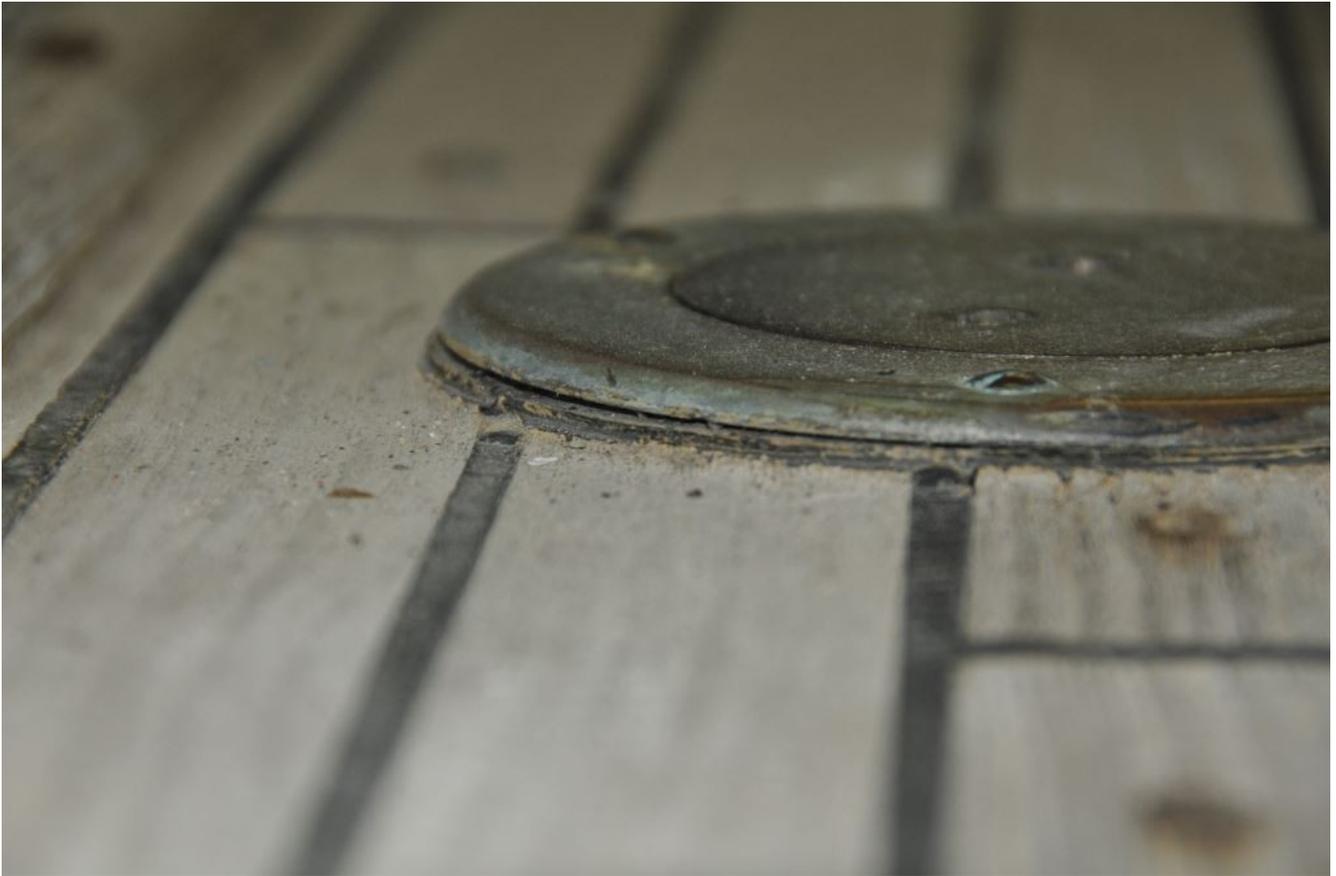
**Deck fills, in teak decks are notorious for leaking water onto tank tops. The gap between this deck fill and its bedding is clear to see. Inspect your deck fills and tank tops regularly.**

visible (such angling is required for compliance with ABYC standards). The number of tanks I've encountered that have failed from the top down, as it were, is simply astounding. Deck fuel fills are notorious for leaking water onto the tops of tanks (why deck hardware leaks, and how to avoid it, is the subject of an upcoming Marine Systems Excellence article), where it often stands, ultimately causing rust or corrosion on steel and aluminum respectively.

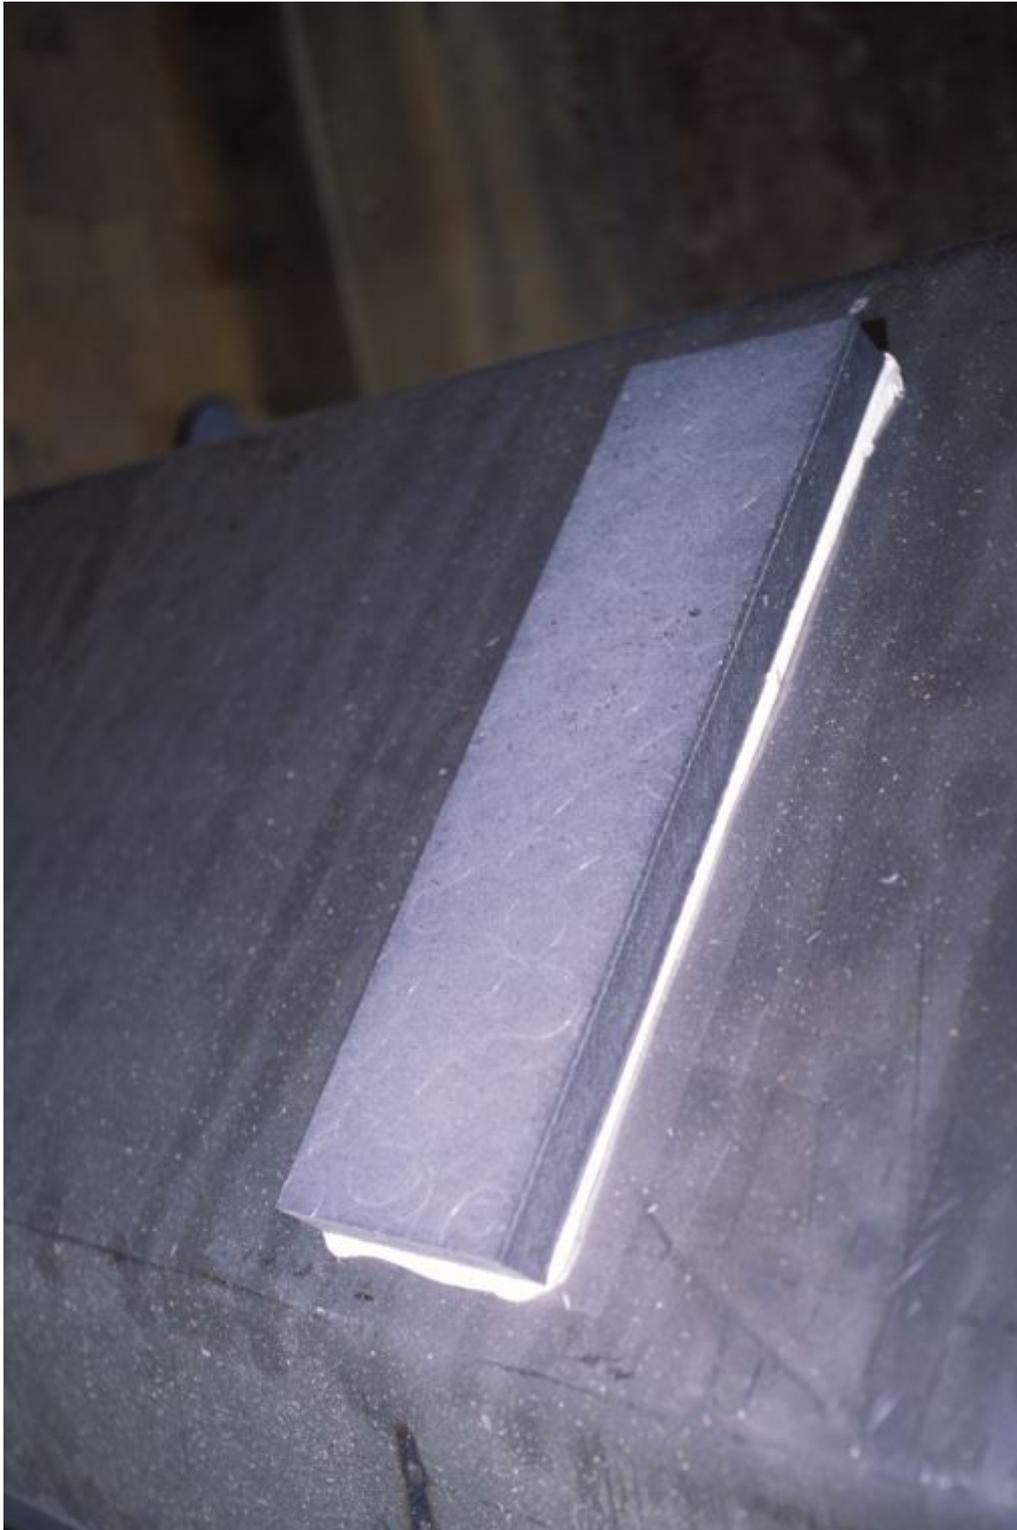
**Spacer material should be bedded to tank bottoms, like that shown here. Doing so prevents water migrating between the tank and the spacer.**

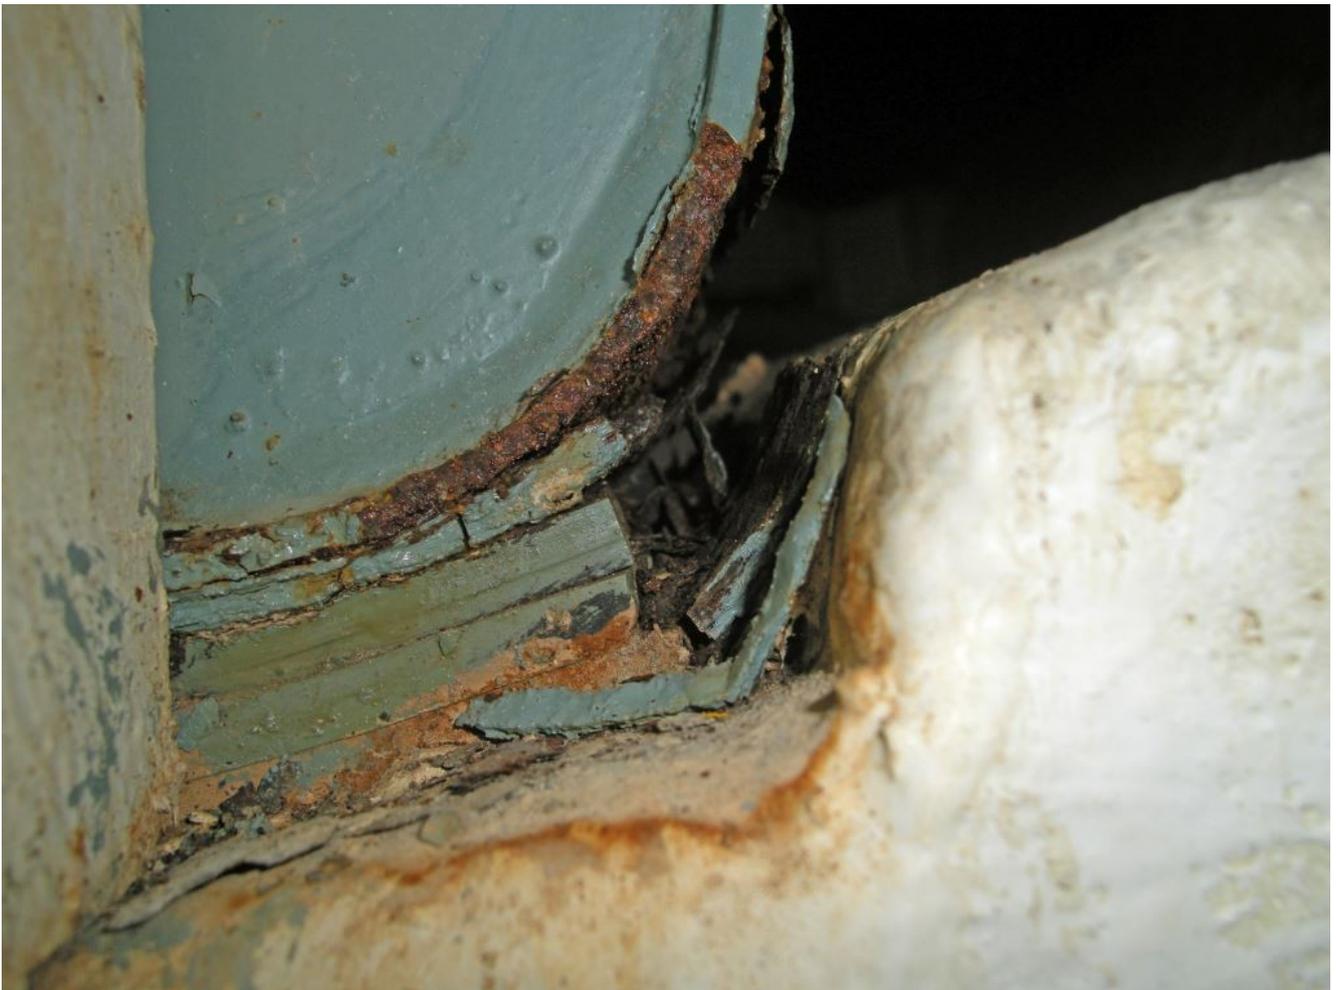
**In spite of the cushion, a strip of hard rubber, this tank rests on, it's suffering from near-terminal corrosion as a result of a deck leak. It is imperative that cushion material, regardless of what form it may take, must be bedded to the tank.**
