# **Fuel Tank Installation**

## **There's More to it than Meets the Eye**

Text and Photos by Steve D'Antonio

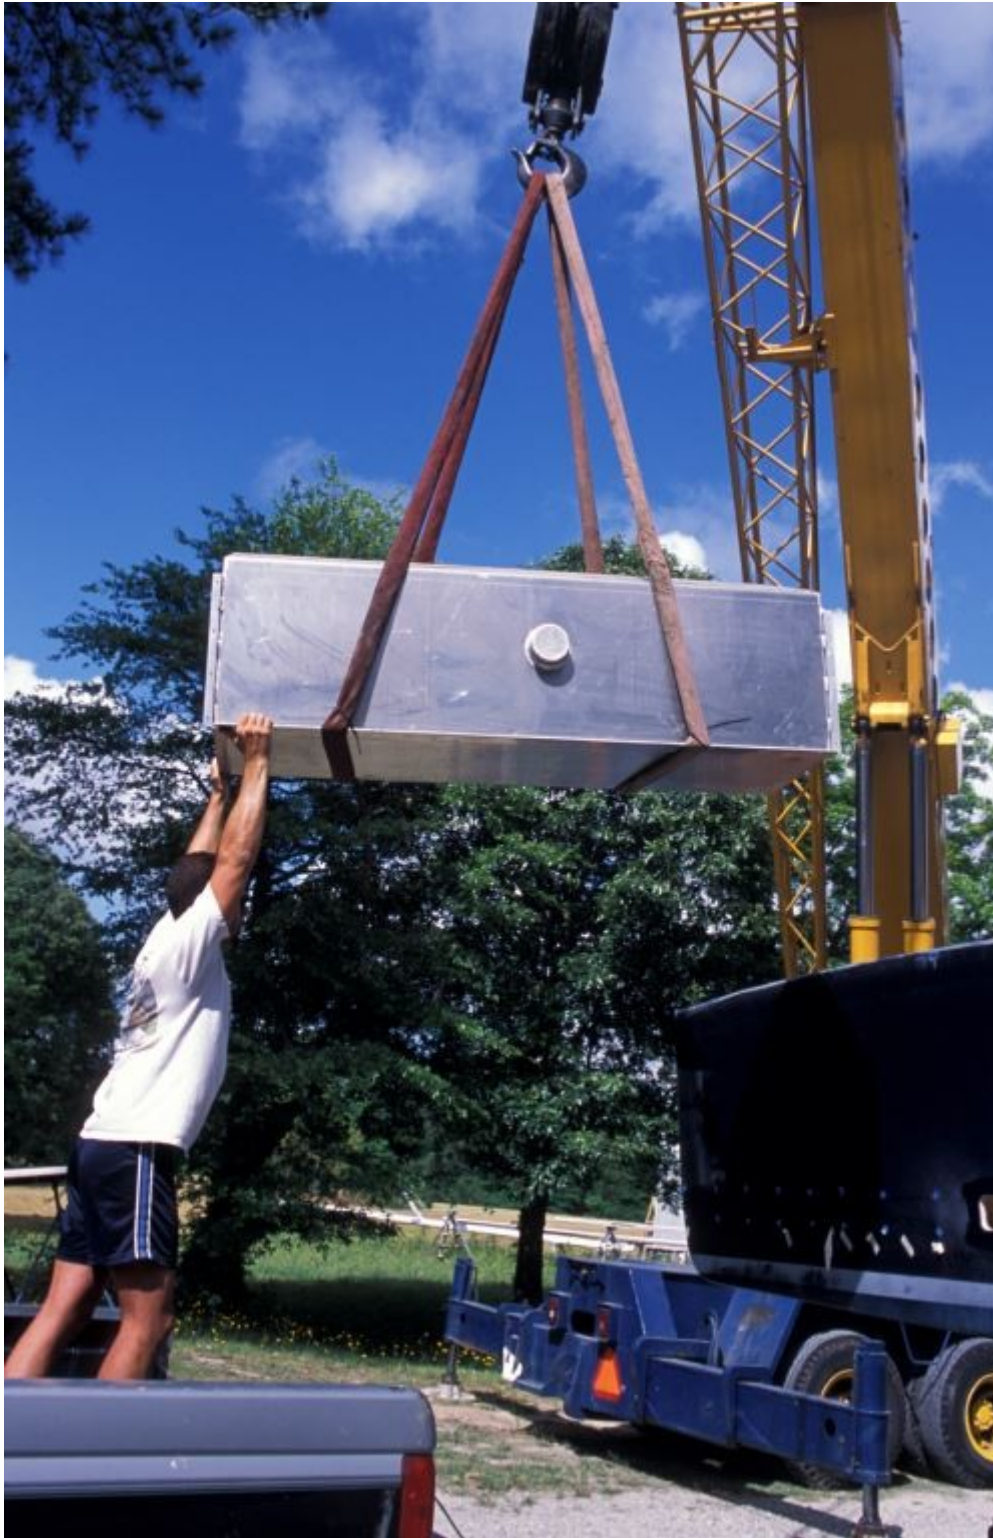
**Fuel tank installations should last the life of the boat, if not for decades.**

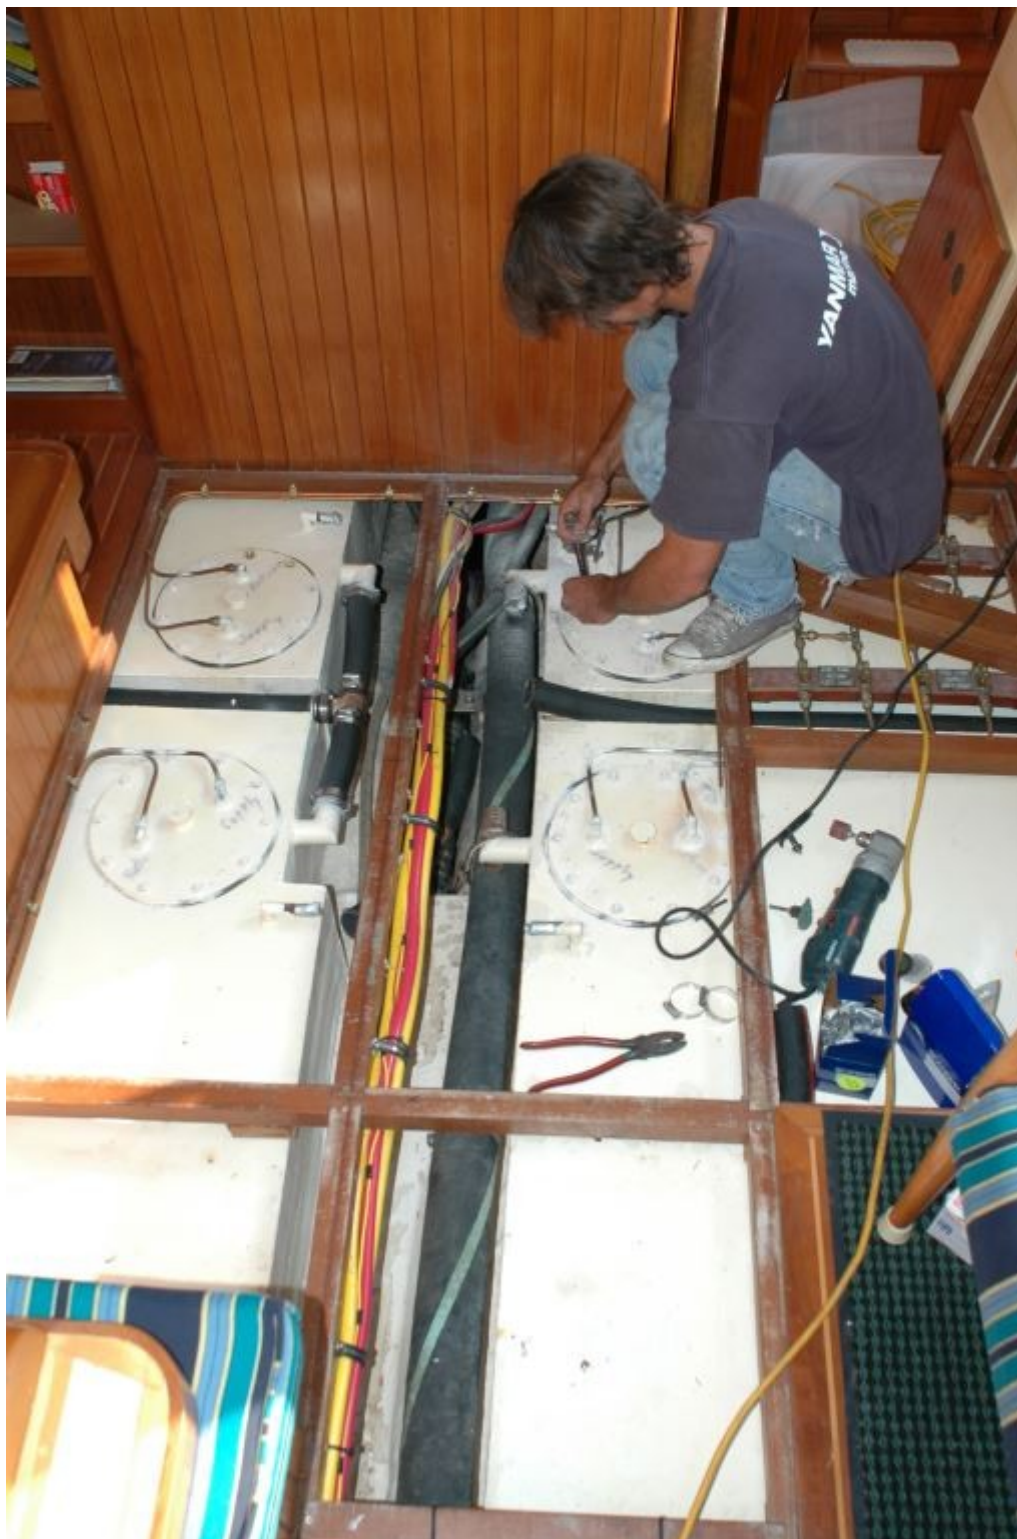
**Replacing tanks on an existing vessel is nothing short of a daunting process. It's nearly always costly and physically invasive. In many cases, two tanks must replace one, with**

**their consequent interconnecting plumbing, in order for them to fit through existing ports or hatches.**

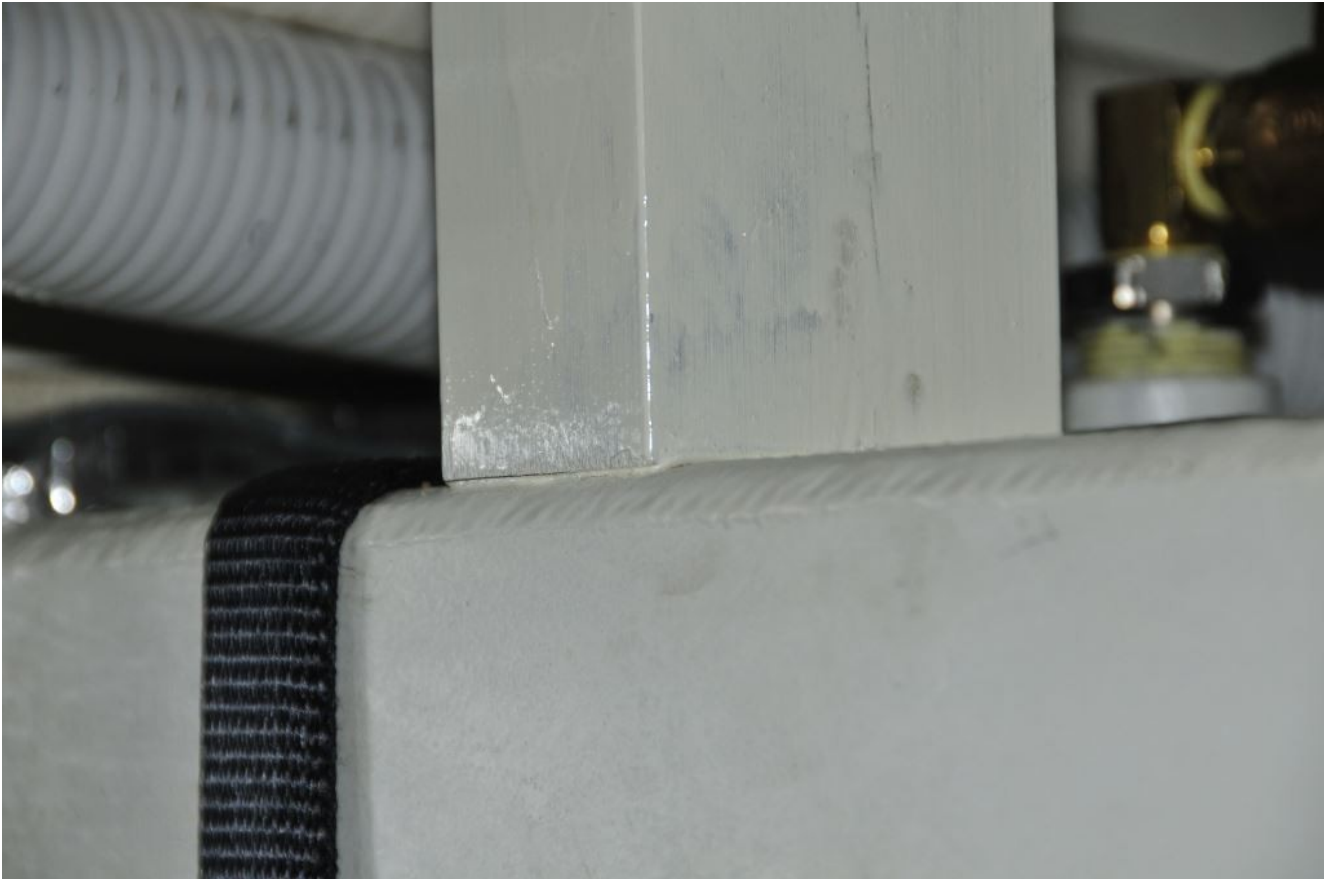
**Fuel tanks must never be used as a supporting structure, to support a sole for instance as is the case in this image, unless they are specifically designed for this purpose. Most tanks are not designed to support anything other than themselves and the fuel they contain.**

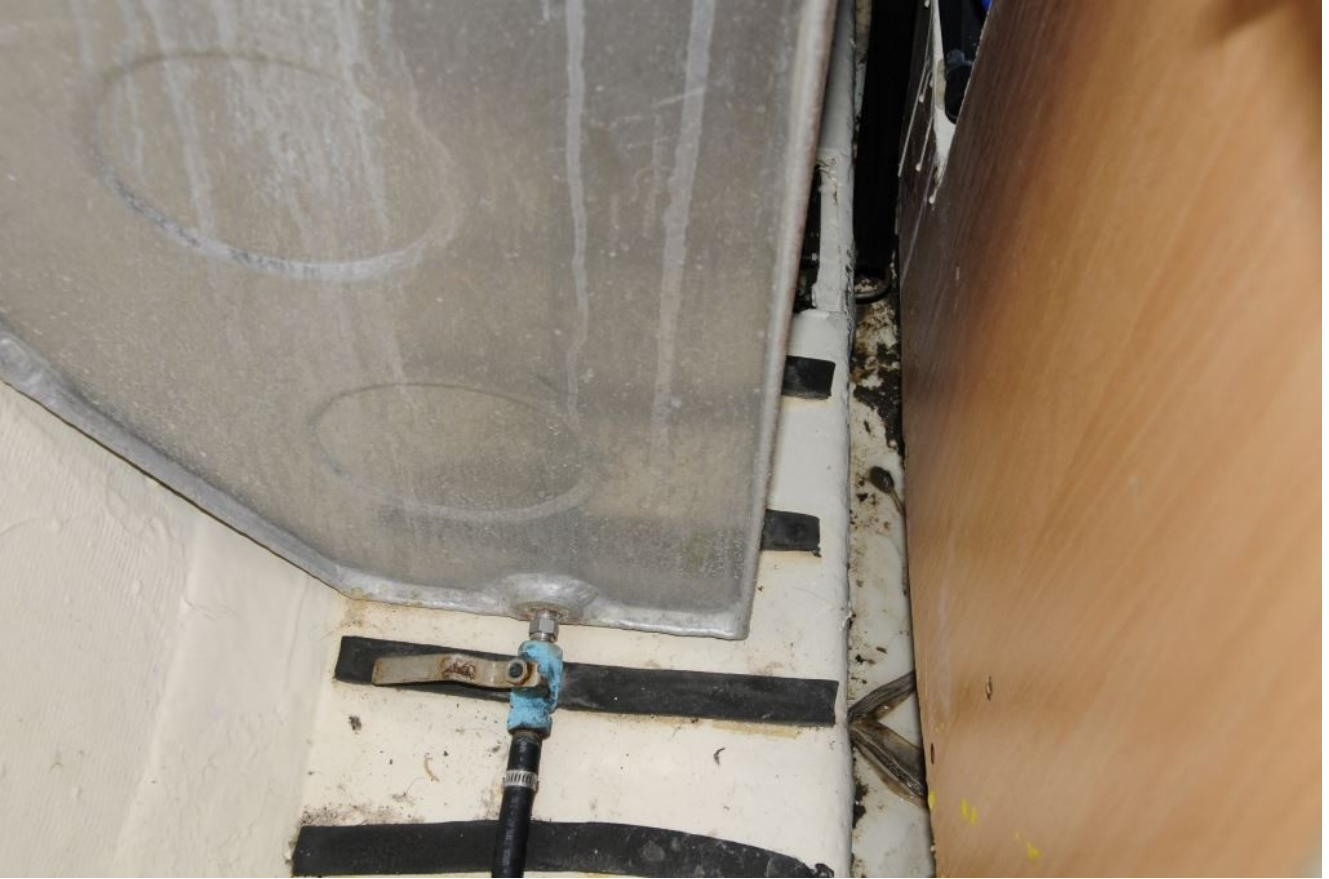
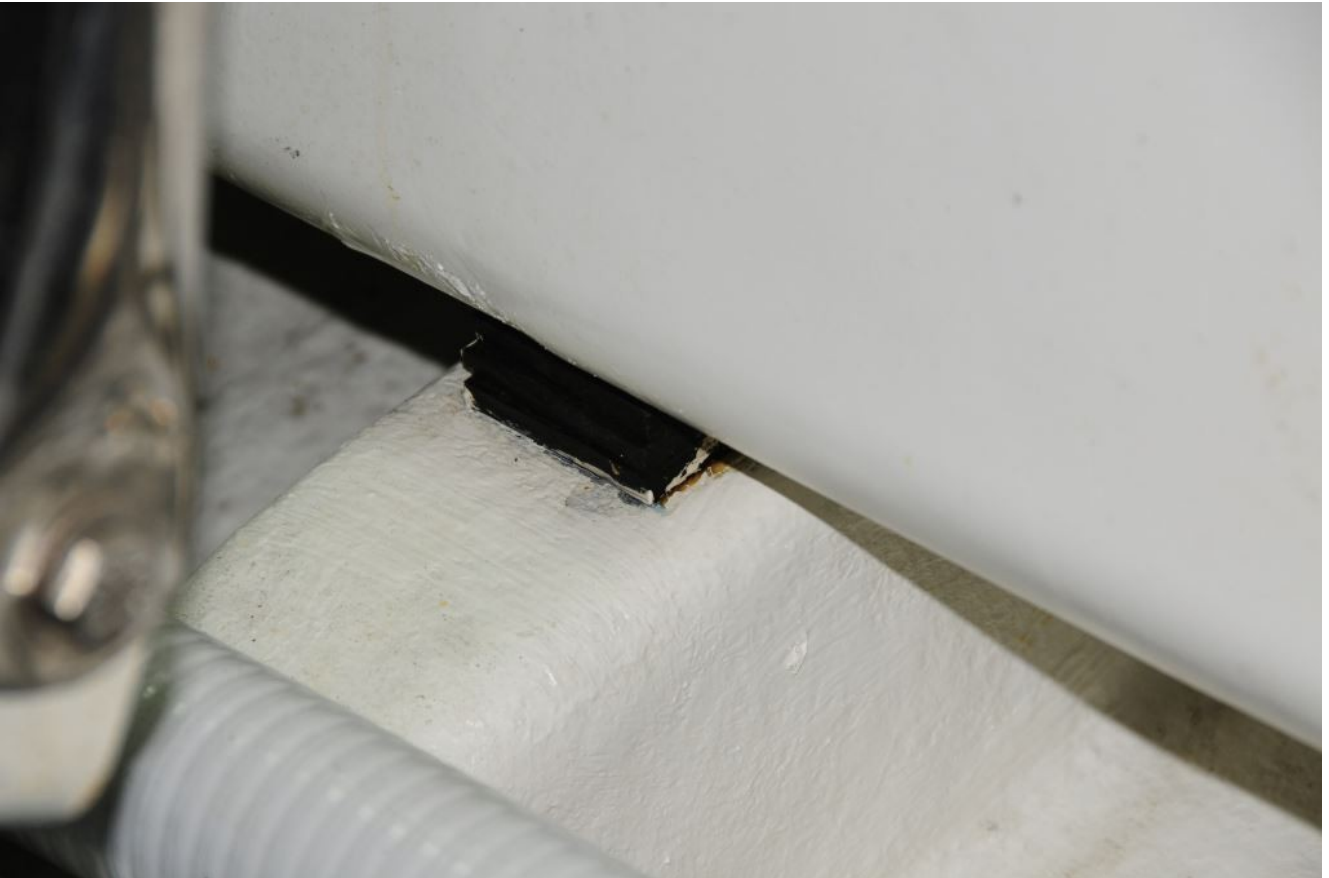
**Tanks, especially metallic tanks, should be elevated above a self or deck to allow for water drainage. Often this is accomplished with thin strips of rubber material, which often compress, and in turn fail to fulfill their intended purpose. Whatever material is used as this spacer, it must be resistant to compression, decay and water absorption.**

Ideally, unless designed and built to be self supporting (this would include internal reinforcement), tanks should rest on continuous shelf-like structures rather than stringers or beams of any sort. When supported in this manner, flexing is minimized if not eliminated. In order to promote drainage and prevent corrosion to a metallic tank's bottom, one to two inch wide,  $\frac{1}{4}$  inch thick spacers made of non-hygroscopic material

(prefabricated fiberglass or GP03 works well) should be *bedded* athwartships to the tank bottom on four to six inch centers, using a polyurethane bedding compound. With this approach, the tank can't rest in standing water and water can't migrate between the tank and the spacers, either of which will lead to corrosion.

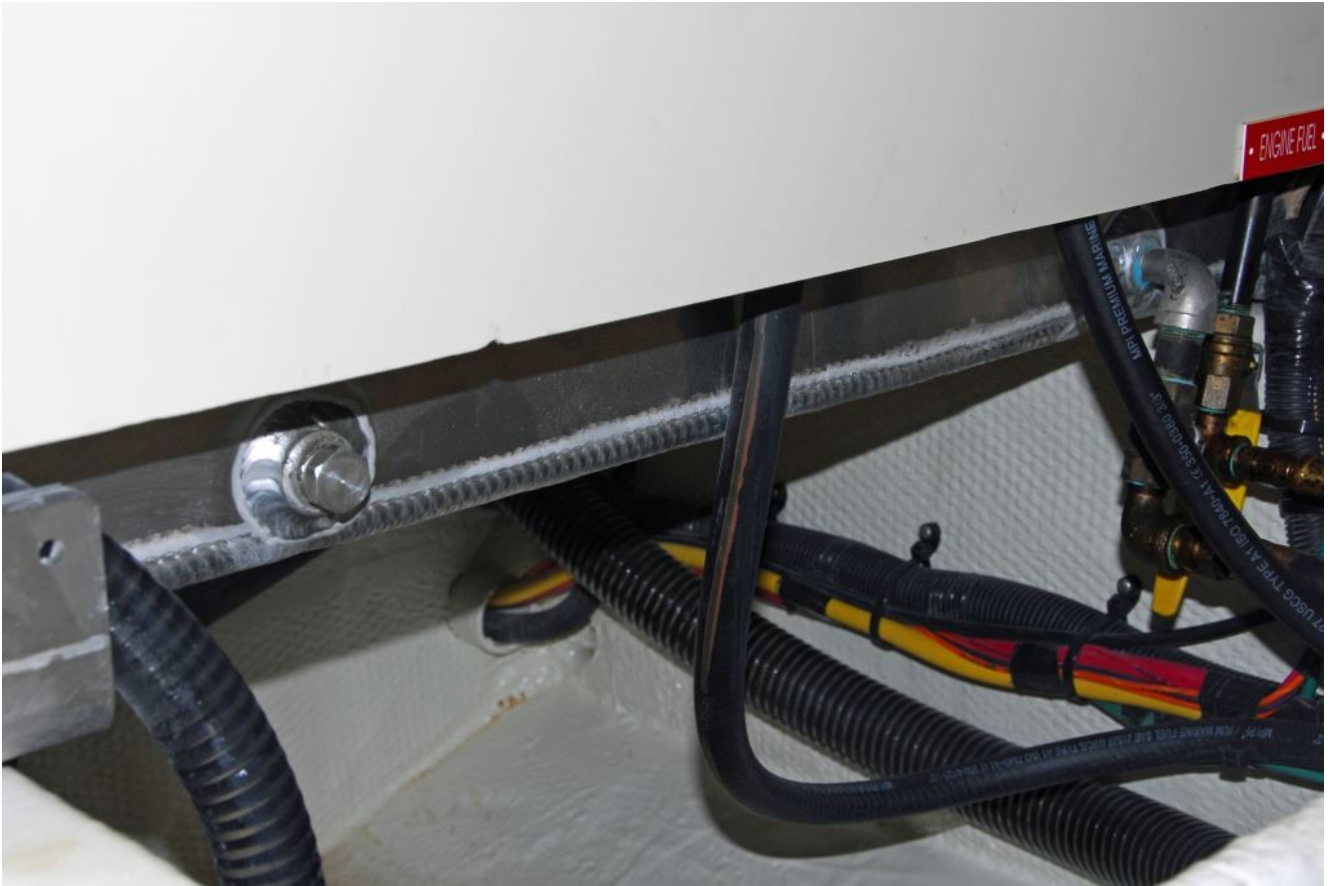
**Large tanks that span great distances, between stringers like this one for instance, are challenged. Unless the tank is specifically designed and built to support its own weight, as well as the fuel within, and pounding g-force loads, then it should be supported by a shelf.**

In another similar flex-induced failure, a large tank, nearly 1000 gallons, spanned the entire beam of a vessel. It was located beneath the cockpit where it rested on a closely spaced set of central stringers as well as on supports located outboard at the tank's extreme beam ends. Once again, when the tank wasn't full it was capable of supporting itself as well as the weight of the fuel. However, once filled the weight of the fuel, over 3.5 tons, caused the beam ends to sag because there was a small gap between the bottom of the tank and these outboard supports, an installation defect if ever there was one. Further exacerbating this problem was the fact that this was a high speed, off shore fishing vessel that was designed to endure slamming loads, as it made its way through tumultuous seas. As the tank absorbed these loads it flexed, initially anyway, which eventually led to its failure at the fulcrum point on the tank's centerline. Interestingly, the crack that developed did so precisely in the middle of a weld bead, indicating that the weld itself, as well as the plate, was sound. The structure simply could not absorb the movement caused by inadequate support.

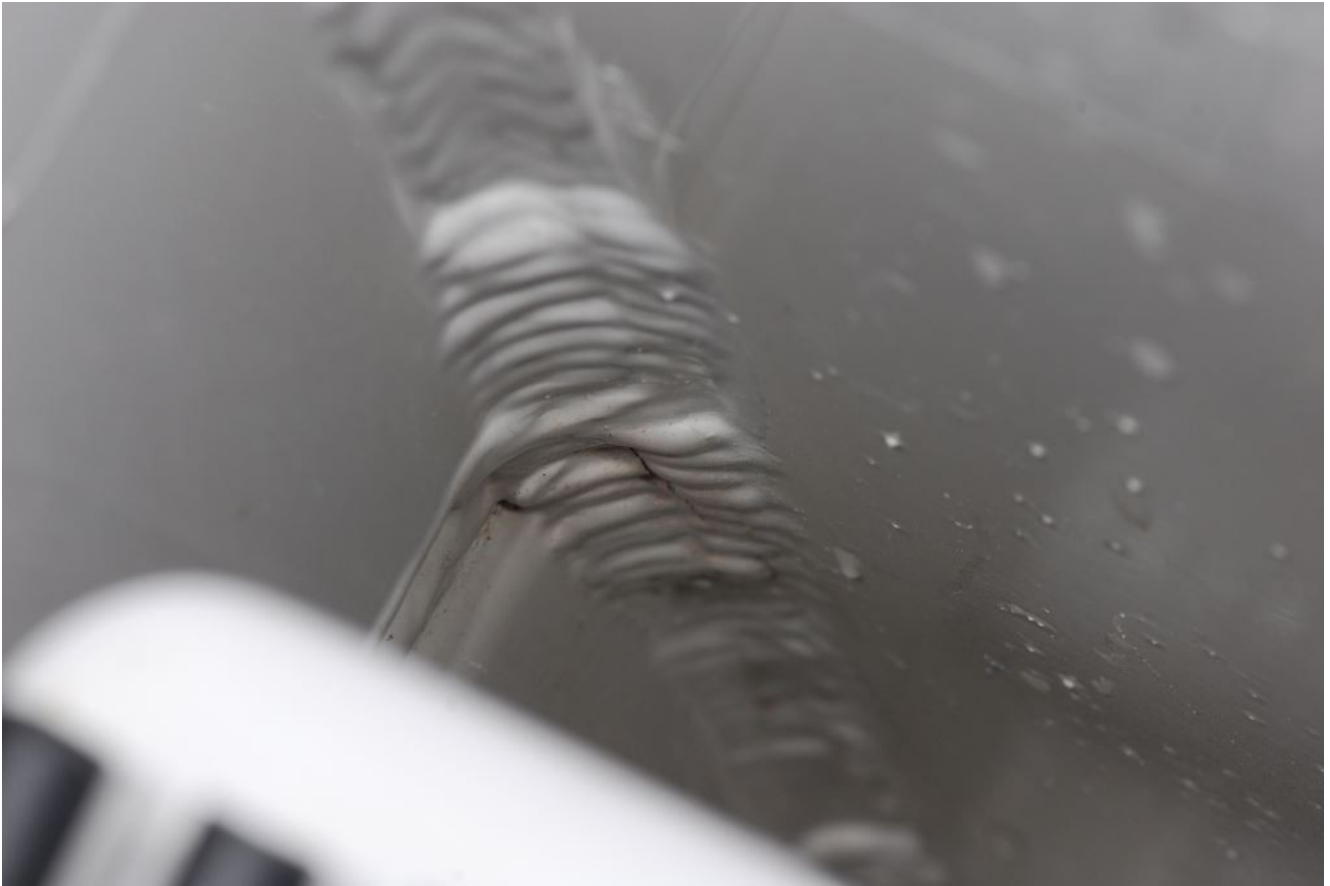
**Tanks should not be allowed to flex or move once installed, they should be fully supported and secured. This large tank, installed in a new vessel, cracked at a weld shortly after the vessel went into service. The tank was not properly supported and as a result, when full, the outboard ends sagged, stressing the center section.**

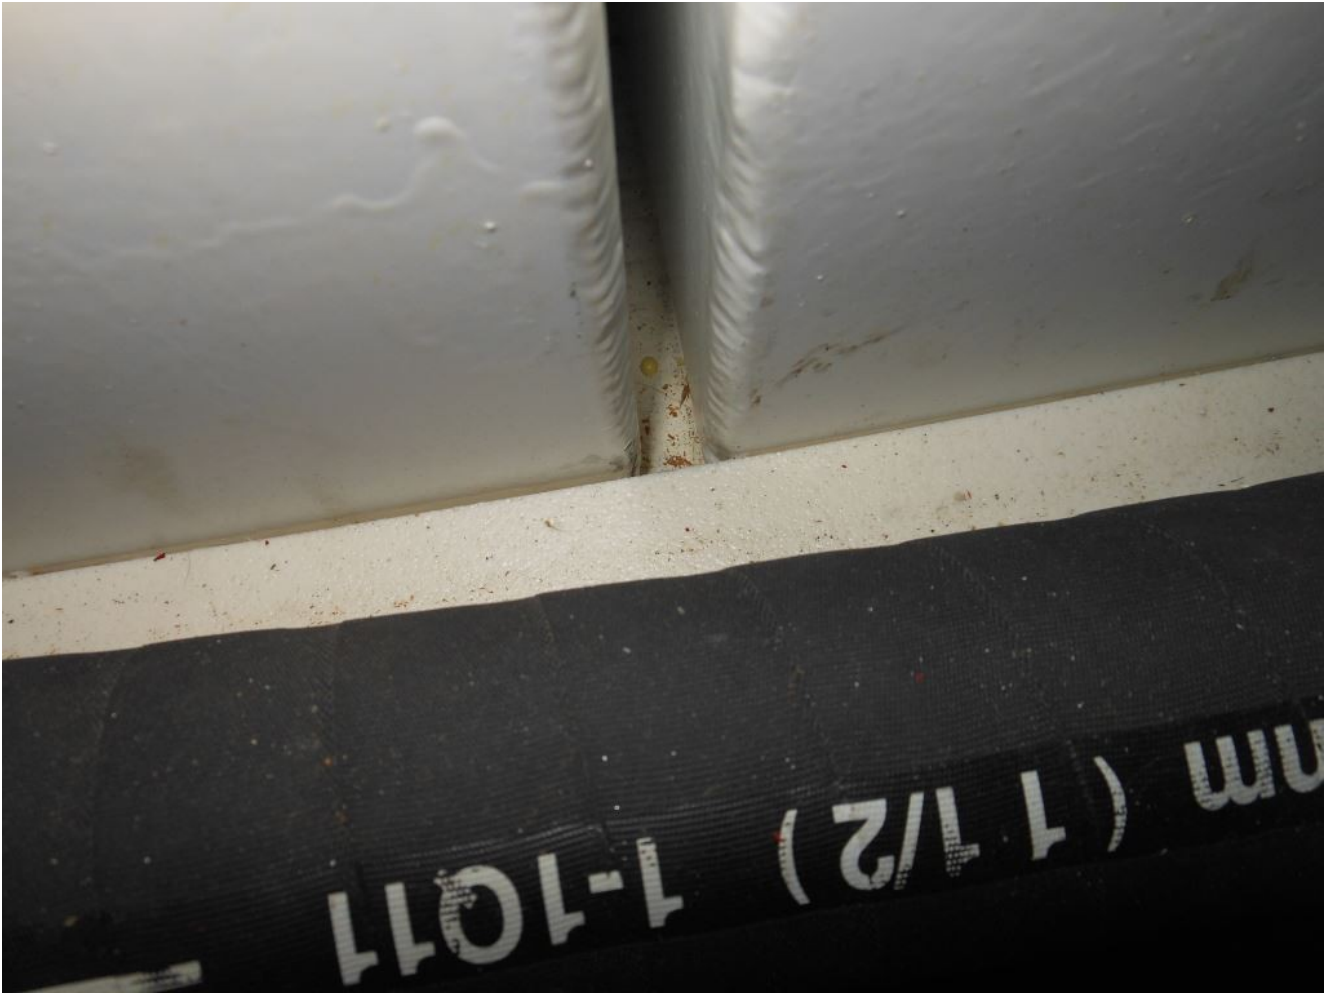
**Water entrapment sounds the death knell for many metallic tanks. Gaps and voids that can retain water allow corrosion and rust to gain a toe hold, which could ultimately lead to tank failure. Tanks should never be installed directly against a surface such as a shelf or cleat like that shown here, as the small gap between the two will retain water. Tank installations should be self-draining, avoiding traps like the one shown here.**

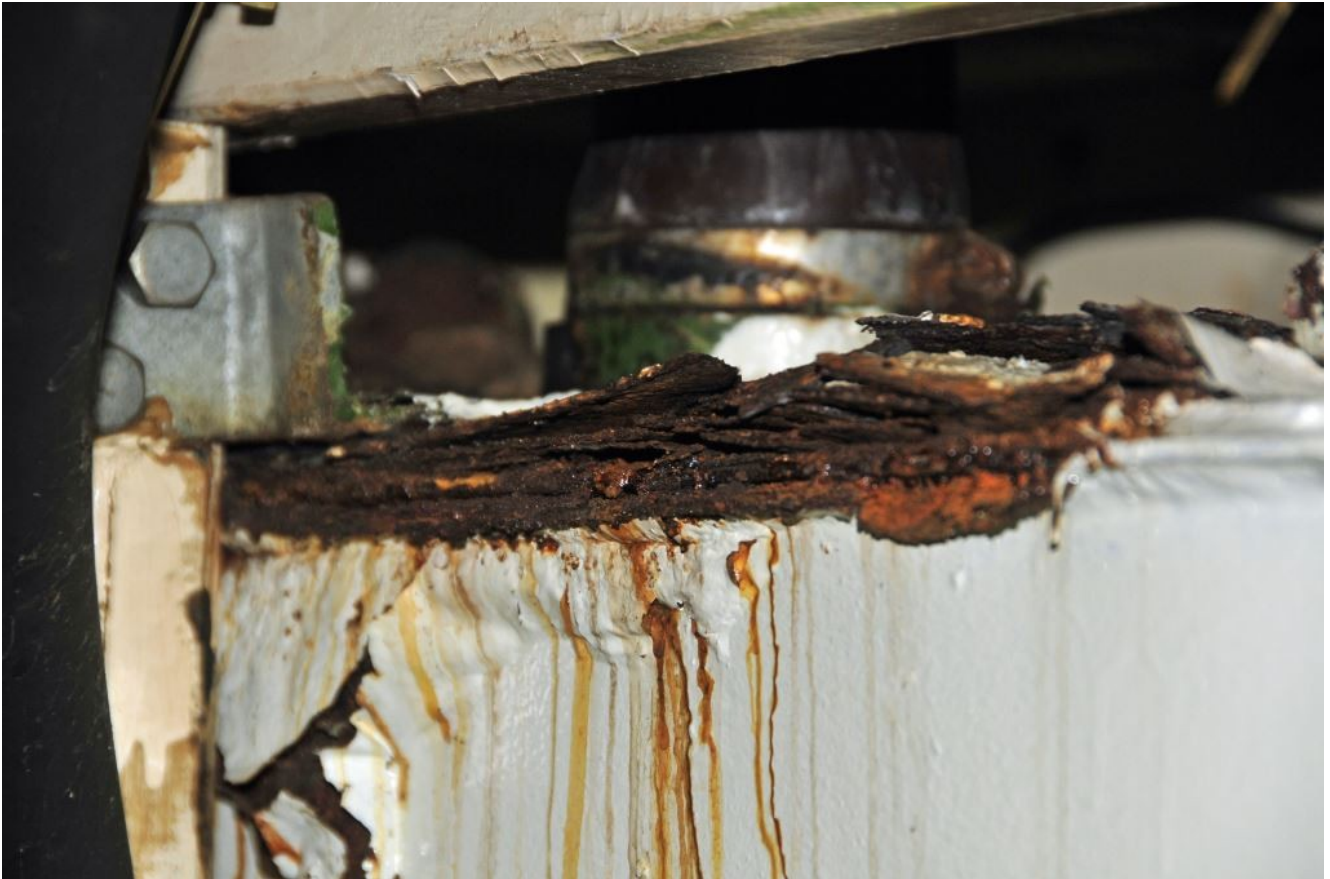
These steel tanks suffer from the classic, deck leak-induced rust and failure scenario. If the tank tops were angled they may have shed water, giving users a clue as to the impending failure. Tanks should be installed in such a way as to enable easy, casual inspection, i.e. they should remain exposed.

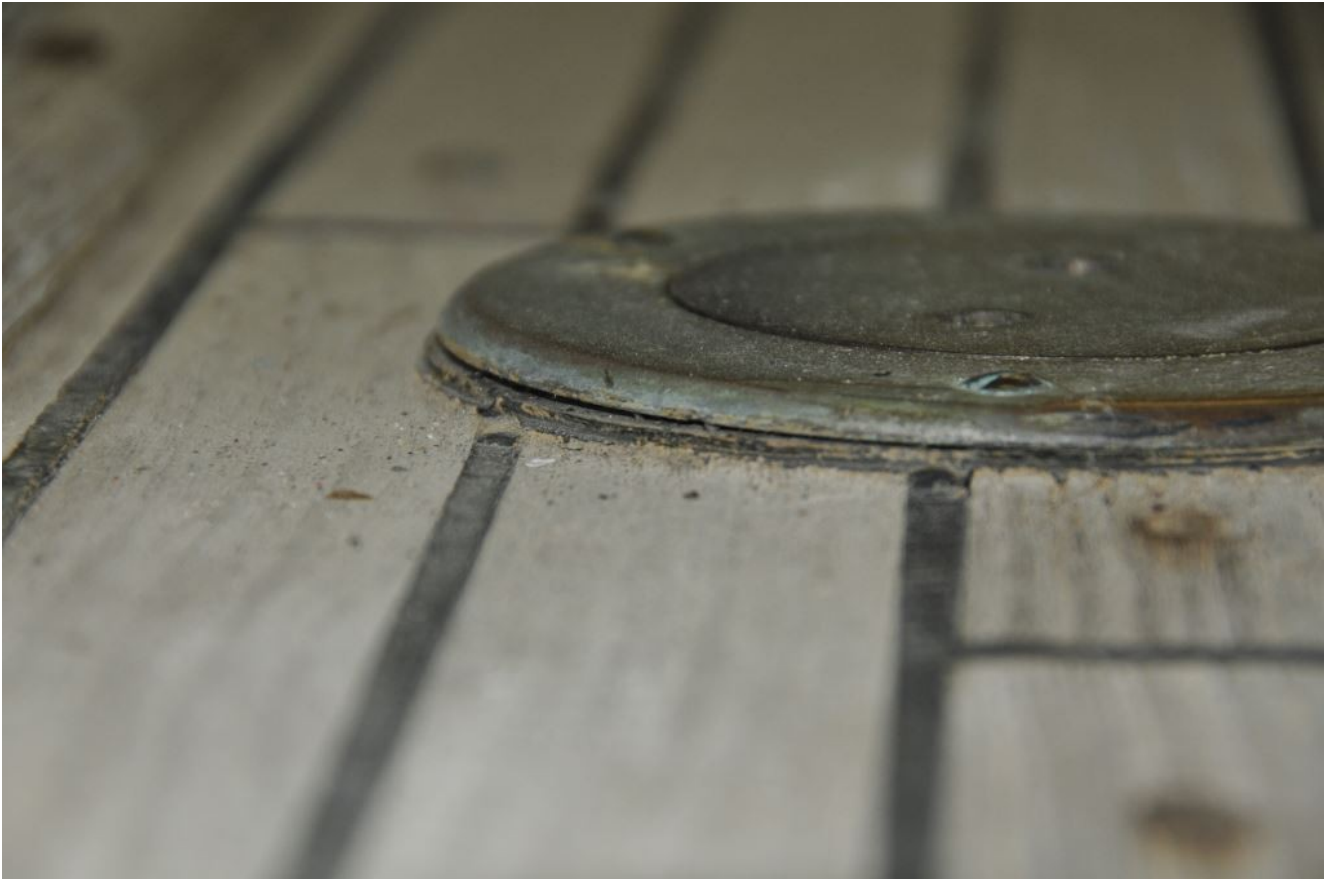
**Deck fills, in teak decks are notorious for leaking water onto tank tops. The gap between this deck fill and its bedding is clear to see. Inspect your deck fills and tank tops regularly.**

visible (such angling is required for compliance with ABYC standards). The number of tanks I've encountered that have failed from the top down, as it were, is simply astounding. Deck fuel fills are notorious for leaking water onto the tops of tanks (why deck hardware leaks, and how to avoid it, is the subject of an upcoming Marine Systems Excellence article), where it often stands, ultimately causing rust or corrosion on steel and aluminum respectively.

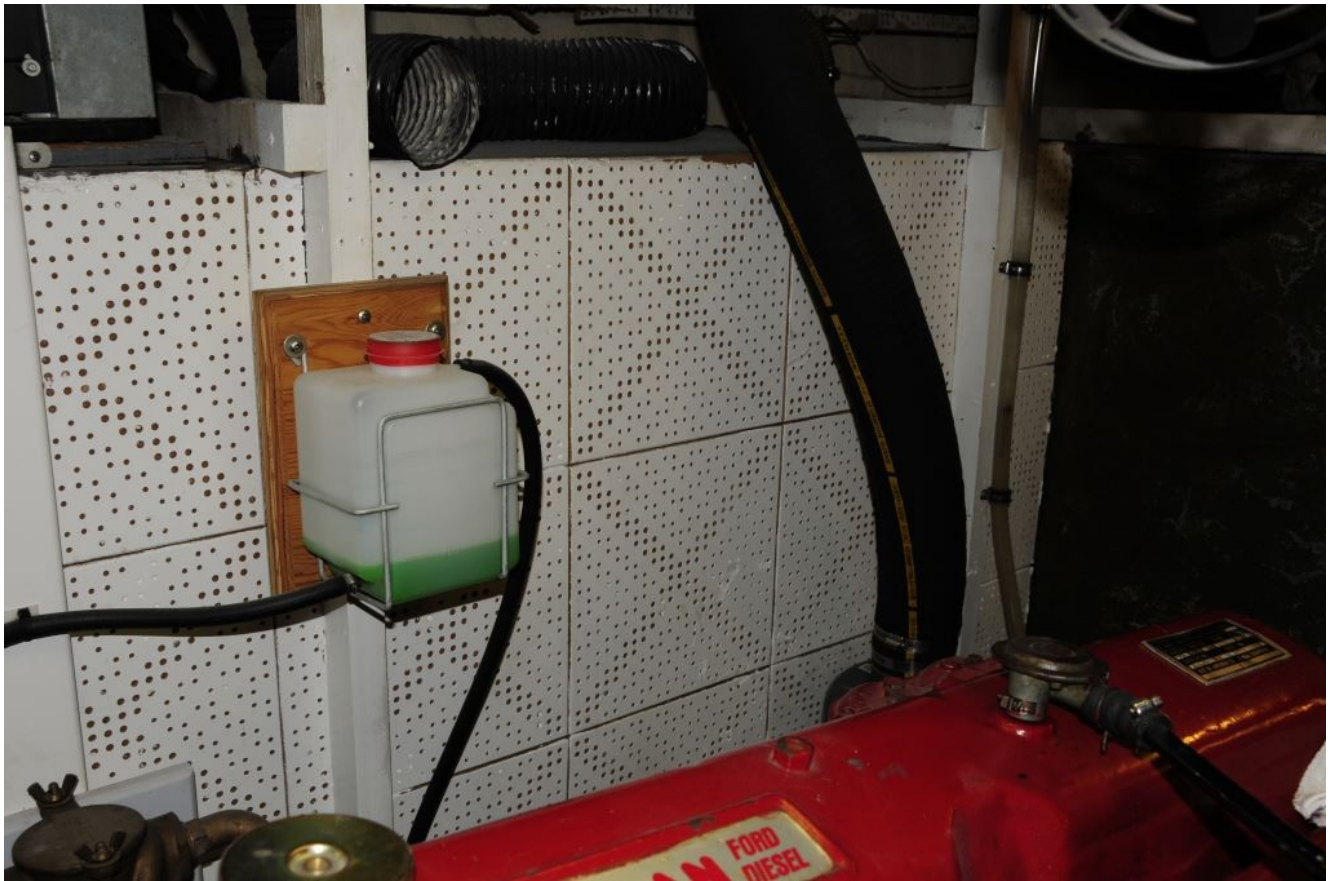
**Many boat builders cover tanks with a fascia or acoustic insulation. While that may provide a small modicum noise reduction, and it may be visually appealing (I don't believe it is, and if it is it's not worth the price paid), it prevents identification of leaks and corrosion. Tanks should remain exposed, particularly metallic tanks.**

A final note on tank installations relates to serviceability and accessibility. Once the tank is installed all “serviceable” components, fill, vent and supply fittings and senders as well as inspection ports should be accessible and ideally they should be visible as well. Covering or sheathing a tank for cosmetic or acoustic purposes is a double edged sword, it may look more attractive, to some, or it may offer (minimal of any) noise reduction in accommodation spaces, however, it also means that leaks, corrosion, deteriorating hose and other issues may go unnoticed. Given the choice, I’d rather see the tank in all its glory.

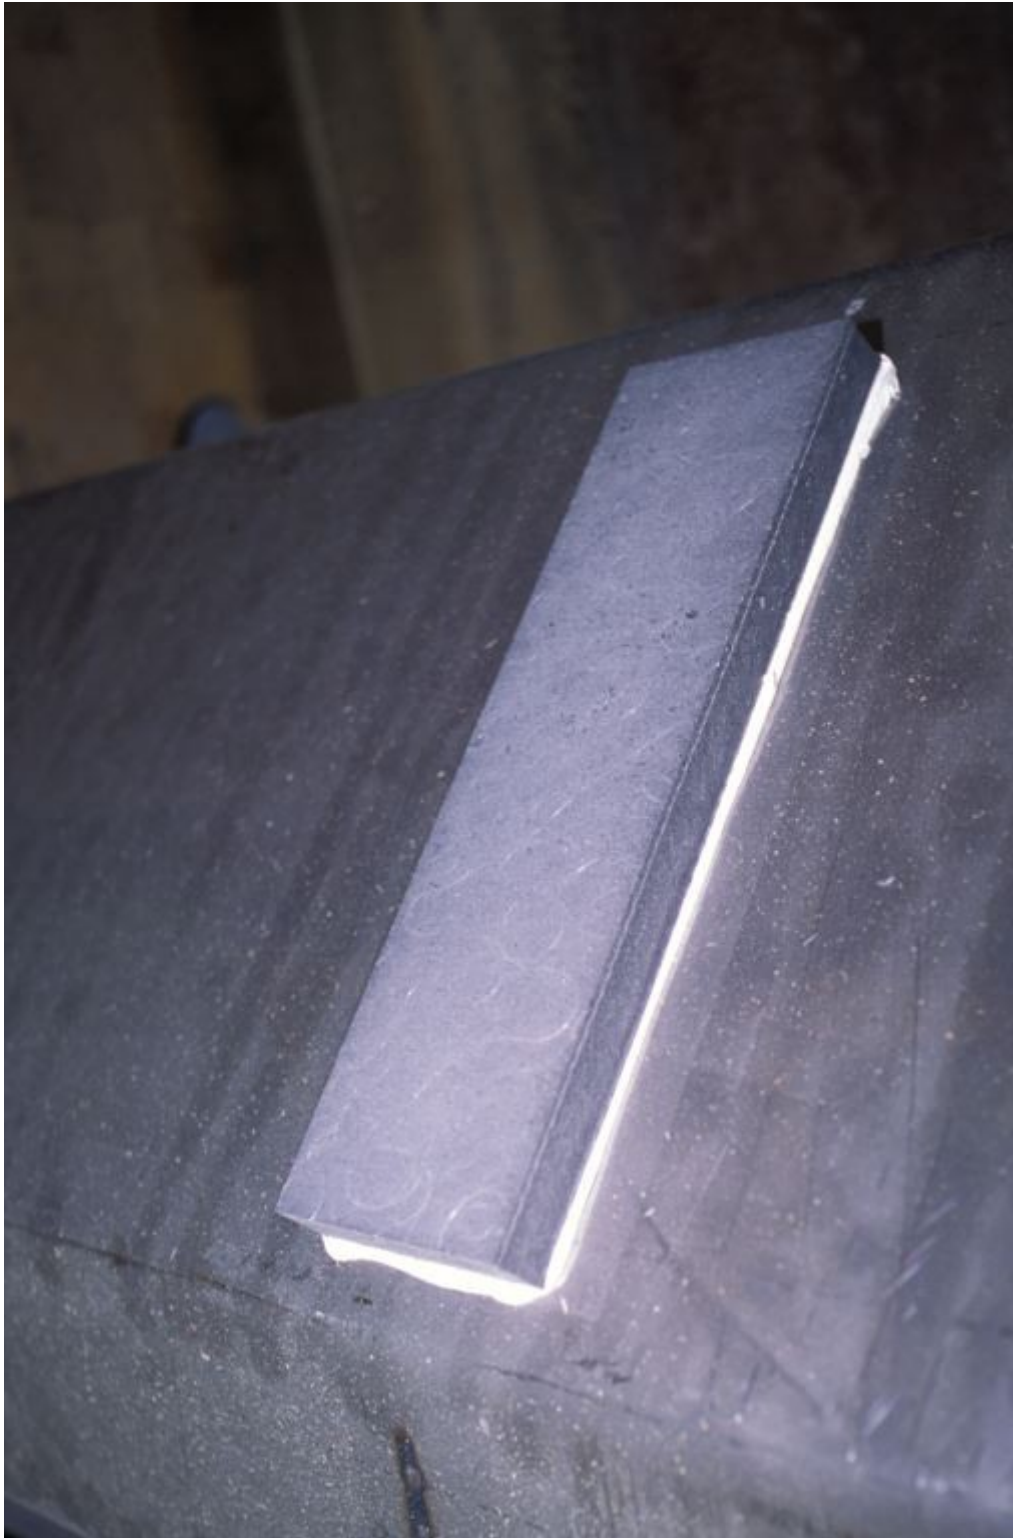
**Spacer material should be bedded to tank bottoms, like that shown here. Doing so prevents water migrating between the tank and the spacer.**

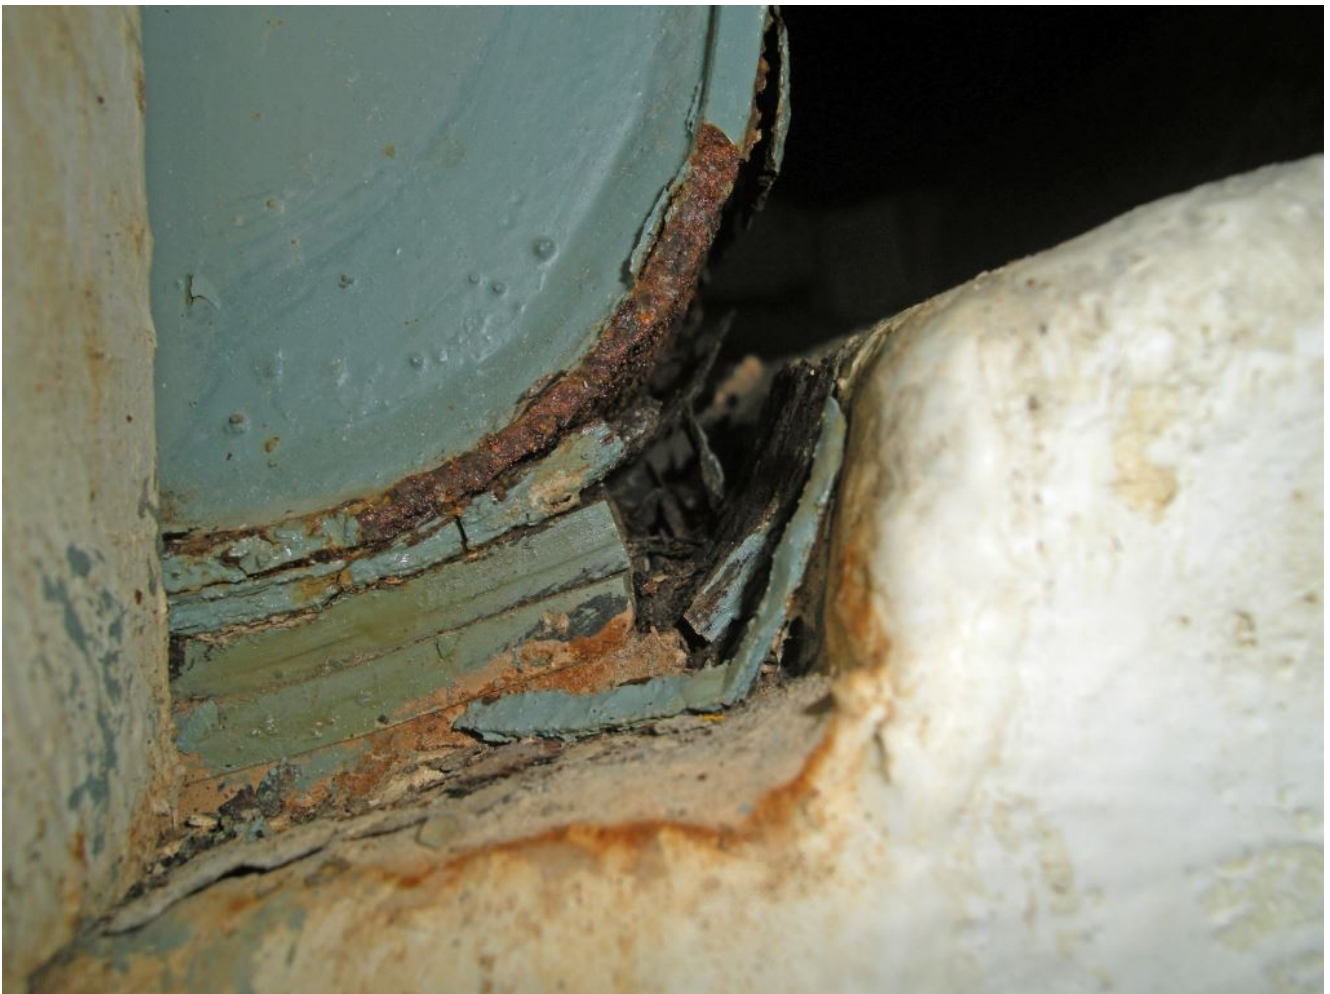
**In spite of the cushion, a strip of hard rubber, this tank rests on, it's suffering from near-terminal corrosion as a result of a deck leak. It is imperative that cushion material, regardless of what form it may take, must be bedded to the tank.**
