Hose Clamps Part I: Design and Selection

Hose Clamps Part I

Design and Selection

Photos and text by Steve D'Antonio

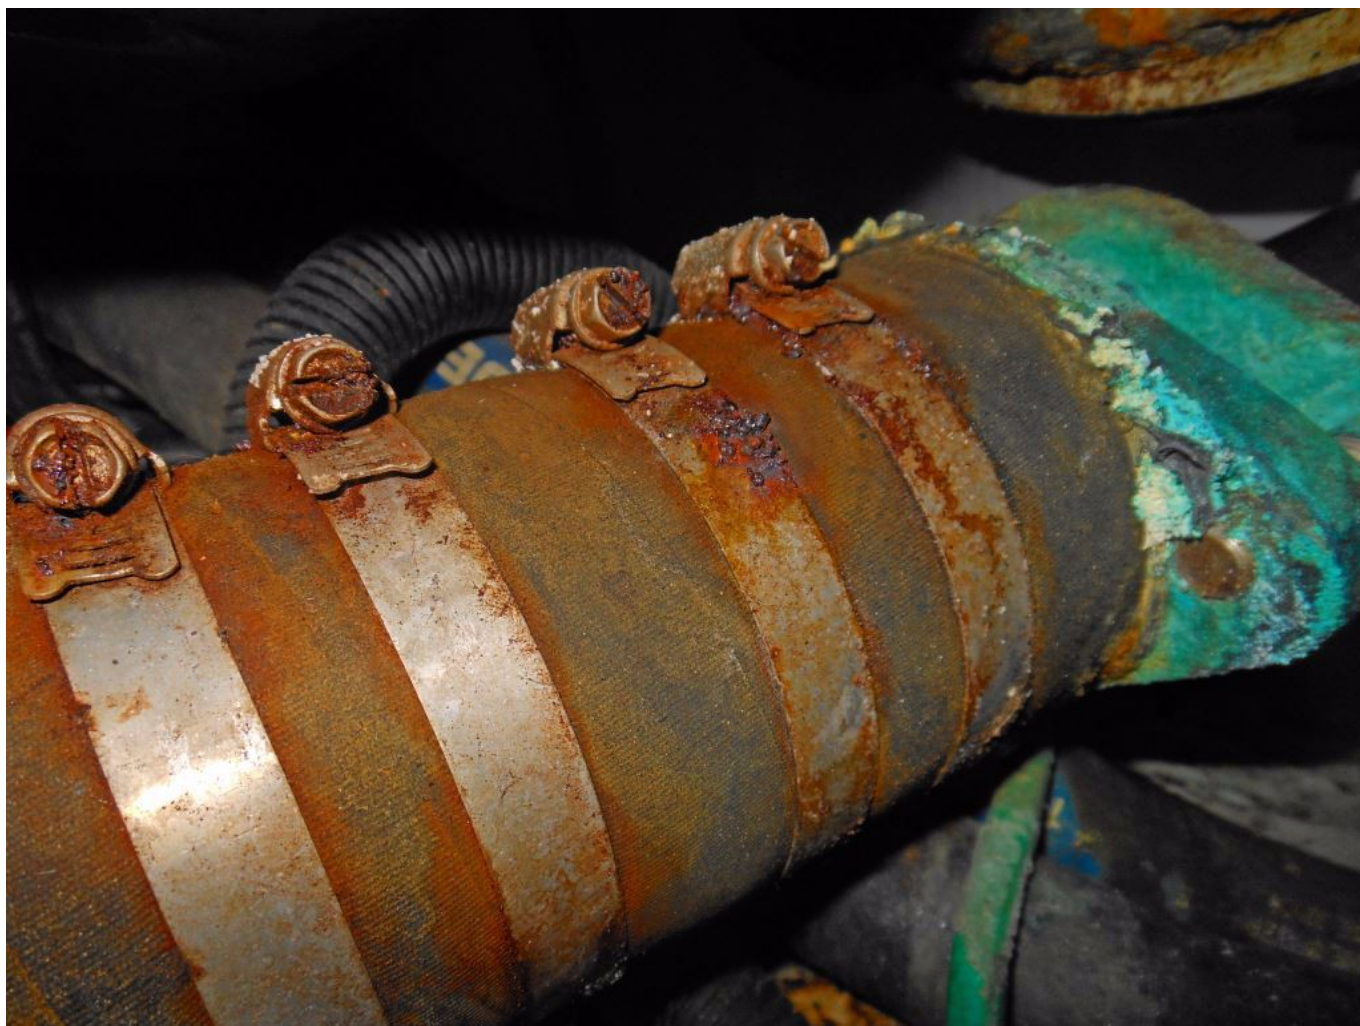
All hose clamps are not created equal, some are far more durable and corrosion resistant than others.

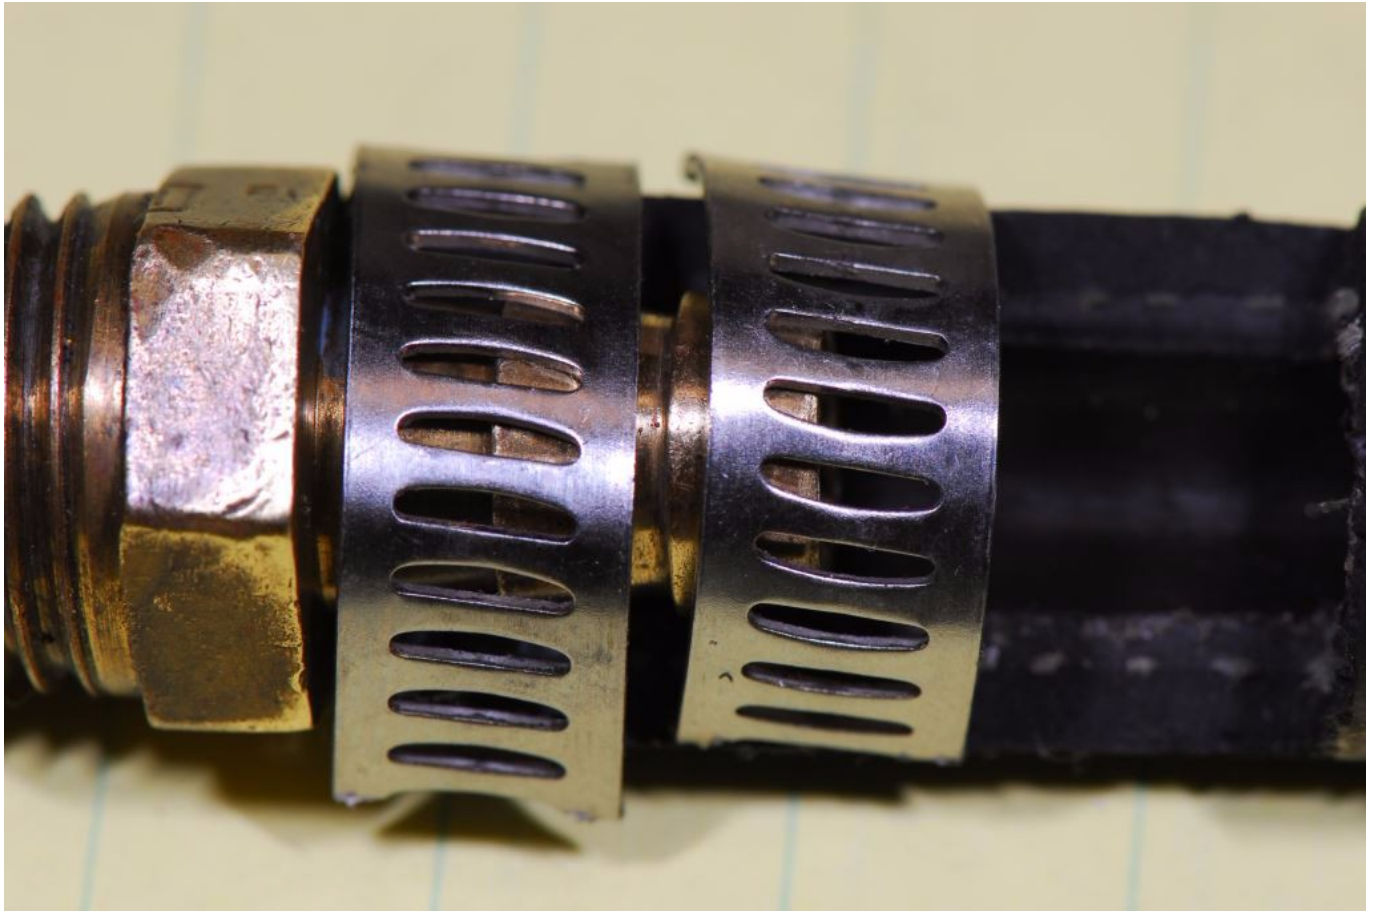
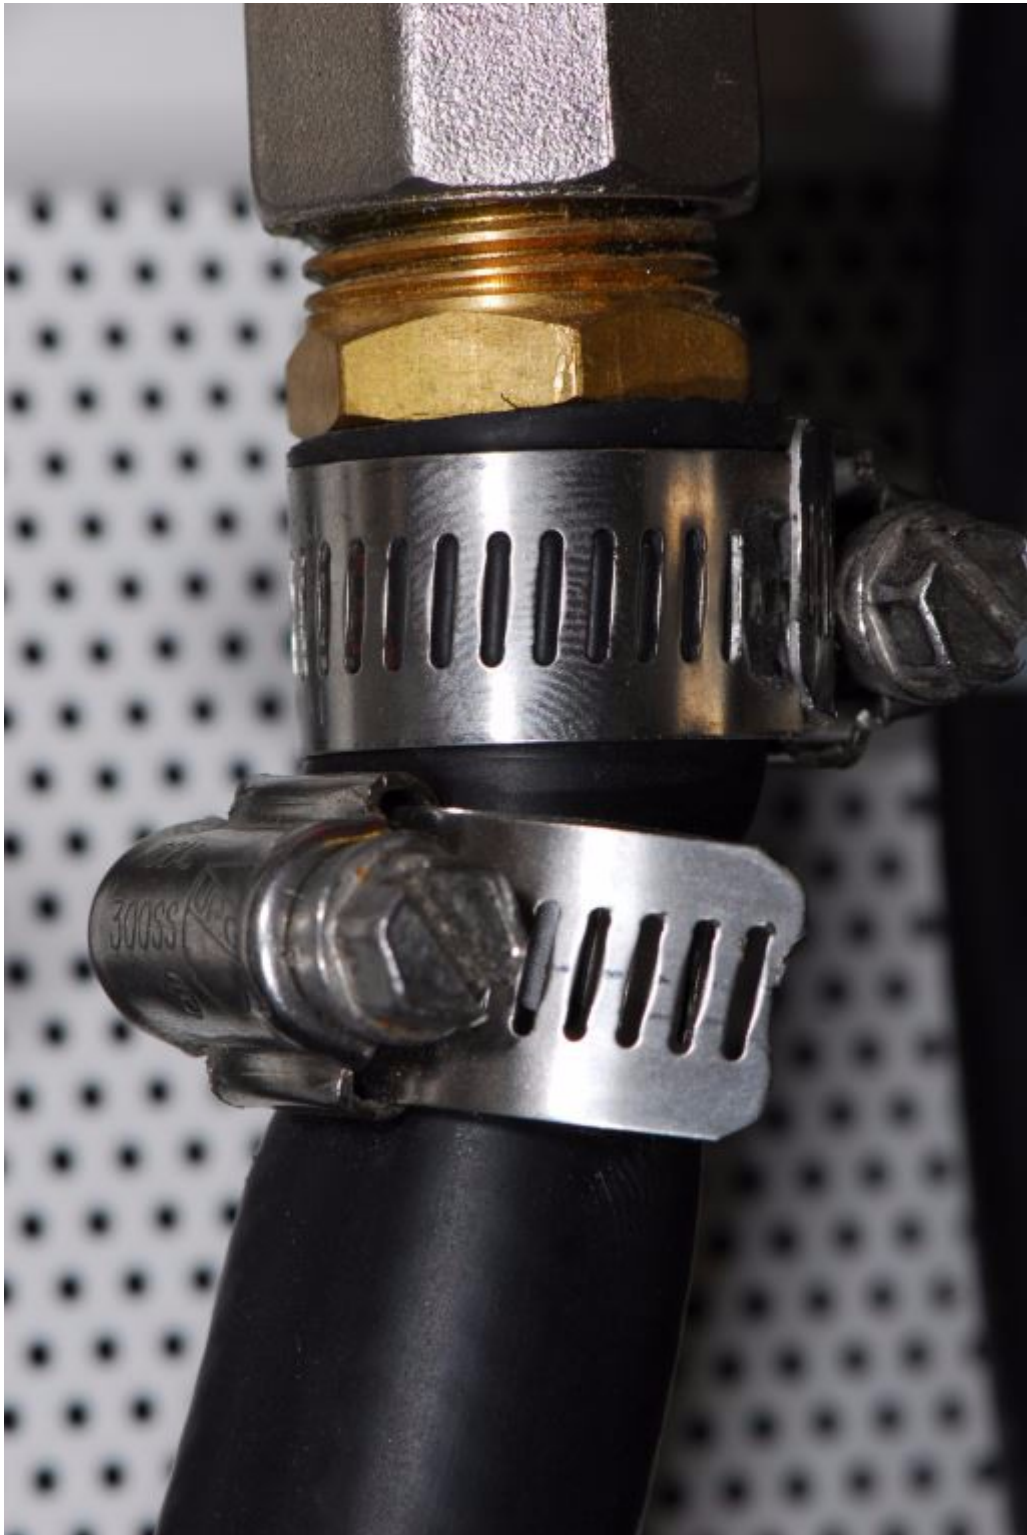
A common oversight involves the installation of two clamps where only one can fully bear on the pipe to hose adapter beneath. If the latter is too short to accept twin clamps, then only a single clamp should be used.

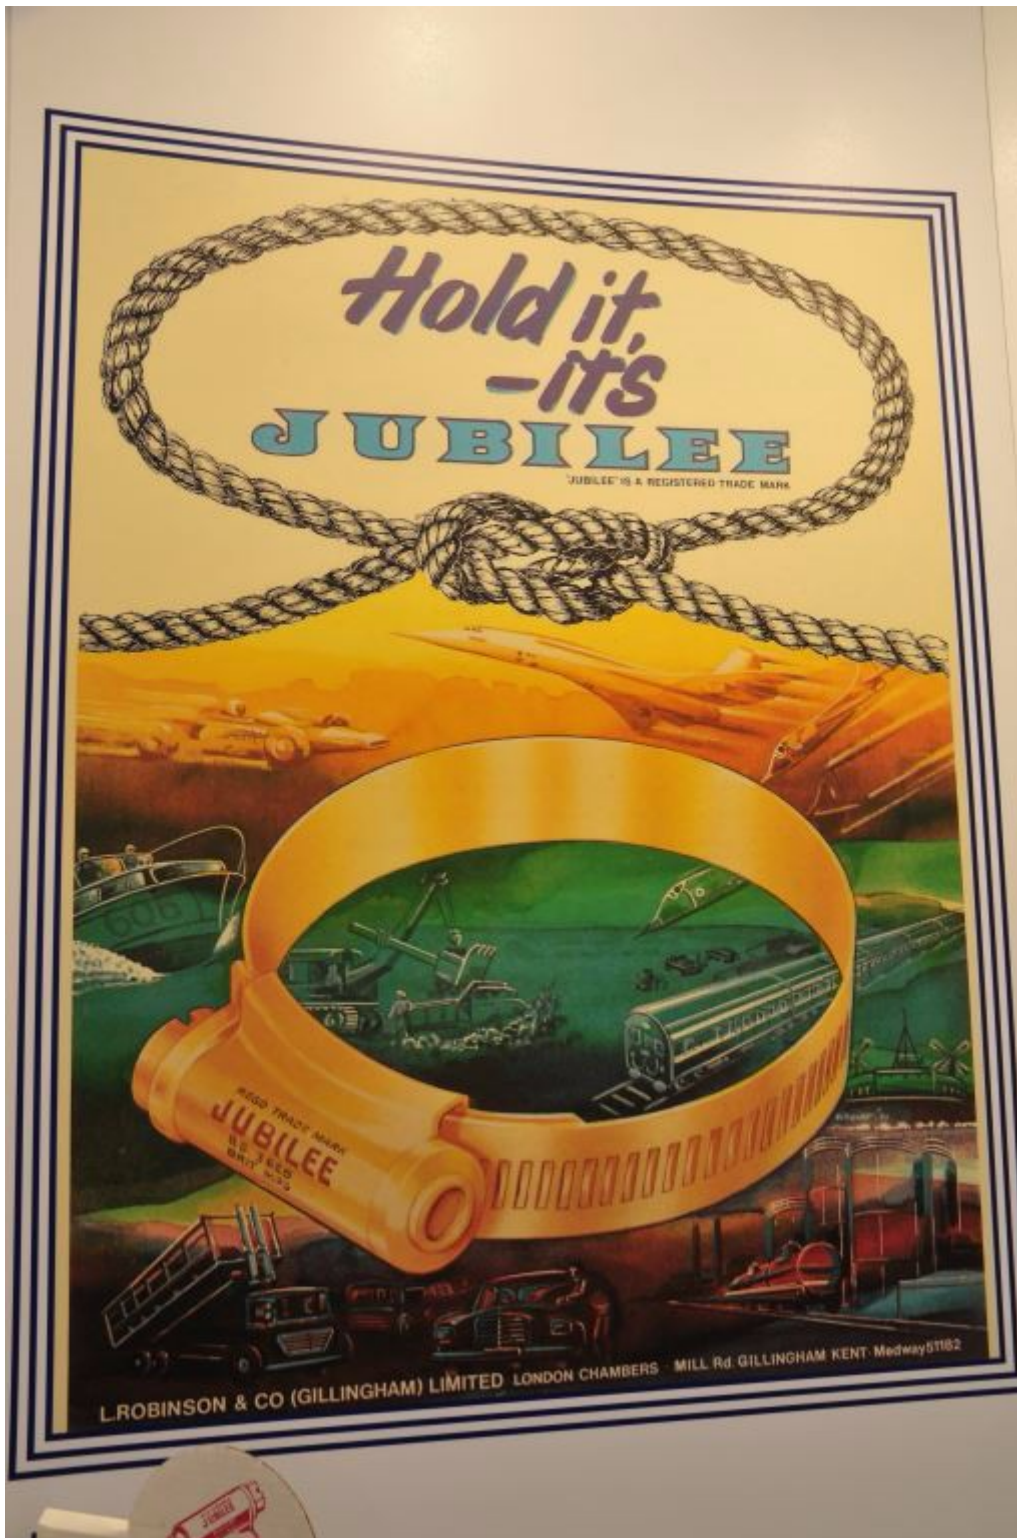
Where it all started; Many Brits still refer to hose clamps as “Jubilee Clips”.

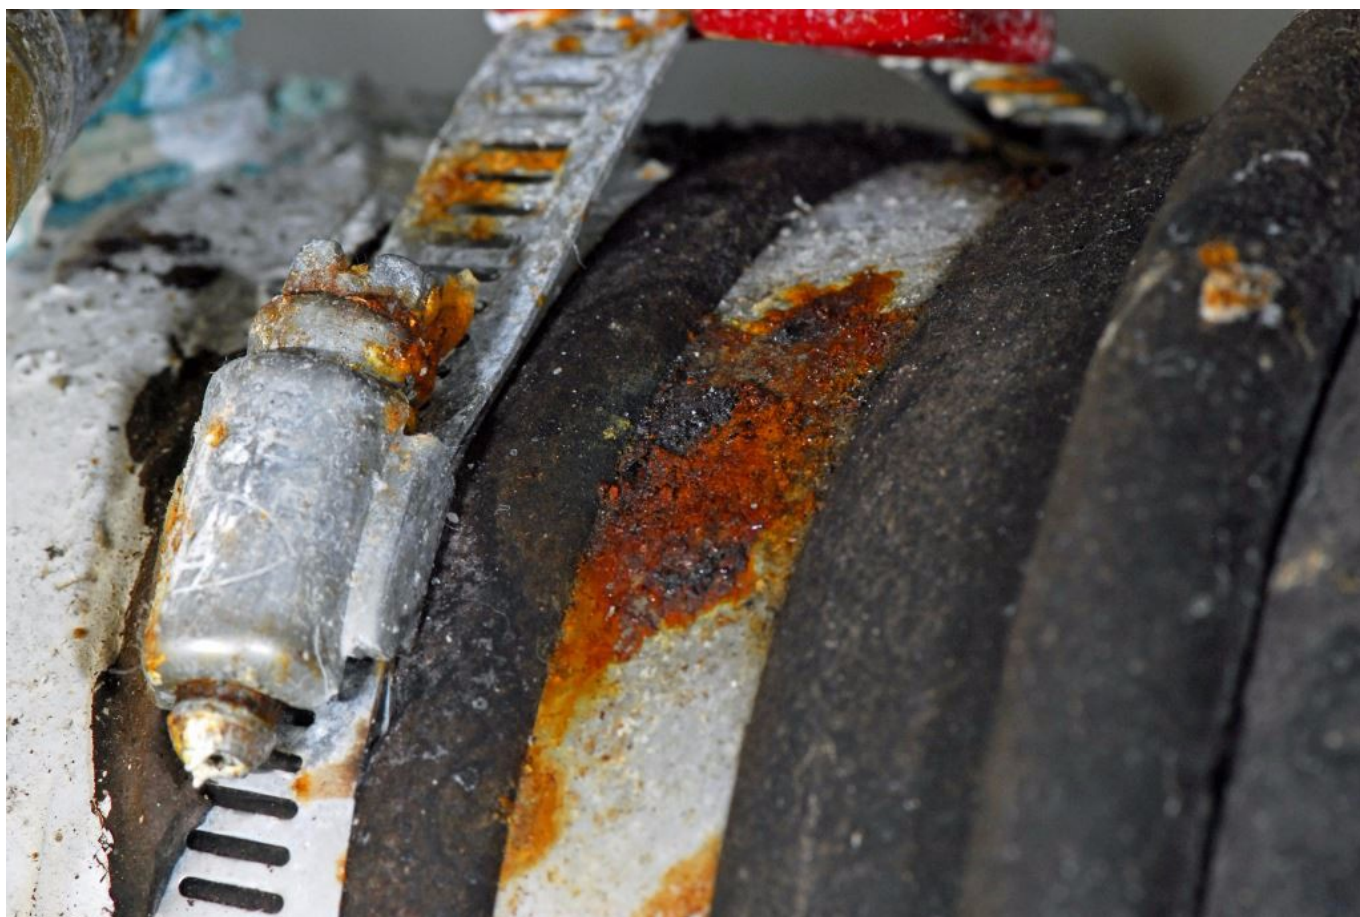
Conventional hose clamps, even those that are all stainless, can come to grief if exposed to the wrong conditions, i.e. continuously wet with seawater.

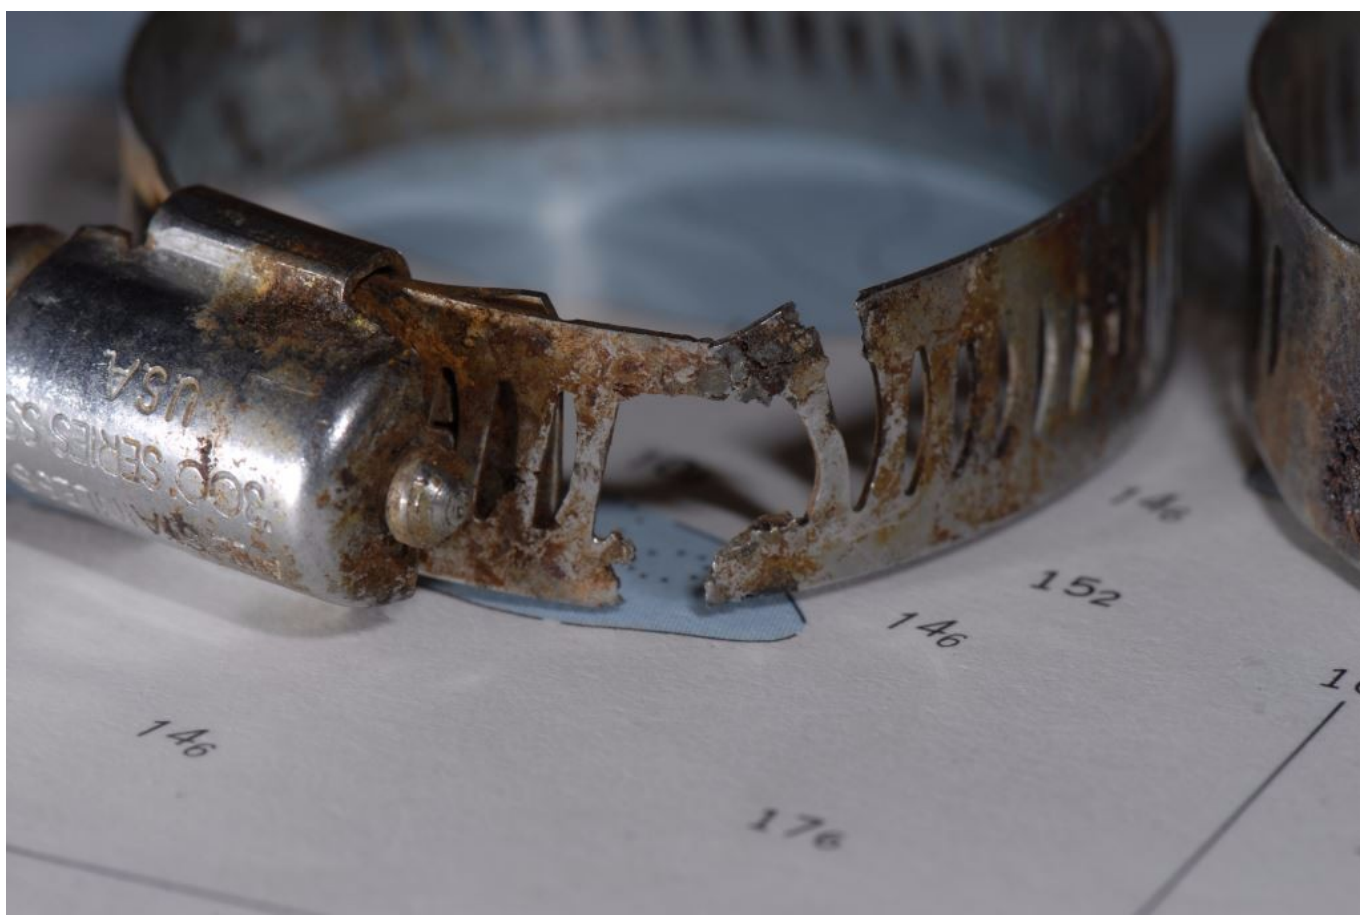
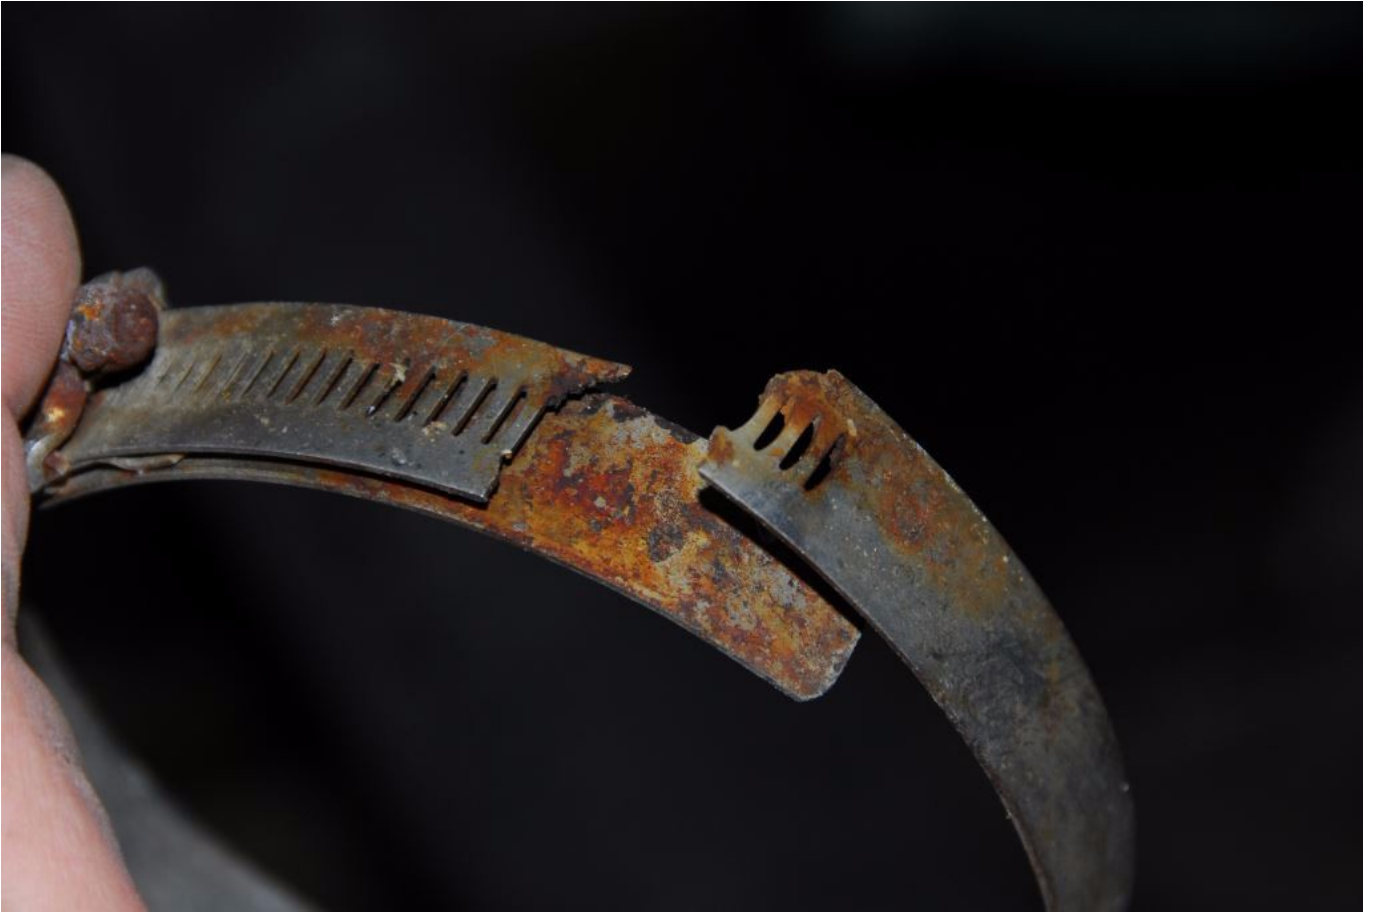
The perforated thread design in traditional hose clamps is often the source of corrosion-induced failures. Microscopic cracks develop adjacent to perforations, providing a toe hold for crevice corrosion.

it isn't without its flaws. Primary among these is the fact that many hose clamps rely on a series perforations that are cut into the band, to form the screw threads. These perforations eliminate a significant portion of the band's cross section, weakening it and allowing it to elongate when tensioned. The elongation leads to micro-cracking, which in turn provides a toe hold for crevice corrosion, a form of metal decay that is peculiar to stainless steel alloy. When hose clamps part they nearly always do so across one of these perforations, either as a result of overstress or corrosion, or a combination of both. Additionally, the typical band itself is comparatively thin, which makes it relatively easy to strip the thread if the screw is over tightened.

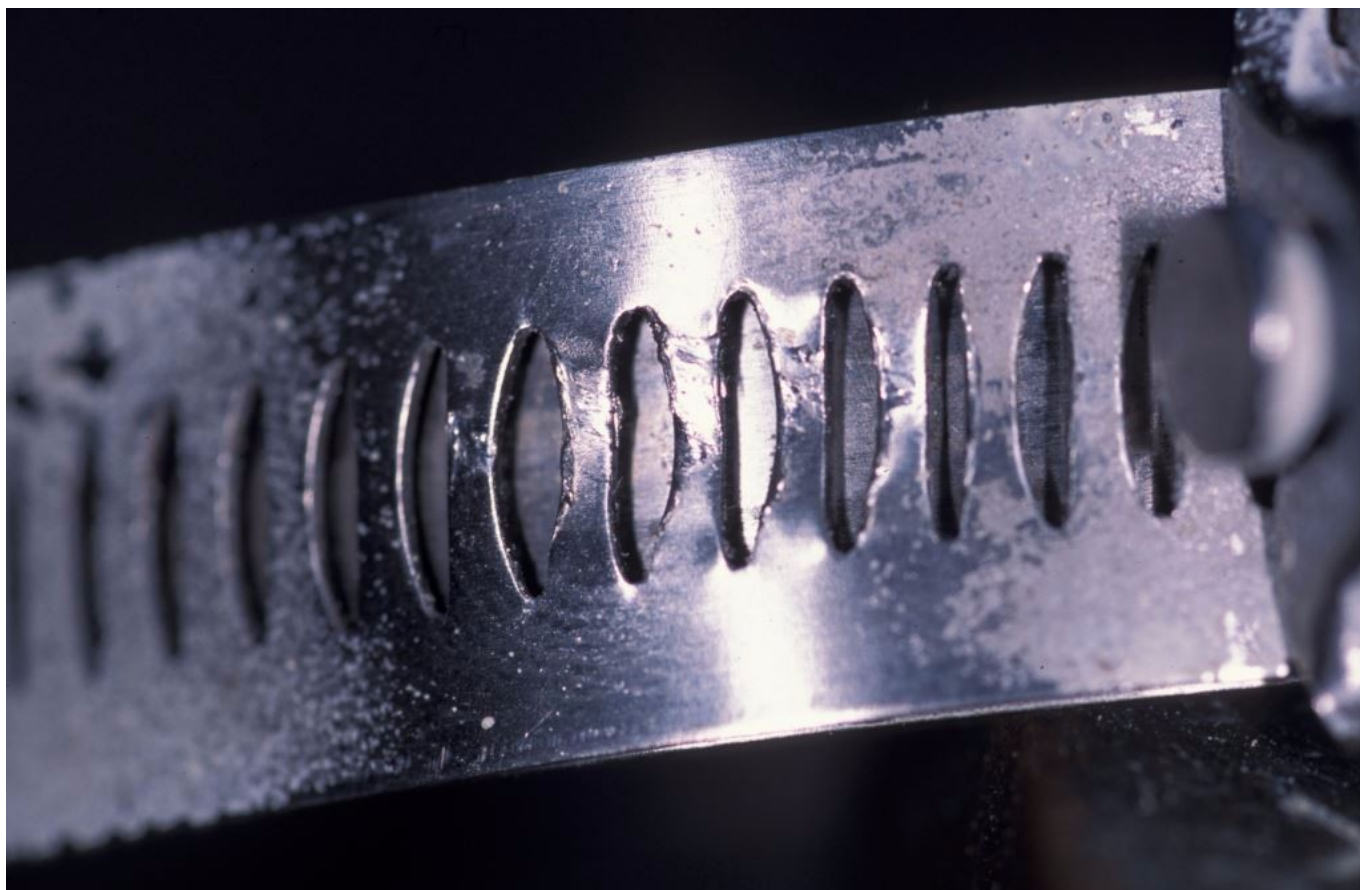
One of many weaknesses; conventional hose clamps rely on a thin band, perforations in which form threads for the clamping screw. It doesn't take much over-tensioning to strip these "threads" ruining the clamp.

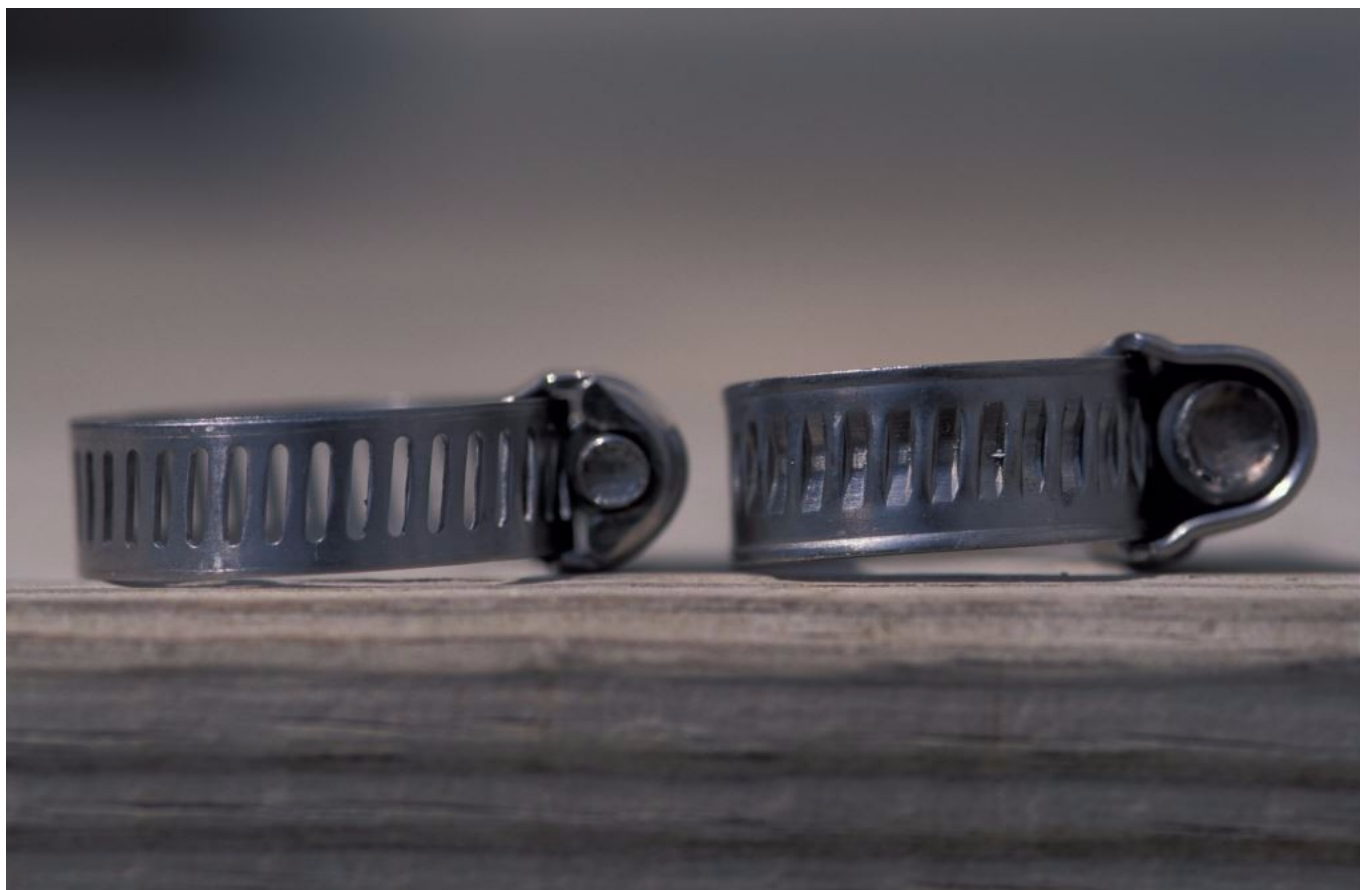
A conventional perforated thread design hose clamp, left, and a high quality, solid band clamp , right. The latter is nearly impervious to thread stripping and crevice corrosion.

Solid band, all stainless steel hose clamps represent a significant leap in both quality and reliability over both automotive and standard marine clamps. This style of clamp eliminates the band perforations, replacing them with embossed rather than perforated threads, necessitating a thicker band, which resists elongation, cracking and stripping. Solid band clamps are virtually immune to stripping even when over tightened.

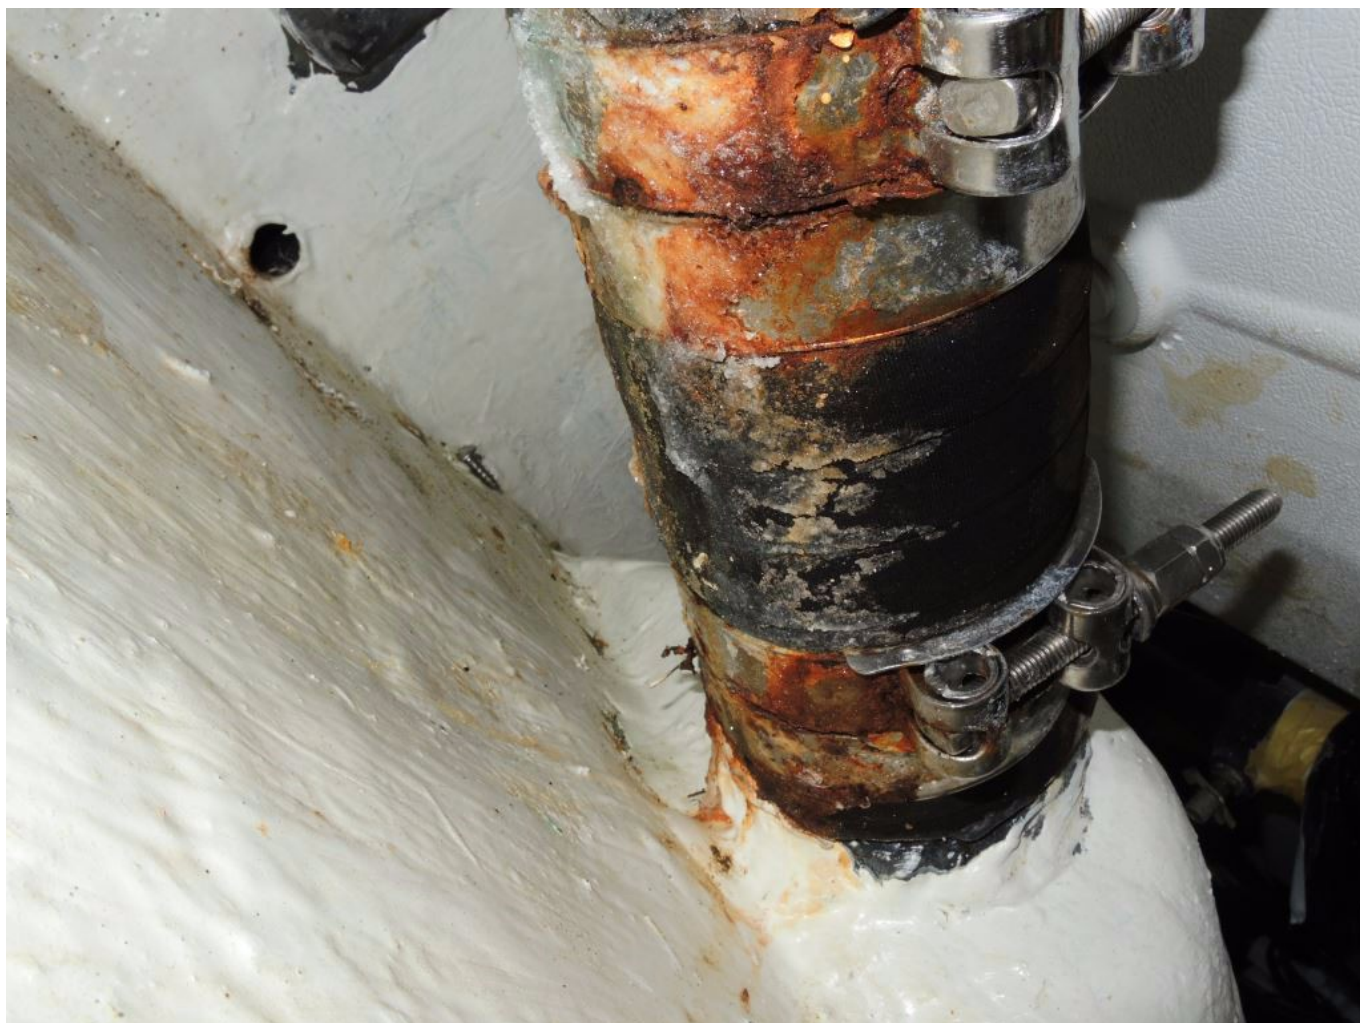
In many cases, hose clamps suffer the most where they can be seen the least; with the underside of stuffing boxes being a prime location for corrosion. These should be inspected regularly, using a mirror if necessary.

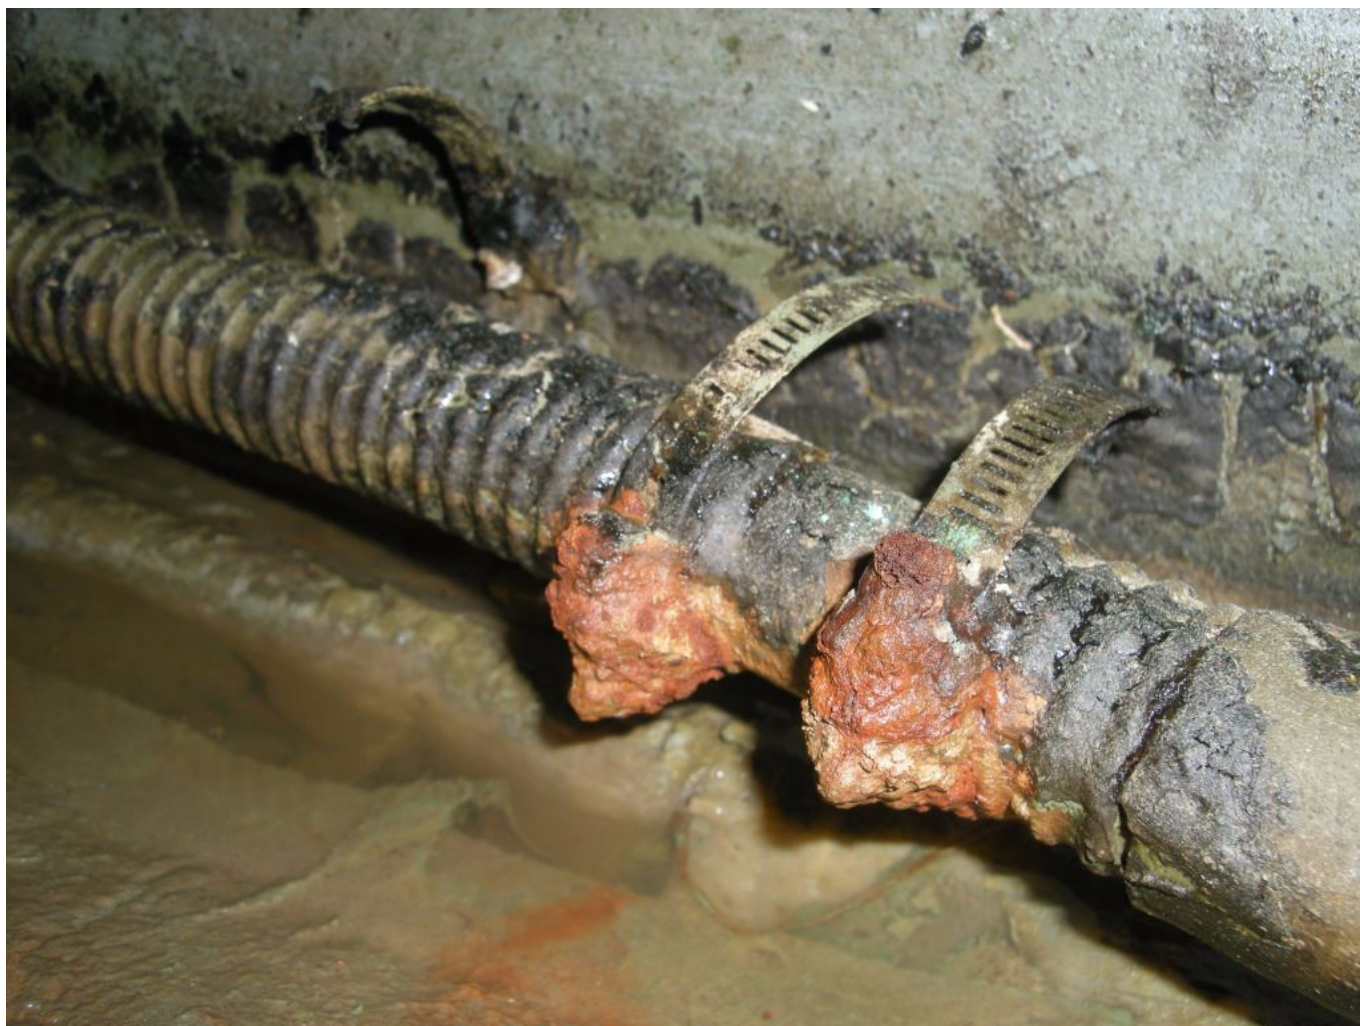
When used in continuously wet locations, like the bilge shown here, ordinary automotive style hose clamps, even those that are all stainless steel, simply don't hold up. If the clamp screws are mild steel, like those shown here, severe rusting will often occur very quickly, often within a matter of months.

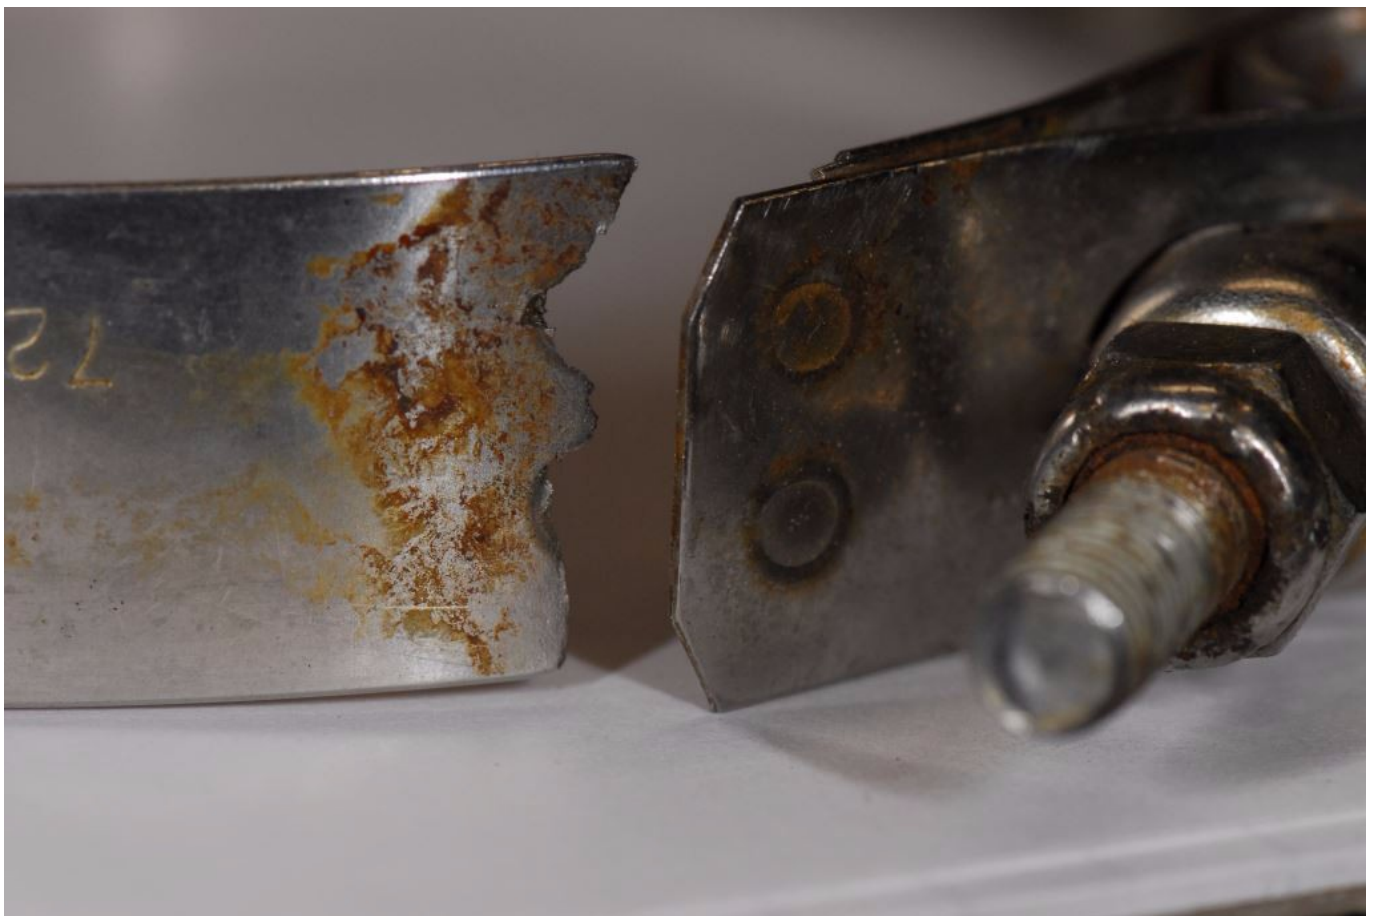
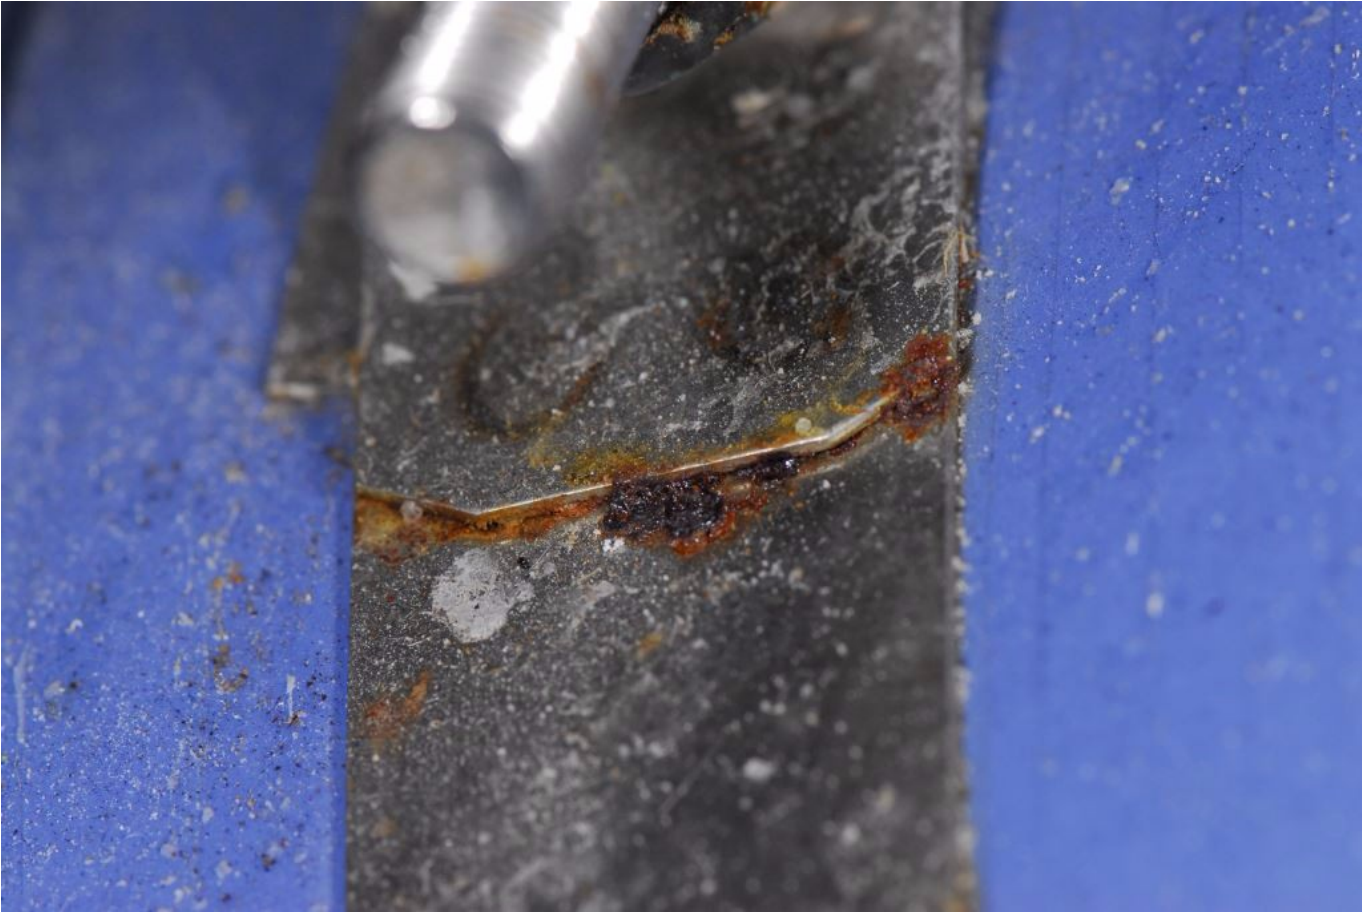
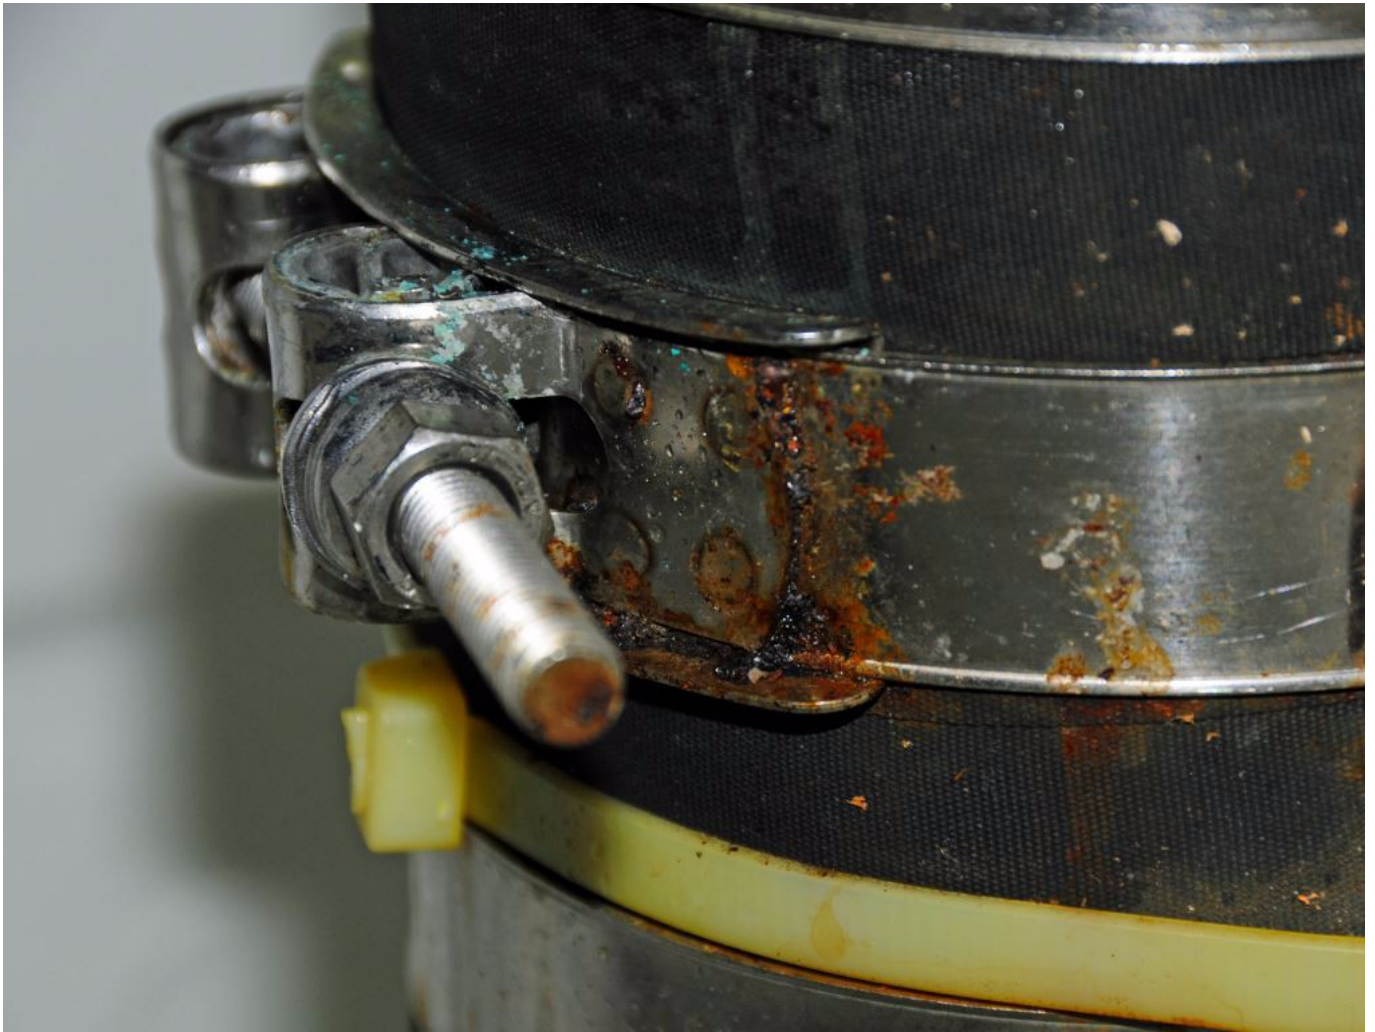
Thanks to their folded design, common T bolt clamps, those that rely on a threaded bolt and nut for clamping, are susceptible to crevice corrosion.

Another Achilles' heel that these clamps possess is a function of the manner in which they are made. The T-bolt is retained by the band by folding the latter over and spot welding it to itself, creating an envelope of sorts. While this makes for a resilient retention method for the T-bolt, it also forms an area where water can be trapped, which often leads to crevice corrosion. If used in routinely used wet locations, such as shaft and rudder stuffing boxes, bilge pump plumbing etc, they are prone to crevice corrosion-induced failure.

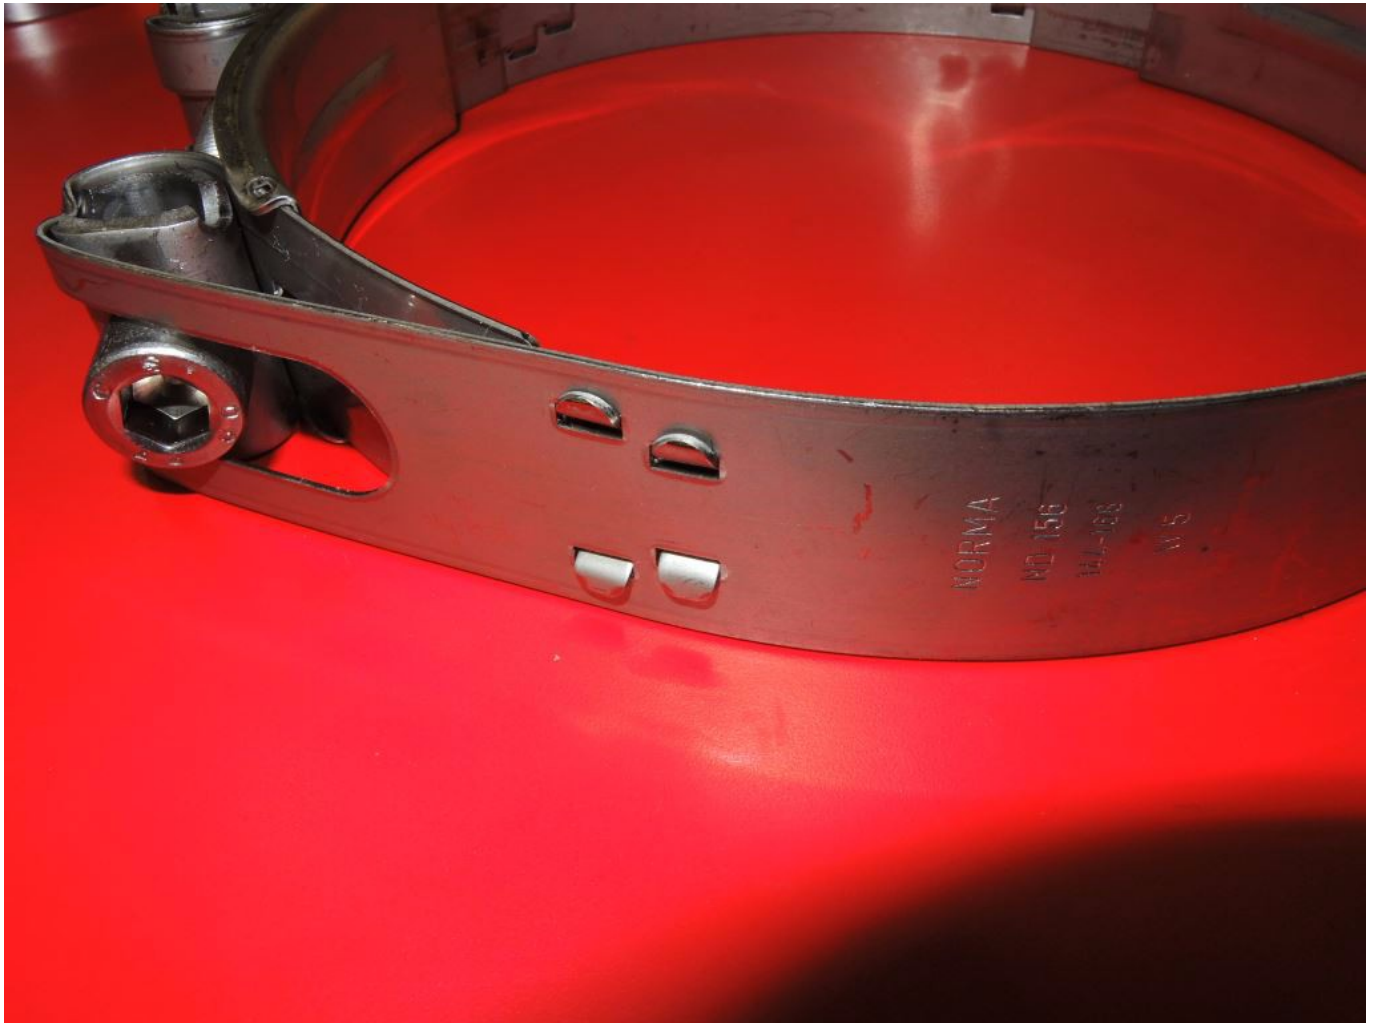
An improvement on the T bolt design does away with the spot welded fold, replacing it an with interlocking mechanism. The result is greater resistance to water entrapment and corrosion.

Because necessity is the mother of invention, a manufacturer named AWAB (they also manufacture high quality solid band hose clamps, in 304 and 316, as well) has created a T-bolt clamp that uses interlocking rather than folded and spot welded bands, virtually eliminating the water-trapping fold and the corrosion to which it so often leads. These clamps are well suited to wet locations without concern for such failures.

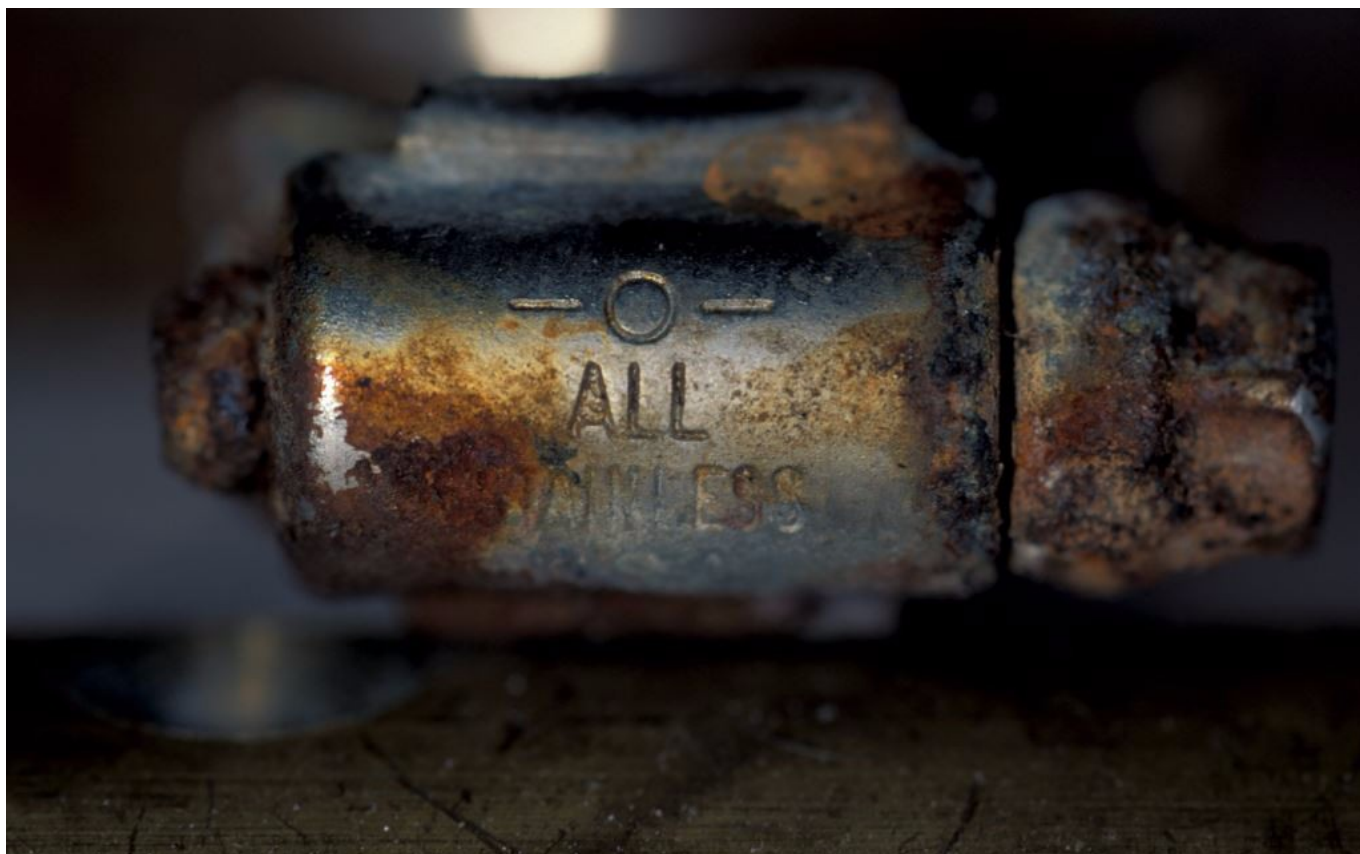
While this automotive-style clamp is embossed, “ALL STAINLESS”, it is in fact a hybrid, the band and screw retainer are stainless steel, while the screw is mild steel.
