## January 2019 Newsletter

### Photo Essay: Seacock Installation

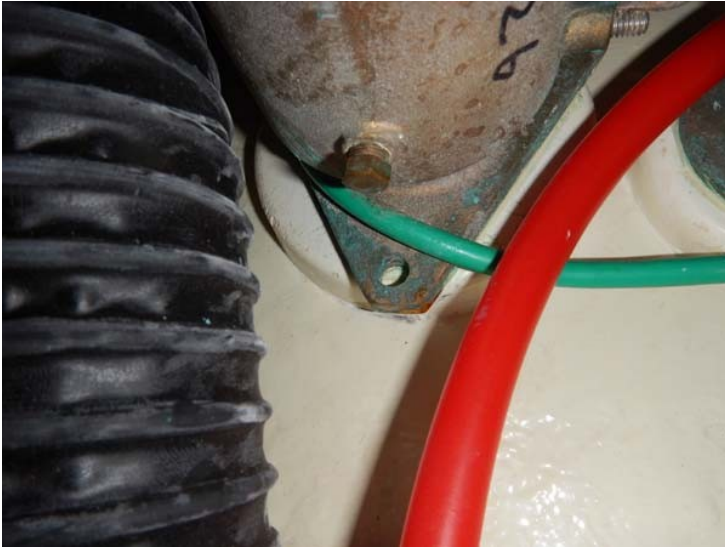
In the example shown here, the backing block is undersized, so much so that the seacock's flange is overhanging, offering little if any reinforcement. In the installations I review I often wonder if boat builders and yard technicians have lost sight of the purpose of a backing block. Its primary mission is to more widely distribute the load imparted by the hardware its serving. In order to achieve that goal, it must cover an area larger than the flange, the greater the load the larger the backing block should be. In the case of seacocks, the backing block diameter should be at least two inches greater than that of the seacock flange, providing a minimum of an inch between the flange and backing block edge.

Finally, if the seacock flange is equipped with holes for fasteners, as the one shown here is, the holes should be filled with fasteners. In other words, the flange must be lag, machine screwed into threaded inserts, or carriage bolted through the hull. Such added reinforcement helps to further secure the seacock assembly and prevent it from breaking or twisting in the event it is struck with a heavy object.

While it's self-evident that seacocks play a vital role in a vessel's watertight integrity, I continue to encounter improperly installed examples on an all to regular basis. Among the most common oversights are incompatible threads, excessive leverage caused by extended hard plumbing, and incorrectly selected materials such as brass, PVC and other non-reinforced plastics.

From an installation perspective, a variety of bad habits also persist within the industry. These include the use of sub-standard backing block materials such as solid timber (it's prone to splitting), high density polyethylene or 'Starboard' (too slippery and not stiff enough) and conventional plywood (too rot prone).
