July 2016 Newsletter

Ask Steve: July 2016

Photo Essay: The High Density Polyethylene Dilemma

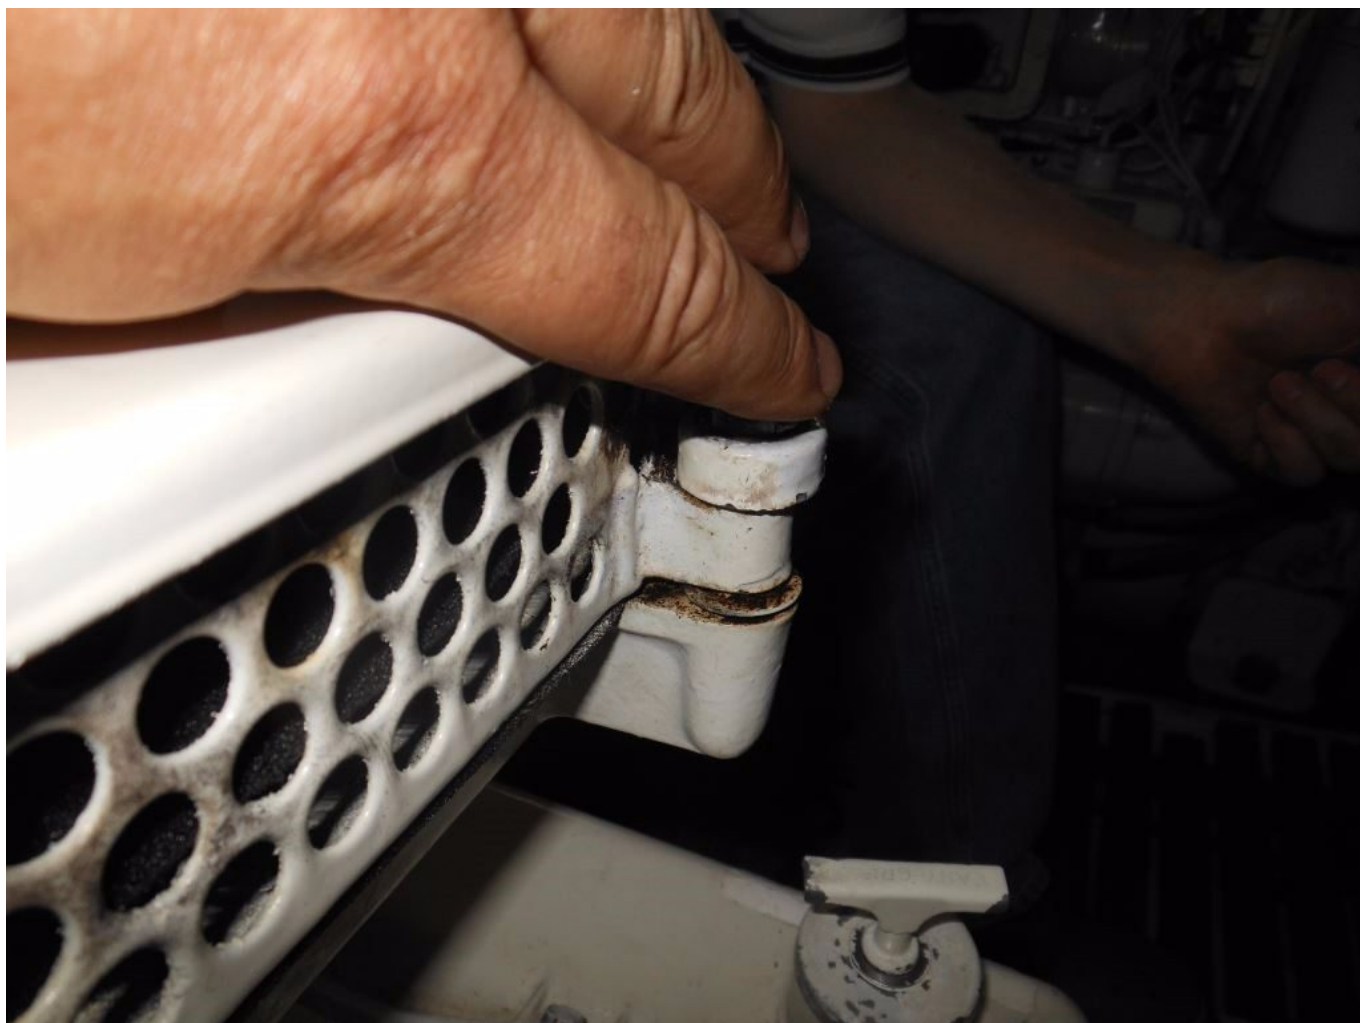
As strange as it seems, and as unusual as it is today, Caterpillars of this model and era were not equipped with conventional pleated air filter elements as we know them. They do utilize a perforated steel box that has a foam element, both can be seen in the image below. Your mechanic is right to an extent, marine engine rooms aren't very dusty, and as such Caterpillar deemed them unnecessary. Today, that logic has evolved, you'd be hard pressed to find a marine diesel engine that is not equipped with an air filter. Contaminants such as fan belt dust or deteriorating acoustic insulation can be drawn onto an engine air intake, however, so the lack of a filter is somewhat of a liability, making it important for you to ensure the engine room air remains as free of suspended particulates as possible.

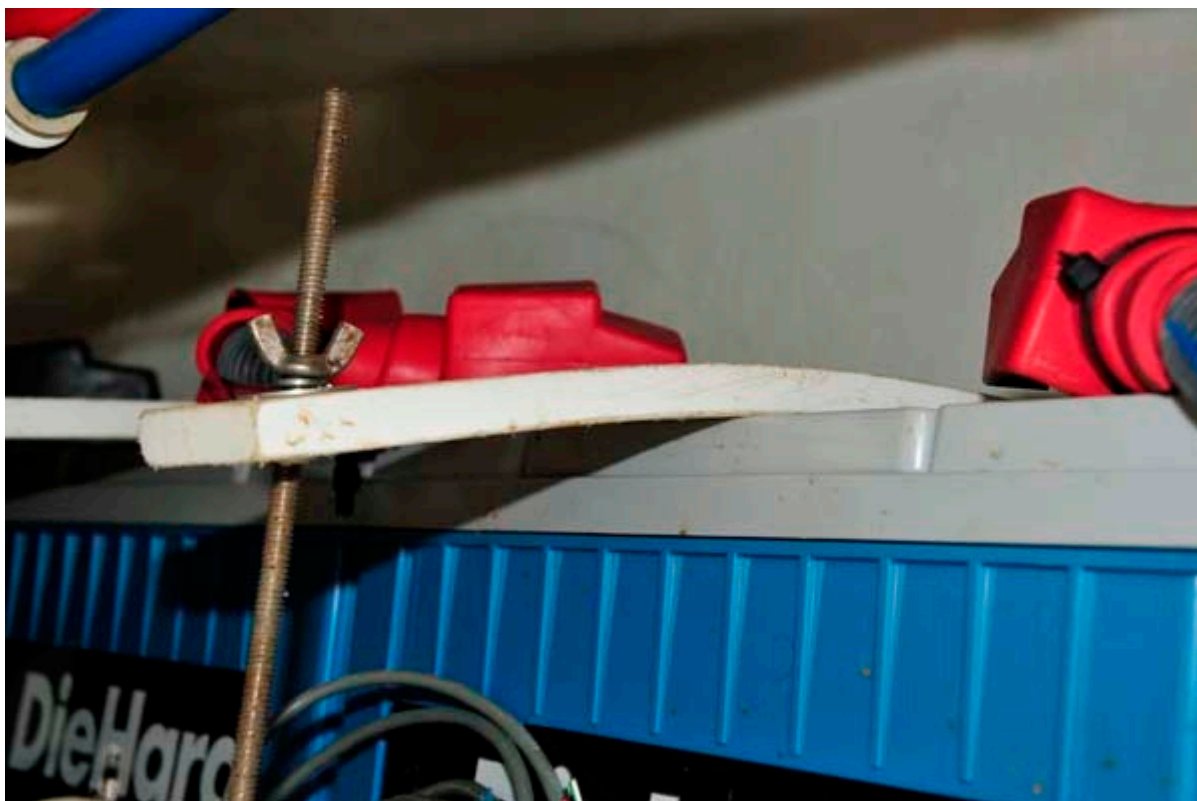
So what's not to like? As versatile and rugged as HDPE may be, there's one thing it's not and that's stiff. Being a non-reinforced plastic (fiberglass is a good example of a reinforced plastic) it is flexible and when unsupported, and loaded, it deforms readily. This is more a shortcoming of the

installer rather than the material, as it's being pressed into roles for which it is not suited. Plainly put, it should not be used in applications that require significant rigidity. In the accompanying image HDPE has been called upon to support batteries, and it's deforming considerably. Even if a shorter section was used, presenting less overhang, I would argue the material is not suited for this role. Two other features embodied by HDPE make it less than ideal in certain applications. One, it's exceptionally dense, it's heavy, and two, it's slippery, especially when wet, which means it's less than ideal in step or tread applications.
