# July 2016 Newsletter

## Ask Steve: July 2016

## **Photo Essay: The High Density Polyethylene Dilemma**

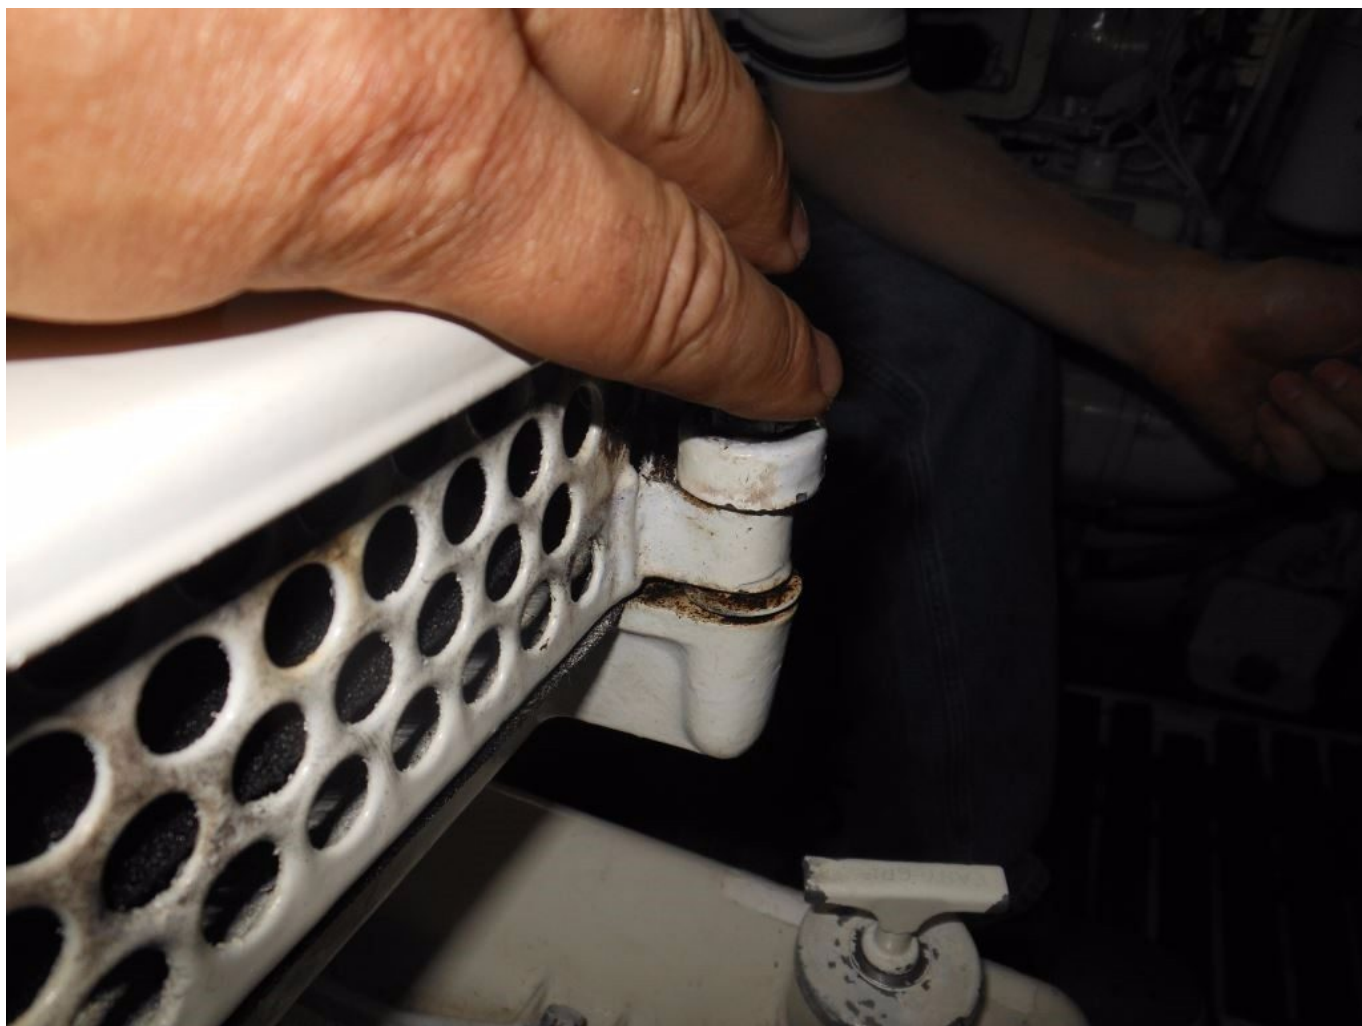
As strange as it seems, and as unusual as it is today, Caterpillars of this model and era were not equipped with conventional pleated air filter elements as we know them. They do utilize a perforated steel box that has a foam element, both can be seen in the image below. Your mechanic is right to an extent, marine engine rooms aren't very dusty, and as such Caterpillar deemed them unnecessary. Today, that logic has evolved, you'd be hard pressed to find a marine diesel engine that is not equipped with an air filter. Contaminants such as fan belt dust or deteriorating acoustic insulation can be drawn onto an engine air intake, however, so the lack of a filter is somewhat of a liability, making it important for you to ensure the engine room air remains as free of suspended particulates as possible.

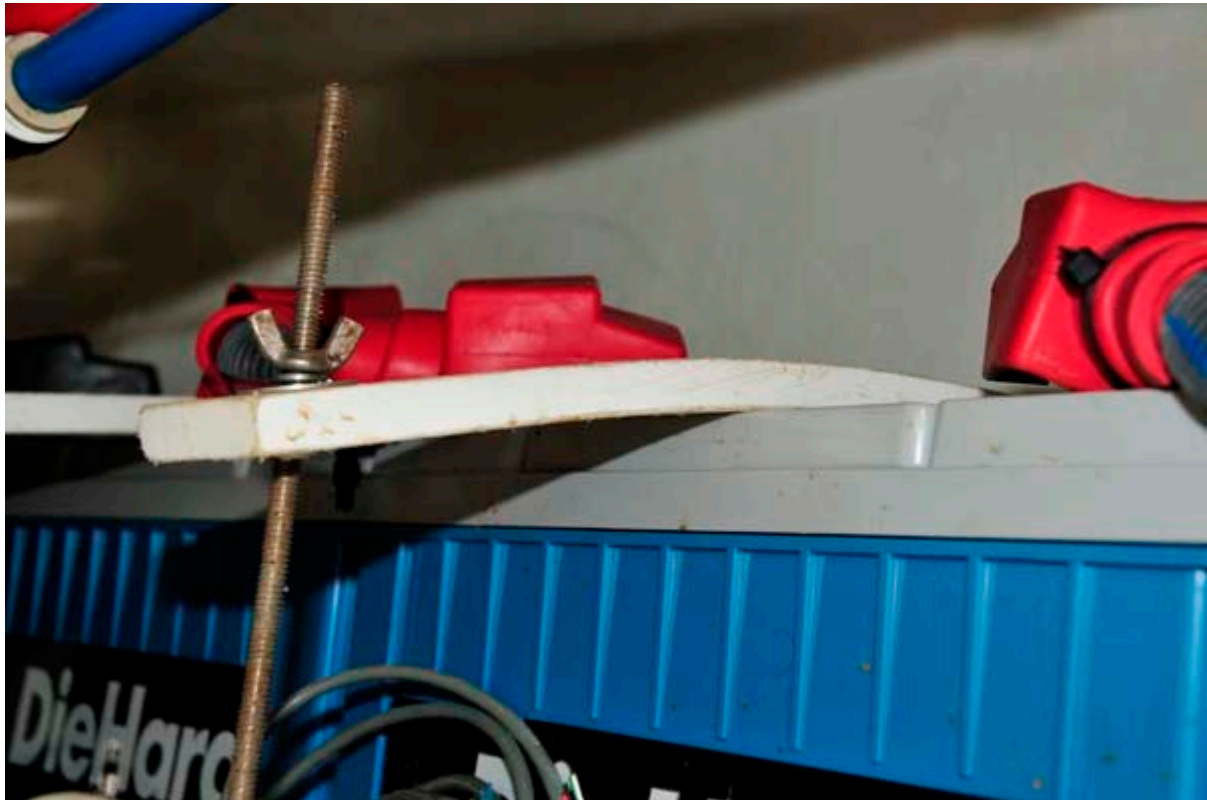
installer rather than the material, as it's being pressed into roles for which it is not suited. Plainly put, it should not be used in applications that require significant rigidity. In the accompanying image HDPE has been called upon to support batteries, and it's deforming considerably. Even if a shorter section was used, presenting less overhang, I would argue the material is not suited for this role. Two other features embodied by HDPE make it less than ideal in certain applications. One, it's exceptionally dense, it's heavy, and two, it's slippery, especially when wet, which means it's less than ideal in step or tread applications.

So what's not to like? As versatile and rugged as HDPE may be, there's one thing it's not and that's stiff. Being a non-reinforced plastic (fiberglass is a good example of a reinforced plastic) it is flexible and when unsupported, and loaded, it deforms readily. This is more a shortcoming of the
