# July 2016 Newsletter

## Ask Steve: July 2016

## **Photo Essay: The High Density Polyethylene Dilemma**

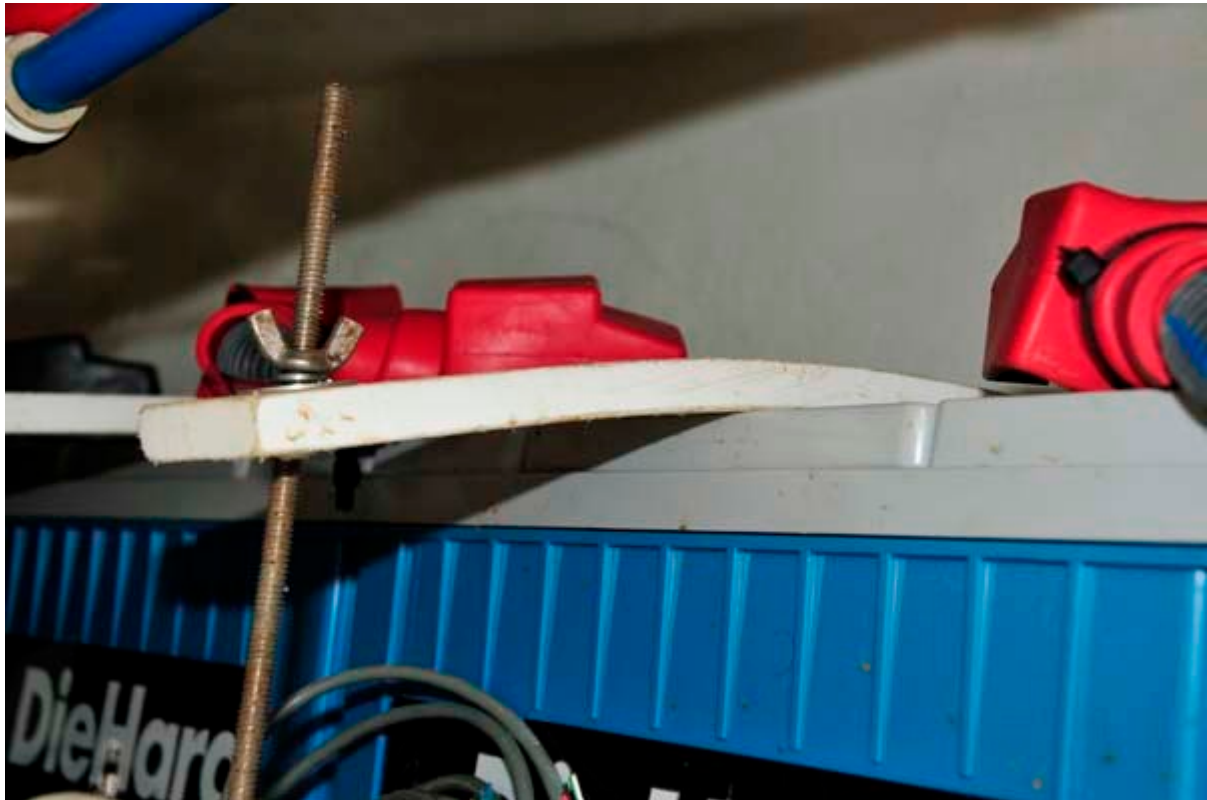
installer rather than the material, as it's being pressed into roles for which it is not suited. Plainly put, it should not be used in applications that require significant rigidity. In the accompanying image HDPE has been called upon to support batteries, and it's deforming considerably. Even if a shorter section was used, presenting less overhang, I would argue the material is not suited for this role. Two other features embodied by HDPE make it less than ideal in certain applications. One, it's exceptionally dense, it's heavy, and two, it's slippery, especially when wet, which means it's less than ideal in step or tread applications.

So what's not to like? As versatile and rugged as HDPE may be, there's one thing it's not and that's stiff. Being a non-reinforced plastic (fiberglass is a good example of a reinforced plastic) it is flexible and when unsupported, and loaded, it deforms readily. This is more a shortcoming of the
