July 2021 Newsletter “Vented Loop Remote Drains”

Photo Essay: Vented Loop Remote Drains

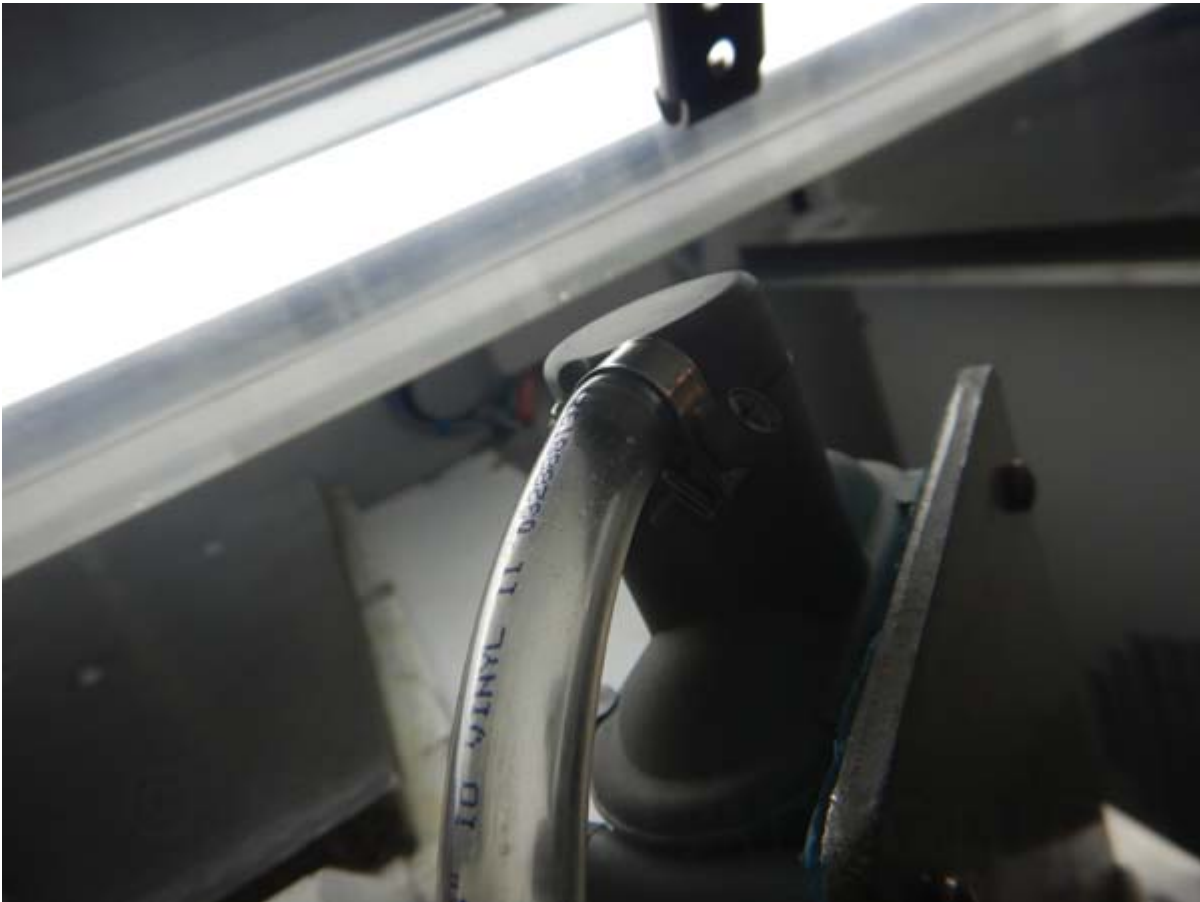
In the accompanying images, a genset vented loop remote hose has kinked. Clear PVC hose, like that which is used here, is prone to this phenomenon, especially when warm. If you choose to remotely vent a vented loop, do so using crush/kink-proof hose, such as Type A or B marine fuel hose, making sure it is routed well above bilge water and terminated in a location where you will notice leakage, which is your signal to repair or replace the vented loop or its check valve. Additionally, it's critically important that the hose be routed so that it drains completely; i.e. it must run continuously down-hill from the vent, so water, and salt, cannot accumulate within.

As simple as vented loops are, they do occasionally fail, with the most common mode being external leakage of water, and since they are often mounted above machinery, like engines and gensets, there is a natural and understandable temptation on the part of installers to fit a remote hose to the loop, most of which are equipped with a small pipe to hose adapter designed for this purpose, routing that leakage away from sensitive gear. As commendable as this effort may be, it's fraught with the potential for disaster. If, for instance, the vent hose is routed to the bilge, and the bilge accumulates water, enough to submerge the end of the hose, water, instead of air, will be drawn into the vented loop, thereby preventing it from breaking the siphon, which in turn could lead to flooding. More insidious is the kinked or crushed remote hose scenario. In that case, the hose may be routed far from bilge water, however, if air cannot pass through it, because it, once again is crushed or kinked, a siphon may be established. I've encountered both scenarios, including those that led to a flooded new genset and flooded year-old propulsion engine.

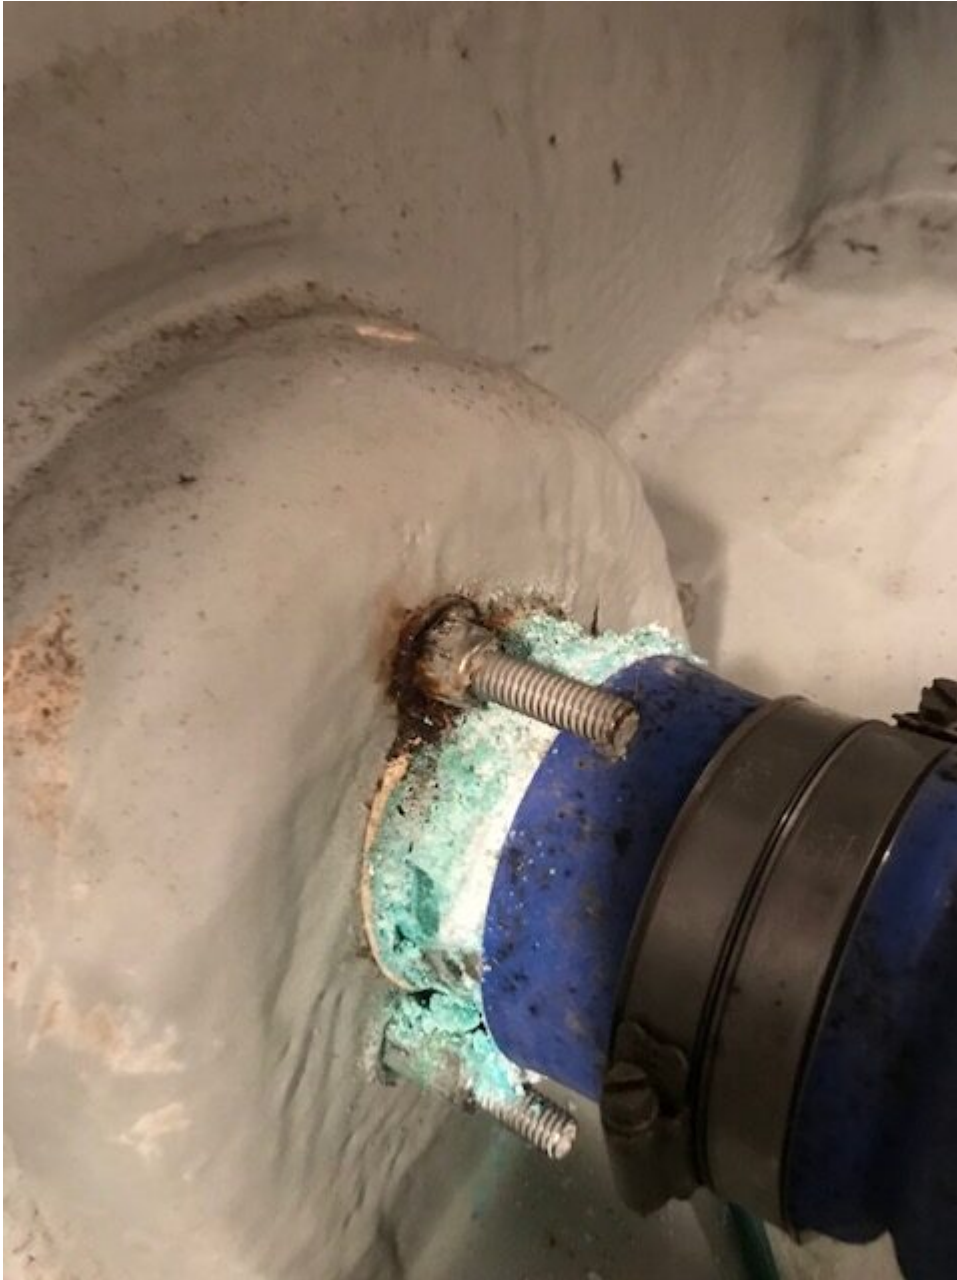
My friend Lee and I have an identical situation, shown in the photograph below. (Lee's boat is a 2005 twin screw Mainship 34 and mine is a 2004 single screw Mainship 30).

I have had this corrosion (?) for several years and Lee noticed his for the first time several months ago. The green ground wire to this part is clean and securely attached to one of the 3 bolts holding the part in place in the shaft log. Zincs on the prop shaft, trim tabs and main zinc on the transom (to which all green wires terminate) are doing their

When you clean the area shown in the photo with a brass brush, the outer fuzzy layer comes off easily but leaves a greenish patina on the fitting's surface. In a week or two the fuzzy layer re-appears and the process of removal repeats itself. The fitting itself seems to be solid but looks can be deceiving. Can you diagnose the cause of the problem and recommend ways to keep it from happening? Thank you in advance for any help you can offer.

The phenomenon you are experiencing is common, it occurs to virtually every copper-based alloy used in marine (and other) applications; the best-known example is bronze deck hardware such as ports and cleats, as well as the Statue of Liberty, copper roofs and many others. Known as verdigris, or cuprous oxide, it's both normal and harmless. Based on your photo, unless the appearance is bothersome to you, it should be of little concern. If however, you ever see pink associated with underwater or raw water copper alloys such as bronze that is of concern as it indicates another type of corrosion called dezincification, you can read more about it [here](#).

Of far greater concern is the rust emanating from beneath the stainless steel through bolt. Stainless steel is a less than ideal material for use in below the waterline applications such as this. Fasteners are especially problematic since most off the shelf varieties are made from 18-8 alloy, the least corrosion-resistant of those suited for marine applications

(for stainless steel, 316 is preferred). Used inside the vessel they are fine, however, they can be problematic on deck where they are prone to staining, and they should definitely not be used for submerged applications such as this. Silicon, zinc-free bronze is a far better choice for this fastening role. For more on this subject see this article.
