June 2020 Newsletter

Photo Essay: The Misplaced Washer

Text and photos © 2020 Steve D'Antonio Marine Consulting, Inc.

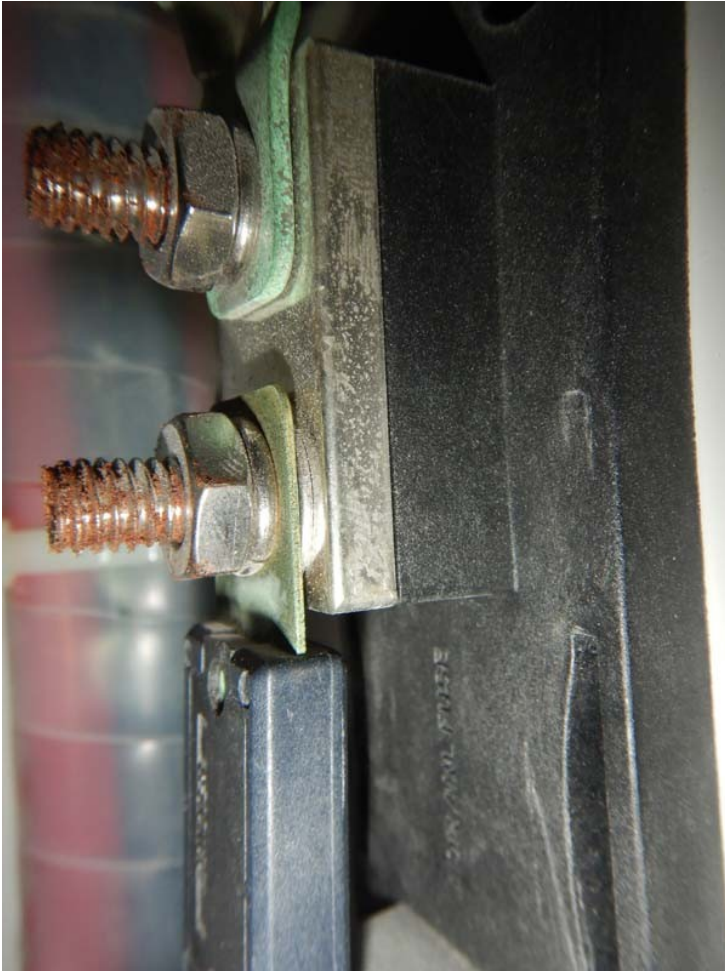
While iron, steel and stainless-steel conduct electricity, the danger arises when these poor conductors, coupled with low mass, i.e. a small component, are called upon to convey high current. The image shown here illustrates, albeit insidiously, exactly the type of scenario that should be avoided. A 300-amp fuse is separated from its fuse block with a thin stainless-steel washer. This is an all too common scenario, and I can only assume the installers who unknowingly make this grievous error believe inserting the washer into this gap is somehow advantageous. In removing stainless steel washers from installations of this sort, I have observed some that have turned purple, the result of extreme heating. When such cyclical heating occurs, the thermal expansion and contraction can

loosen the connection, which in turn leads to arcing, and carbon accumulation, and thus even higher resistance, and heat generation. In short, this is a fire hazard, one that should be avoided at all costs.

Inspect your high current connections at fuse holders like this, starters, alternators, battery terminals, switches, and bus bars. Ensure that ring terminals make direct contact with conducting surfaces, with nothing in between.

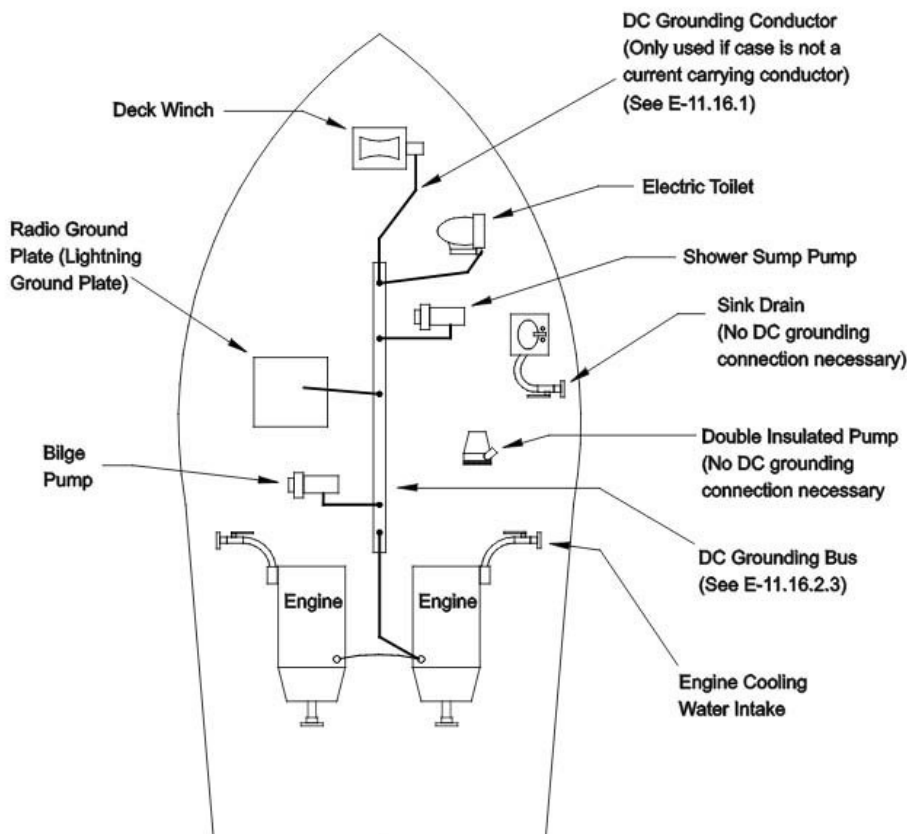
FIGURE 16 – DC GROUNDING SYSTEM

If a DC grounding system is installed, the DC grounding conductor shall be used to connect metallic non-current-carrying parts of DC machinery and engine blocks to the engine negative terminal or its bus for the purpose of minimizing stray current corrosion and ensuring a fault current path in the event of a short circuit (see FIGURE 16).?

thinking it is, and these are standard on most gensets from Onan, it's one of three studs that are located outside the sound enclosure. The ground stud isn't specifically grounding just the enclosure, it's grounding the genset base, and chassis as well, along with the block. This is in compliance with ABYC standards, which I've excerpted below.

This wire should be the same size as the DC positive cable. It's in place to carry a DC positive fault or short to the generator enclosure, block or chassis. The AC safety ground, to which you refer, is too small to safely resolve such a ground fault without overheating, and because the generator start circuit is exempt from over-current protection, there's no possibility of blowing a fuse or tripping a circuit breaker to resolve the fault. Therefore, a chassis ground must be present, and it must be sized so that it can carry a fault from the largest DC positive cable connected to the equipment.
