Editorial: Engine Room Prima Donnas – Feature: The Engine Room’s Unsung Hero; Motor Mounts

Text and photos by Steve D’Antonio

The Engine Room’s Unsung Hero; Motor Mounts

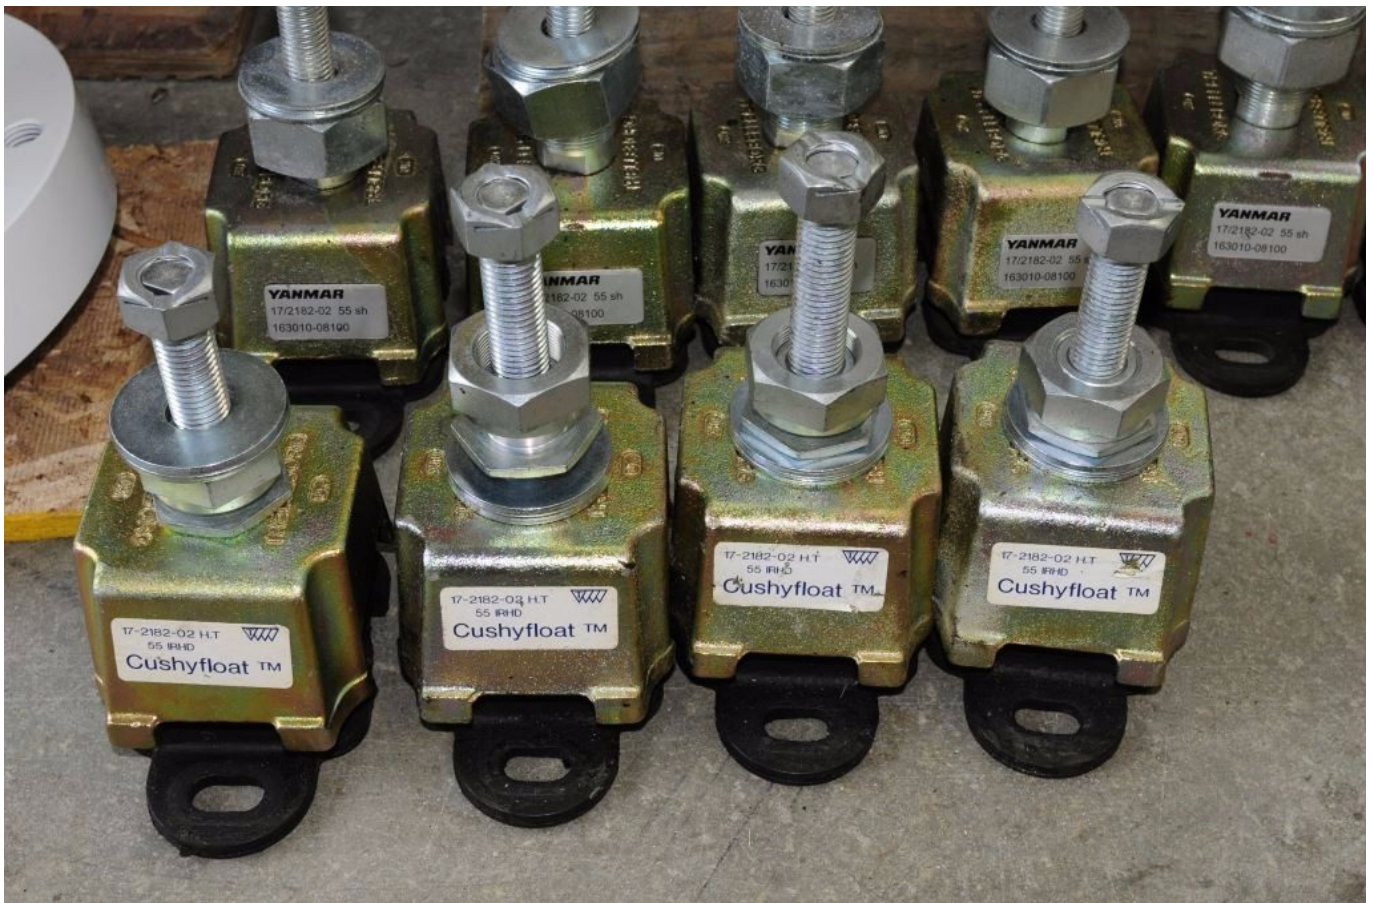
A couple of years ago I came across one of those, 'it looks good but it's seriously wrong' scenarios. These can be very challenging because those who are responsible for them are often reluctant to accept that they may be flawed, because they *look* right.

I crouched down alongside the engine and took a good long look at the motor mounts, and the longer I looked, the less I liked what I saw. The mounts were over-extended, a common problem that I'll discuss in greater detail below, and their bases were not parallel with the engine's centerline, so much so that one end of the mount's flexible section was in compression, while the other was in tension, or at least not evenly tensioned. Furthermore, the weight of the engine was not evenly distributed; some mounts were bearing more of the engine's weight, and thus were more compressed, than others, which can cause, among other things, vibration issues. In spite of appearances, this installation was insidiously problematic.

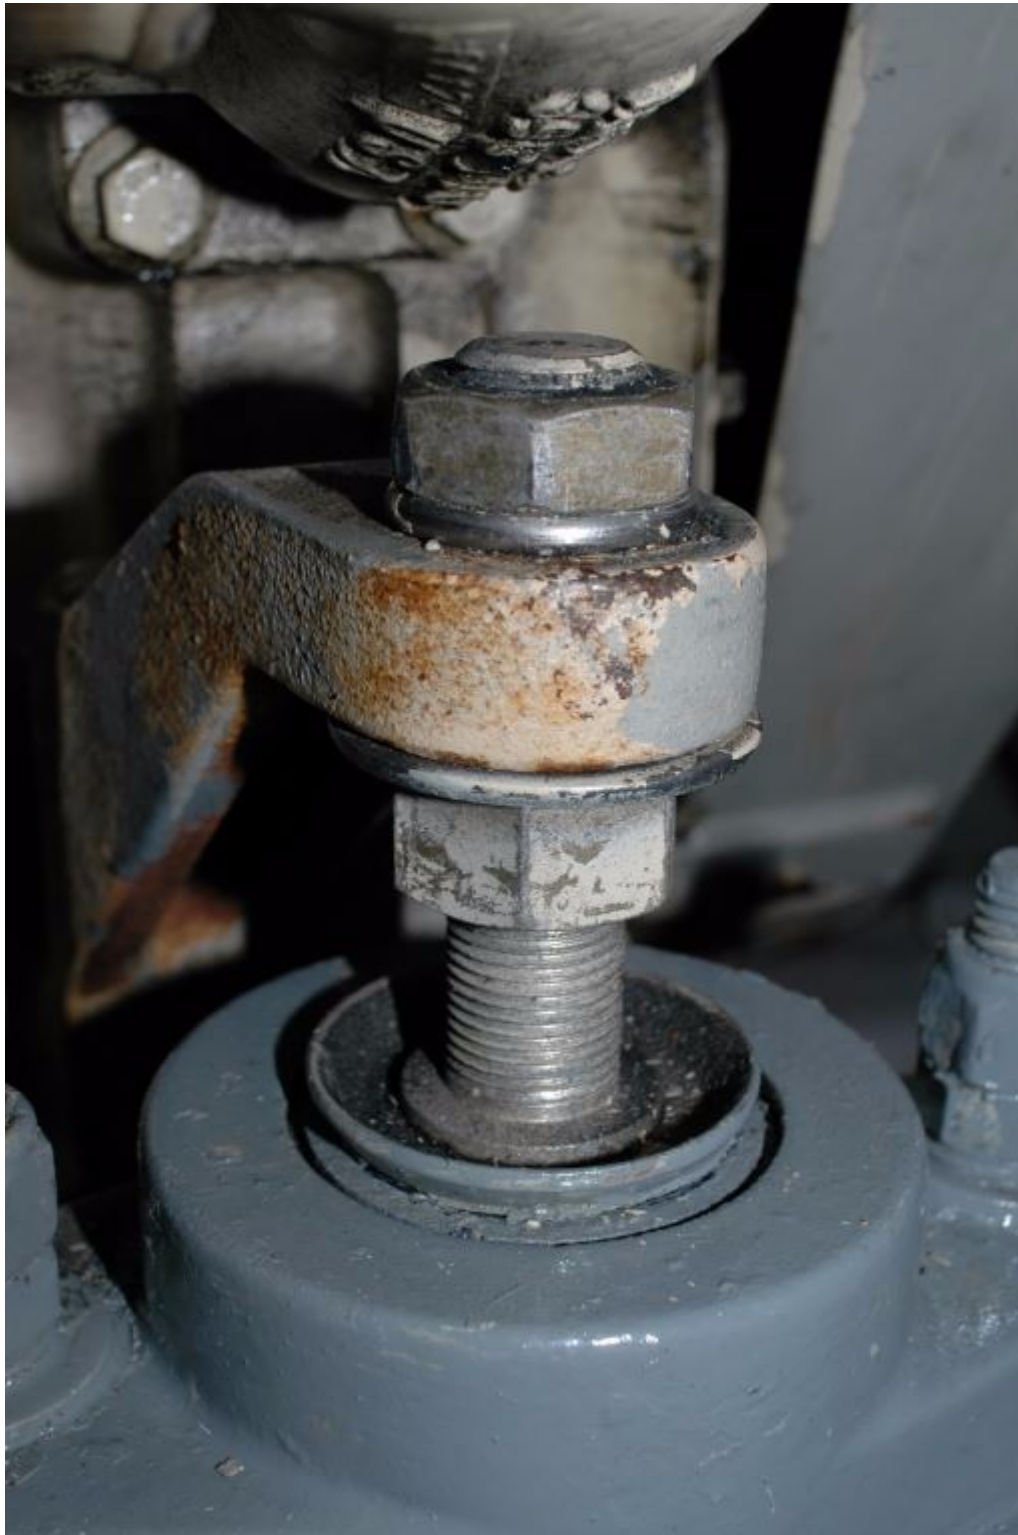
The engine's bracket or foot should reside somewhere in the middle of a motor mount's stud. This one is at the limit of its upward adjustment, exposing the mount to excessive load thanks to the added leverage.

Among the most common mount installation faults involves the aforementioned over-extension of adjustment or leveling studs. The adjustment stud allows the installer to account for *small* variations in alignment between the transmission's output coupling, and the propeller shaft coupling, with emphasis on the word 'small'. Ideally, and most motor mount manufacturers are clear about this, once alignment is complete, the engine bracket, which is supported by the adjustment stud, should reside somewhere near the mid-point of the stud, allowing for future adjustment, and not at the extreme maximum or minimum height of adjustment, with the former presenting more of an issue than the latter. The higher the bracket is on the mount's stud, the more leverage that is applied from the propeller's thrust, the more stress

placed on the stud, and the greater the likelihood of failure. If the engine bracket will end up too high on the adjustment stud, the mount should be shimmed using a non-compressible material such as steel, aluminum or fiberglass or epoxy sheet laminate such as GP03 or G10 respectively.

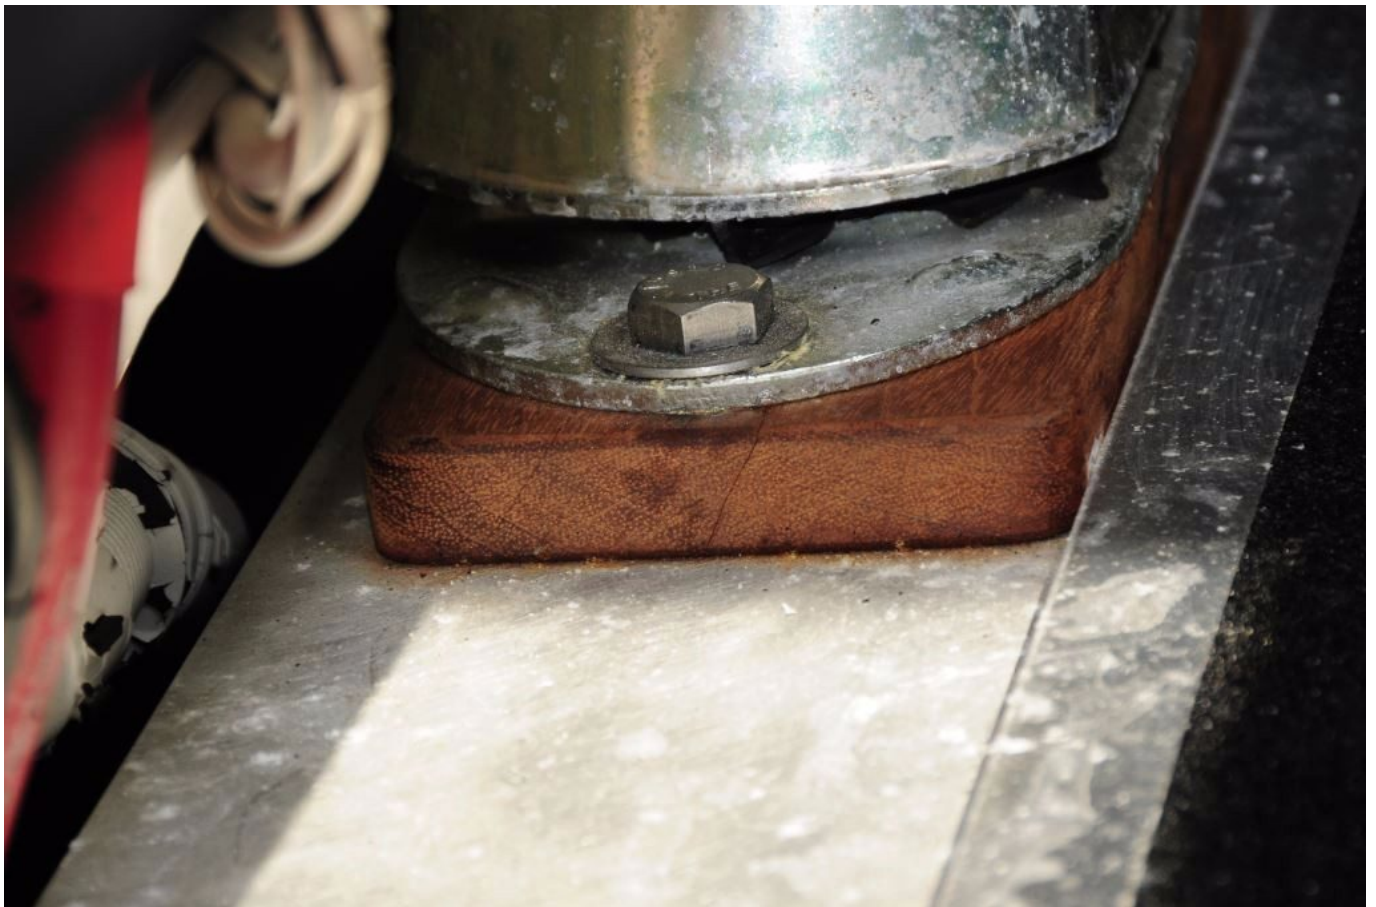
Because of its compressibility and propensity to crack, timber, even teak, is not a suitable material for shimming motor mounts.

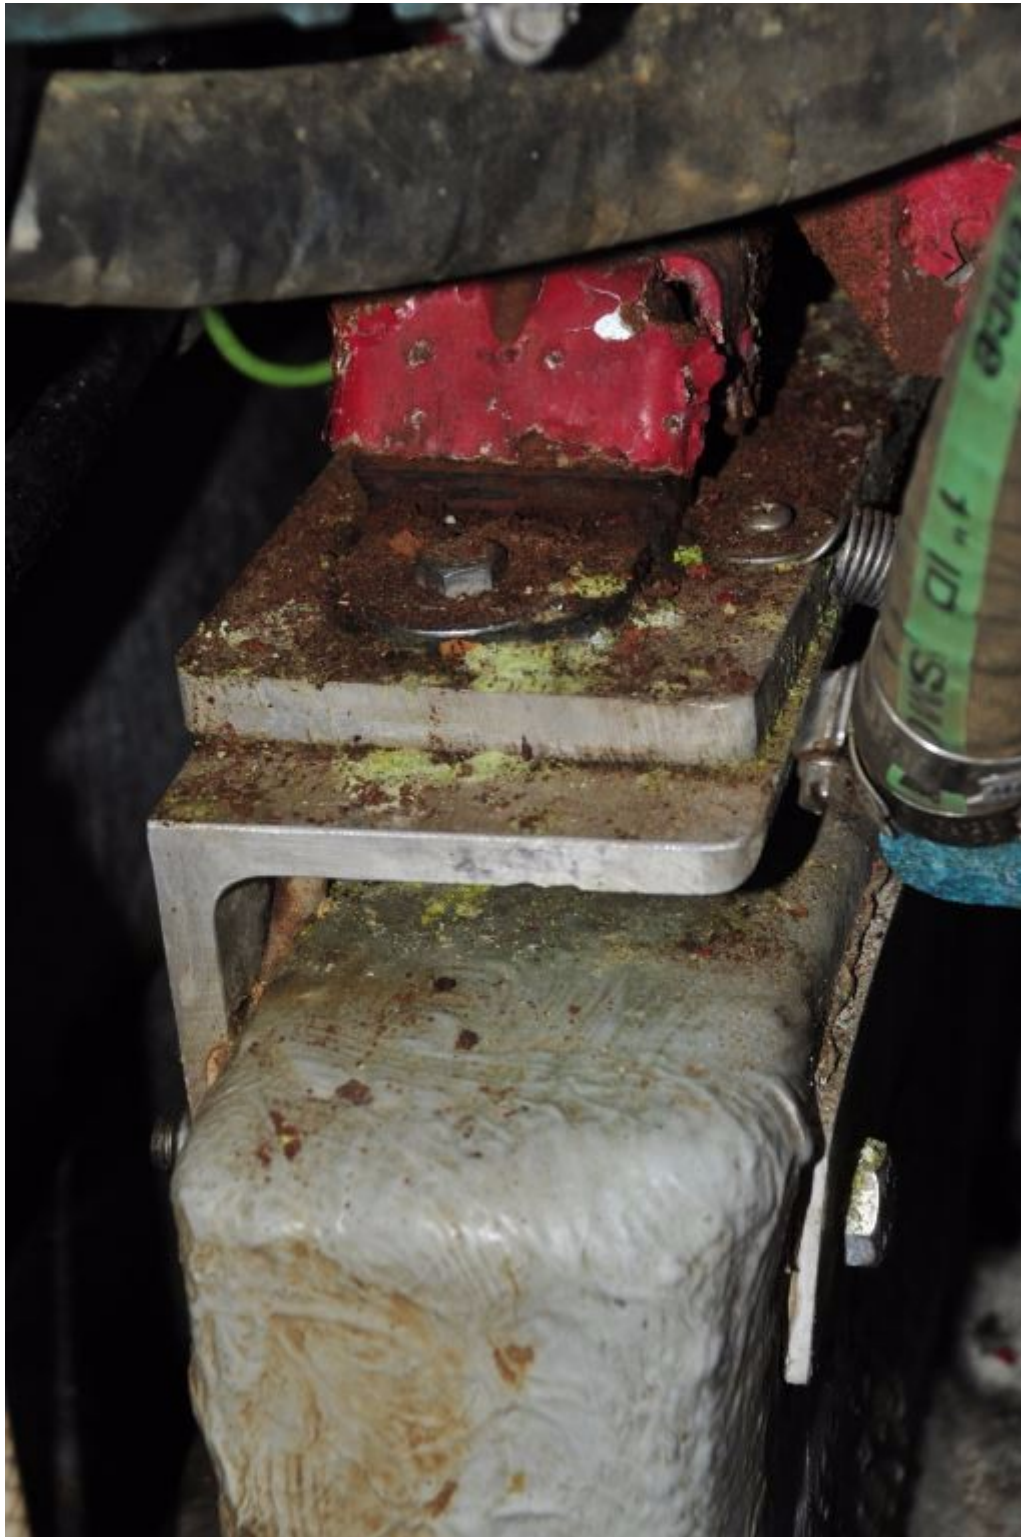
Even with the best of intentions, there are many ways a motor mount installation can go wrong. In this case the most egregious is the cantilevered “diving board” support bracket. Not only is this prone to failure, it’s also likely to compound vibration.

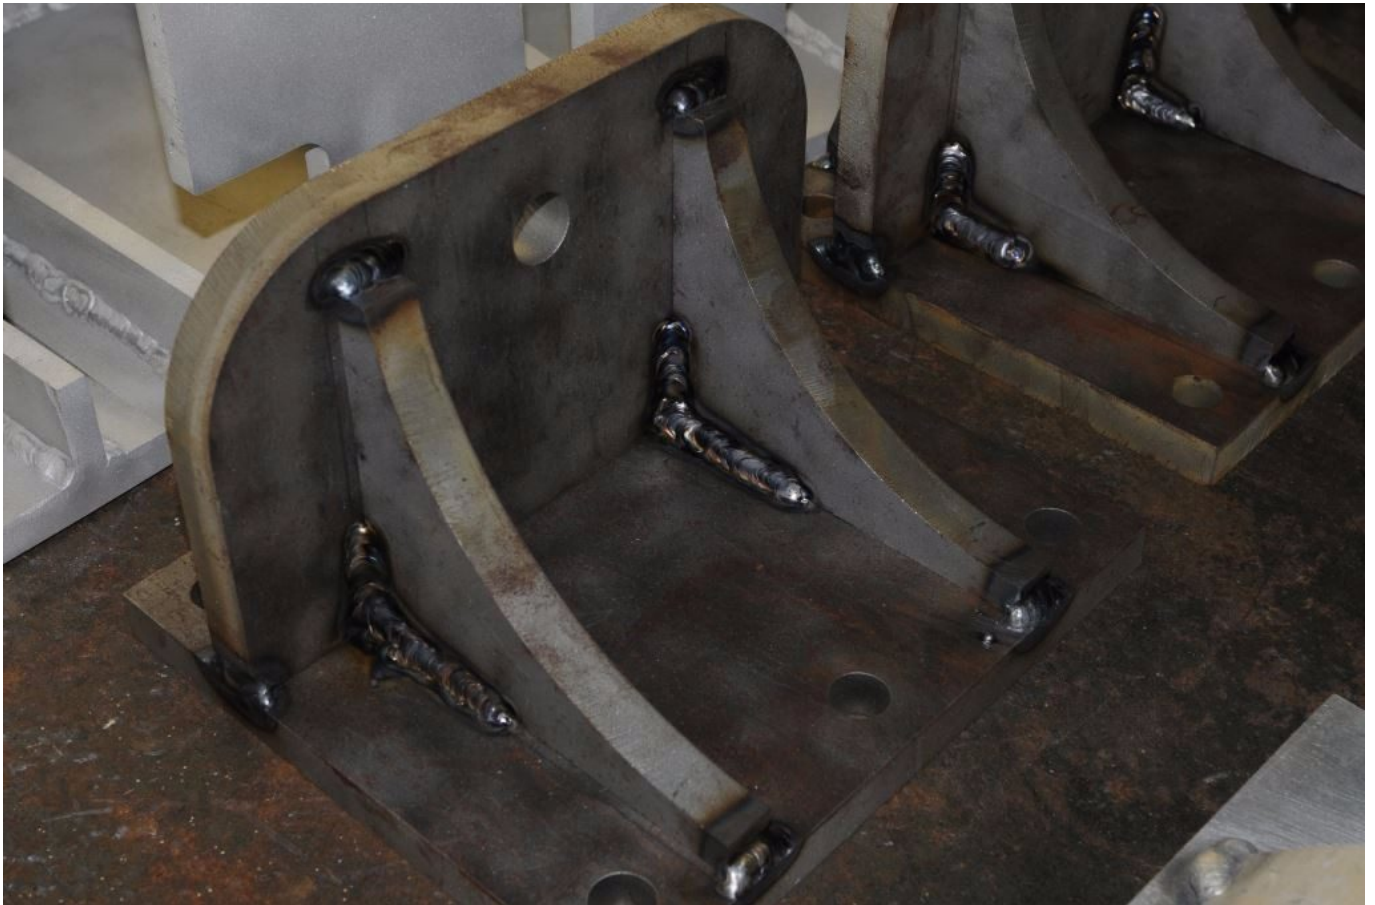
If a motor mount cannot be installed directly on a stringer, then a bracket must be fabricated. Brackets must be heavily built, and inflexible. The ones shown here are in the process of being fabricated to support a 790 hp engine.

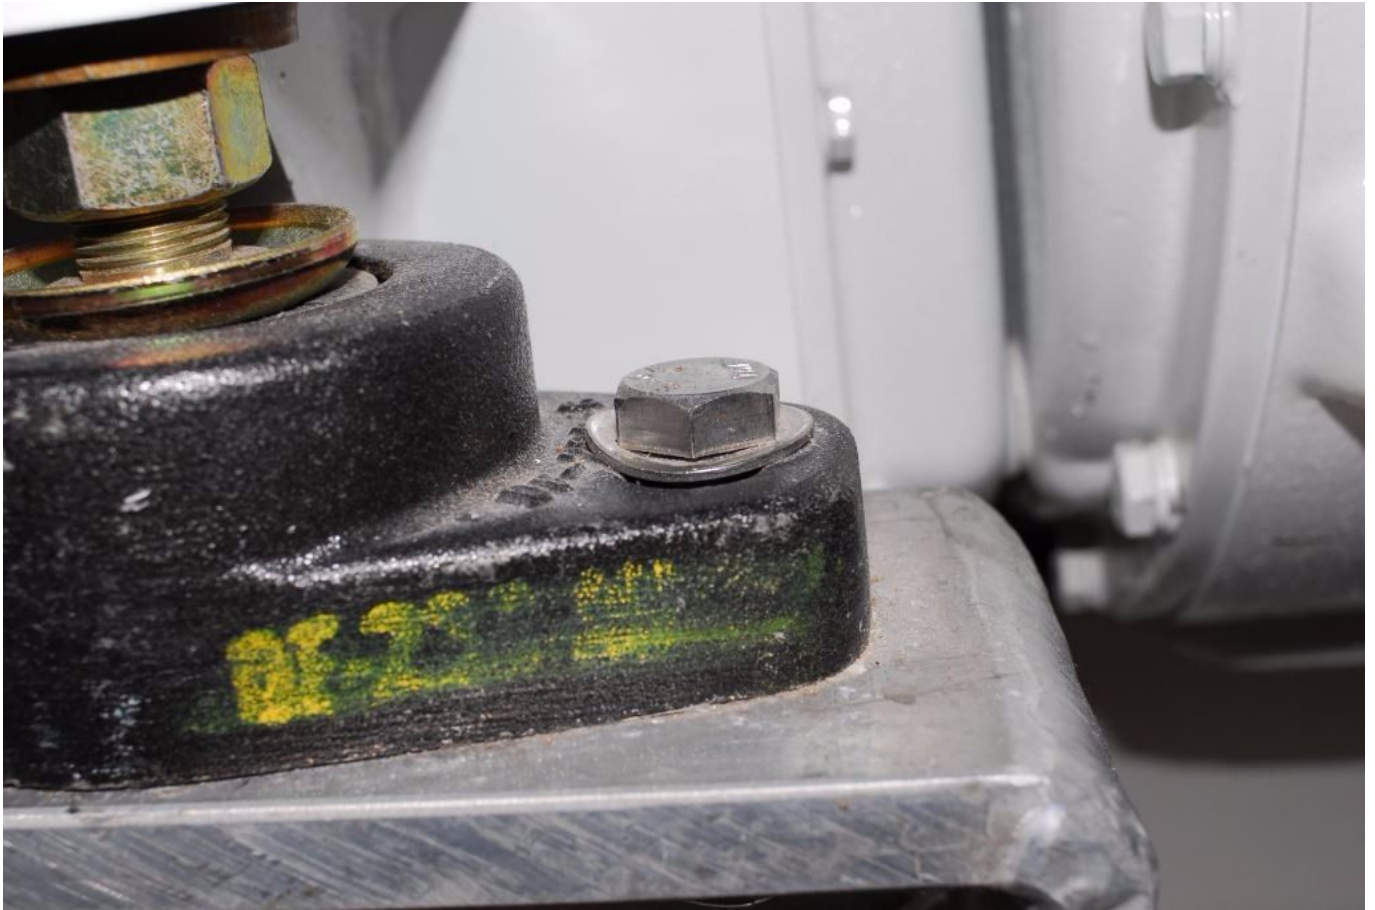
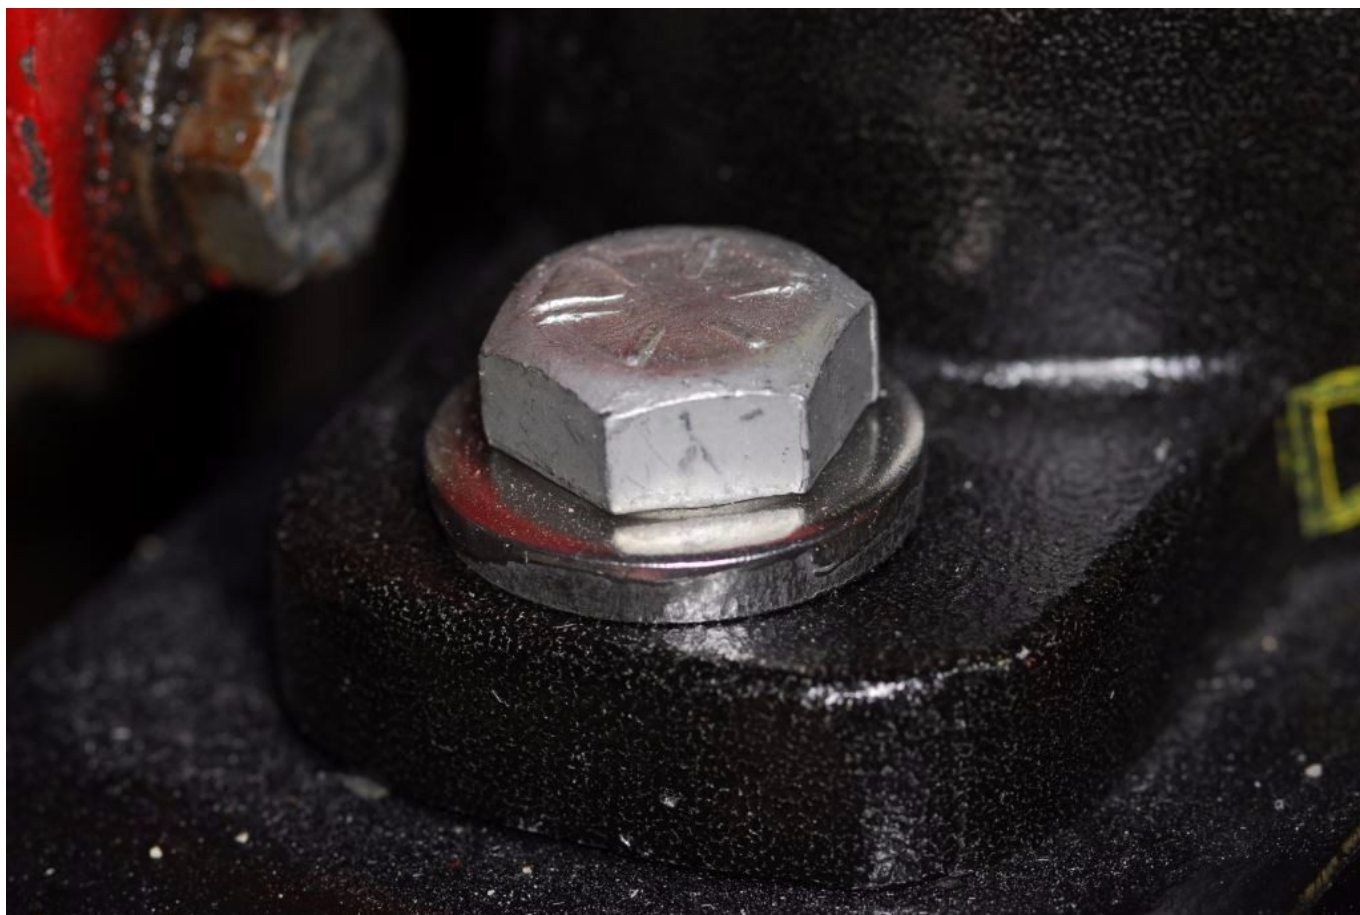
Standard, thin fender washers (top) and stainless steel bolts simply lack the necessary rigidity and tensile strength for use in many motor mount applications. The heavy duty thick washer (above), and grade 8 bolt, shown here provide the necessary support for the anticipated loads.

Unlike conventional thin washers thick, beefier washers are able to resist deformation under the very heavy loads to which motor mount hardware is subject. Because many mounts include an athwartship adjustment slot, fasteners that secure mounts to stringers should also be equipped with heavy duty, deformation-resistant washers. Any deformation in motor mount washers is too much, look carefully at yours and upgrade them if necessary.

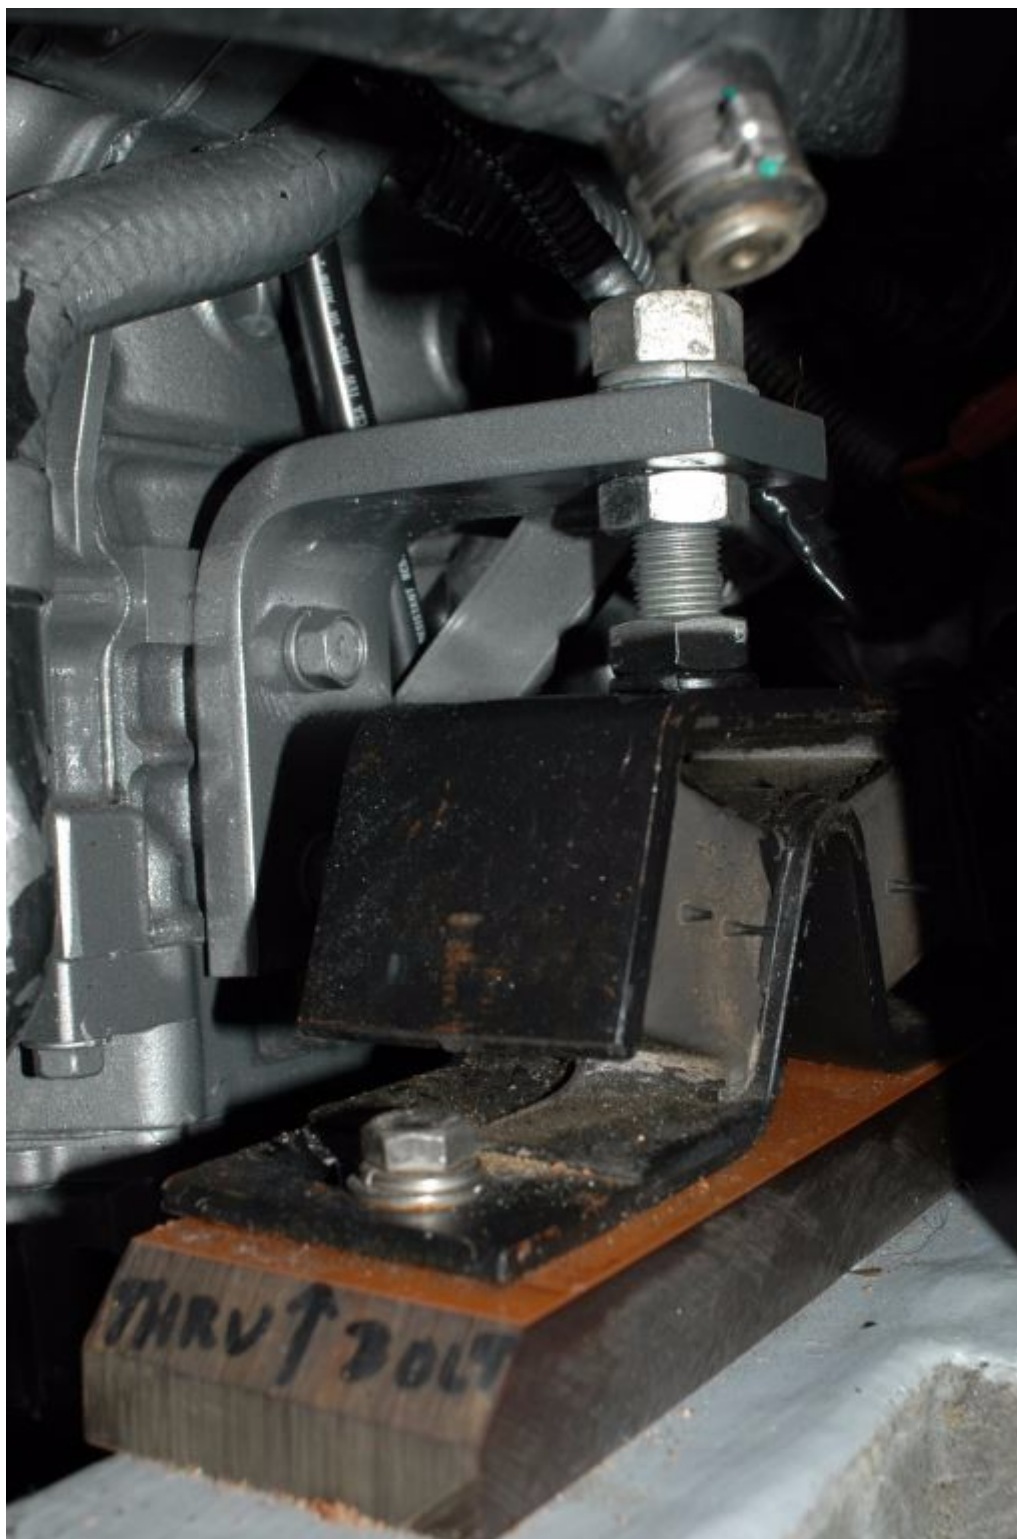
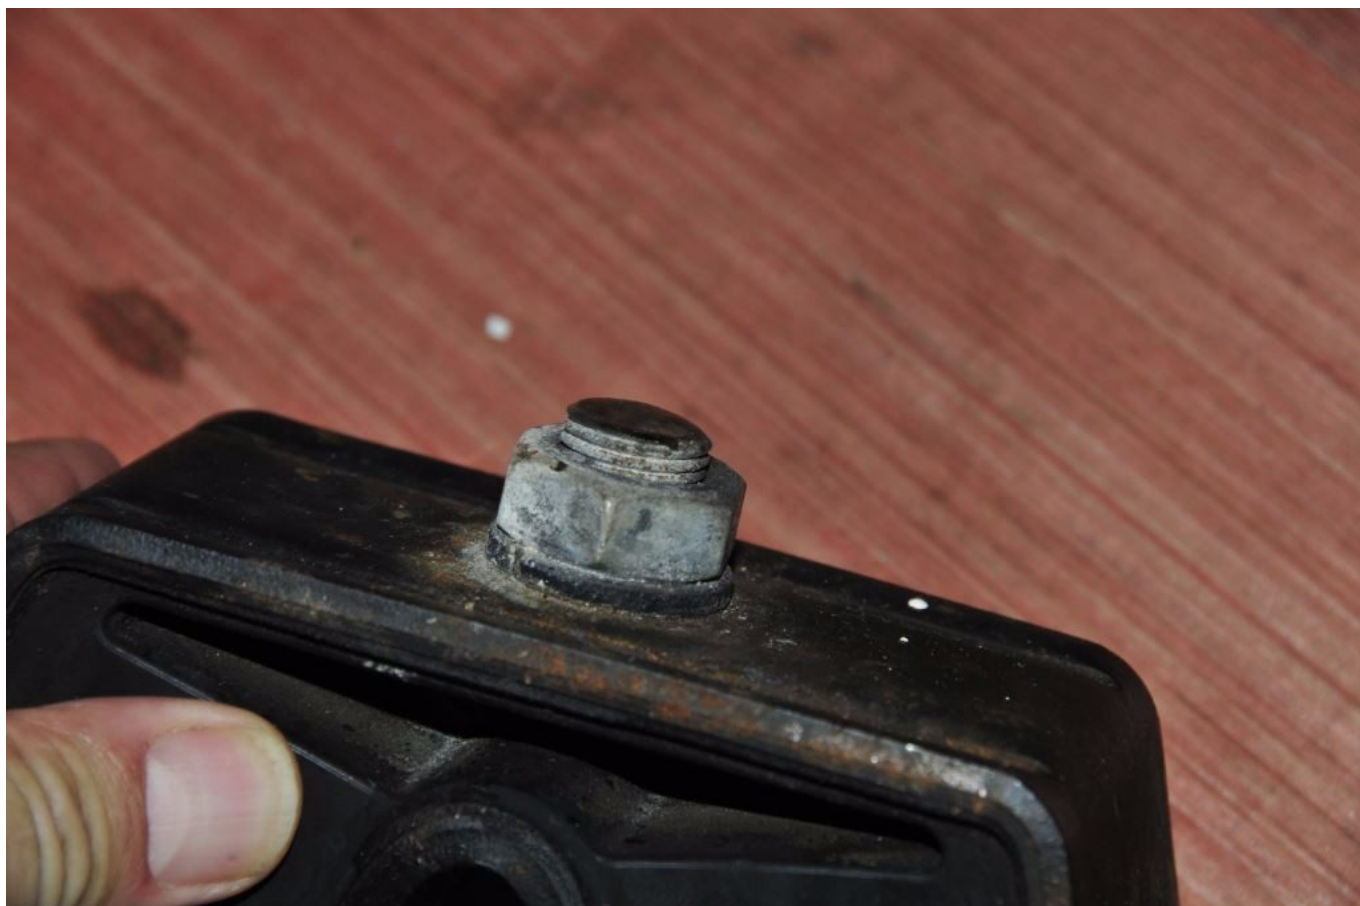
Over-extension (top) is a common issue with motor mount installations; often leading to failure of the stud (above). In spite of the composite shim that has been added to this mount, the problem remains.

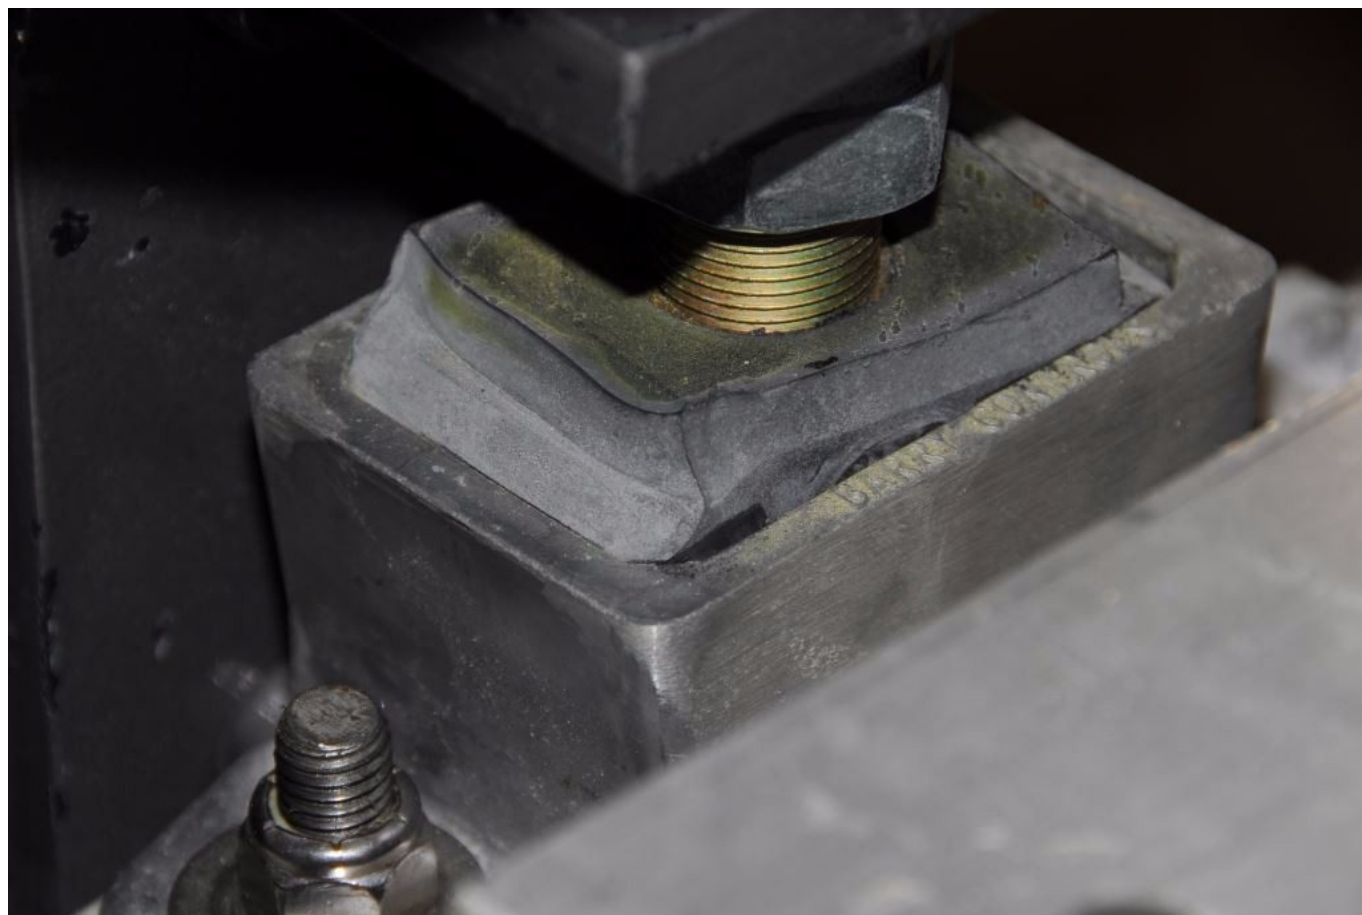
This mount is failing because it has been installed incorrectly, the surface on which it rests is not parallel to the engine's bracket in both planes, causing the rubber insert to deform.

Mounts must also be installed in such a way as to avoid caster (toe in toe out) or camber ("rocking" or tilted inboard or outboard). They must be upright and parallel to the engine

support bracket and stringer, preferably within 4° in all directions.

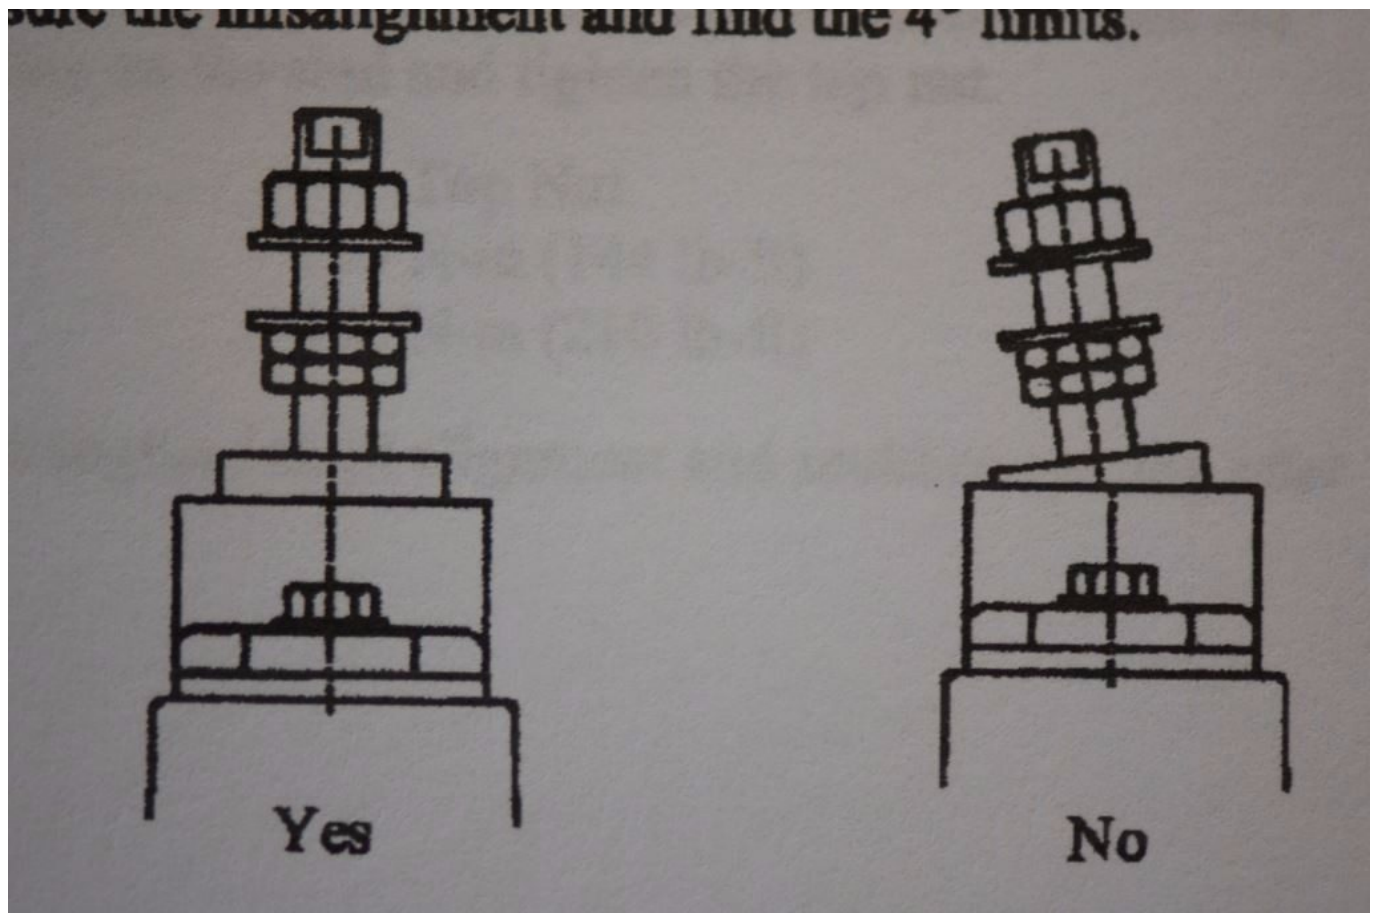
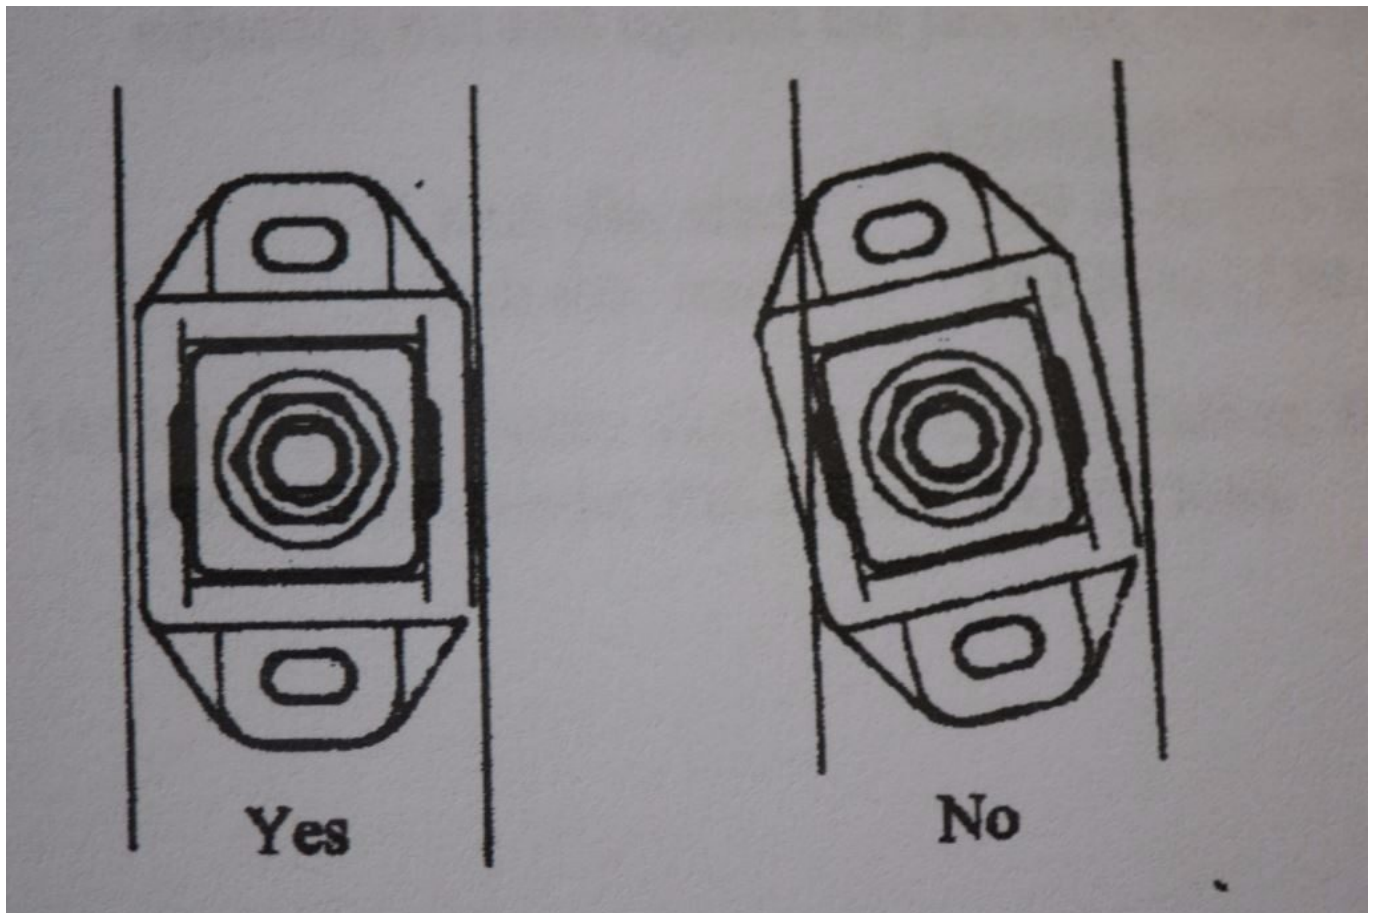
Avoid toe and camber when installing motor mounts, adjustment studs must be perpendicular with the engine bracket, and the mount base must be parallel with the crankshaft centerline and stringer or shim surface (diagrams courtesy Barry Controls).

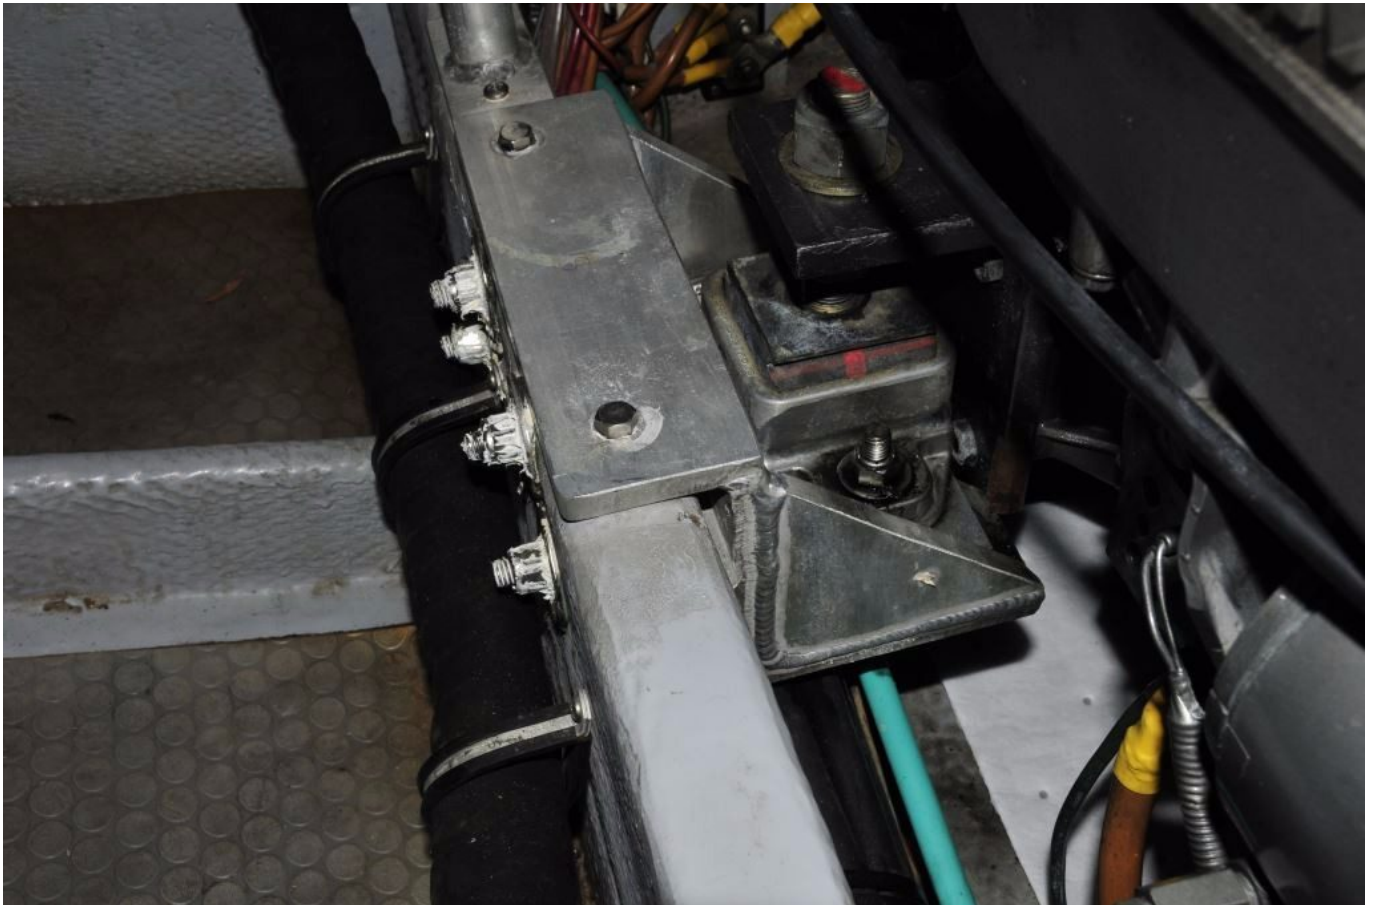
Motor mounts and their brackets should be gusseted, to prevent flexing, and through bolted.

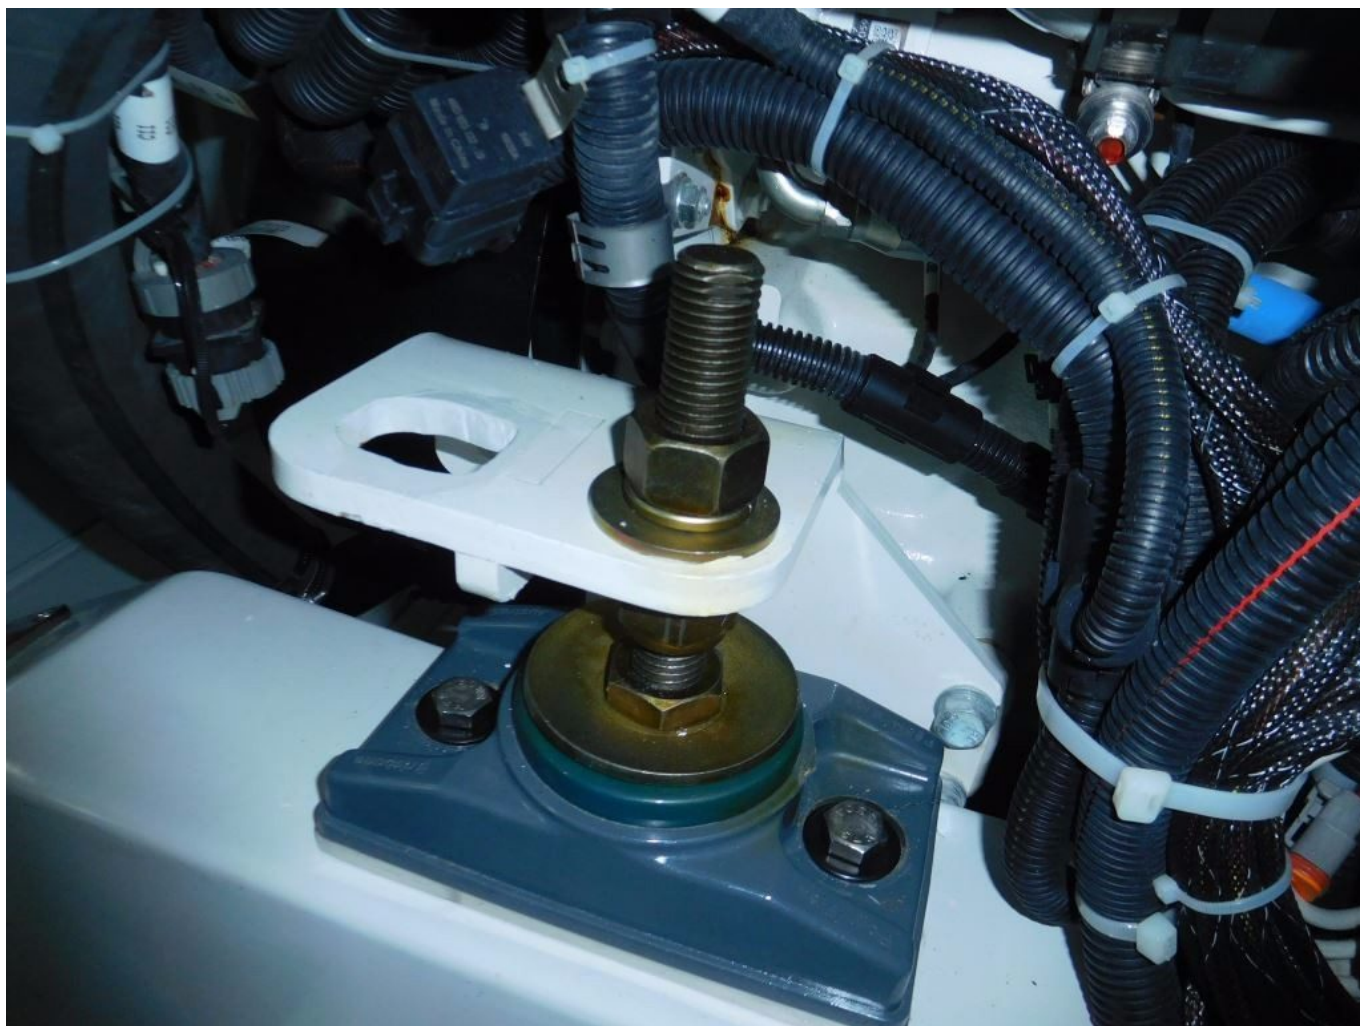
Corrosion is an ever present issue where motor mounts are concerned. The base of this mount is made from composite, it will therefore never rust. The adjustment stud has been coated with a film corrosion inhibitor that dries to a wax-like consistency. Note the aluminum shim beneath this mount.

Once the alignment is set it may need one additional check to account for settling, thereafter it rarely has to be adjusted and herein lies the problem. With disuse, any mechanical component can become balky and motor mounts are no exception. You may find, when the day comes where the engine alignment must be adjusted, the mounts are frozen solid with years of accumulated corrosion. Inspect your mounts for rust, make sure they are free of rust and corrosion, and then spray them liberally with a corrosion inhibitor to keep rust at bay. Some petroleum based lubricants and rust preventatives may attack the mount's rubber shock absorber (if exposed, some designs

incorporate an “oil shield” or umbrella); avoid them or use with caution, avoiding application onto the flexible component. I prefer a ‘tacky’ product such as CRC Heavy Duty Corrosion Inhibitor, as it will neither run into, nor attack rubber.

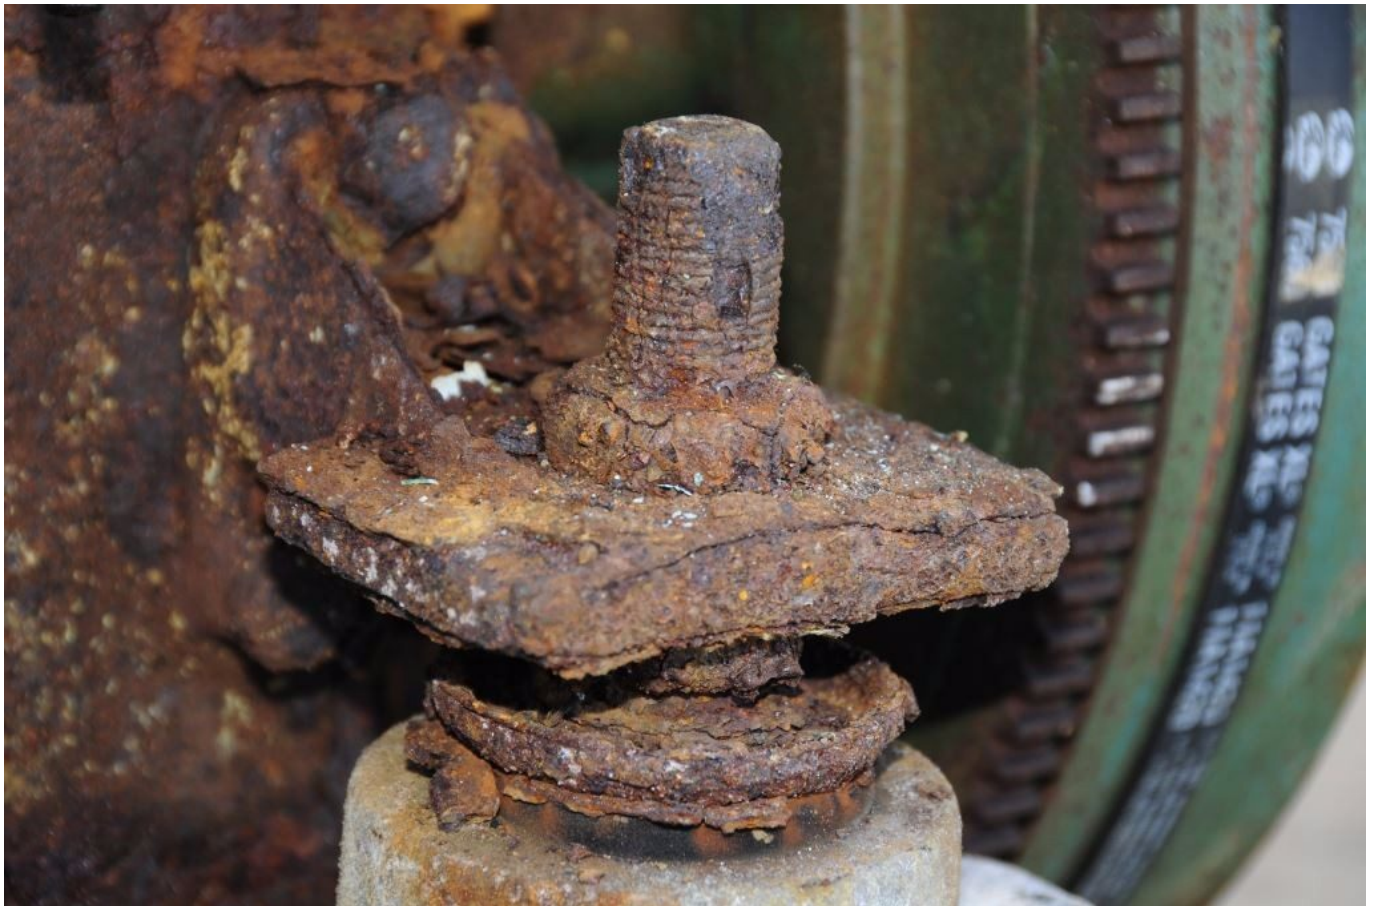
Motor mounts are adjustable and while they may not need to be adjusted often, they must be kept free of corrosion and in good working order.

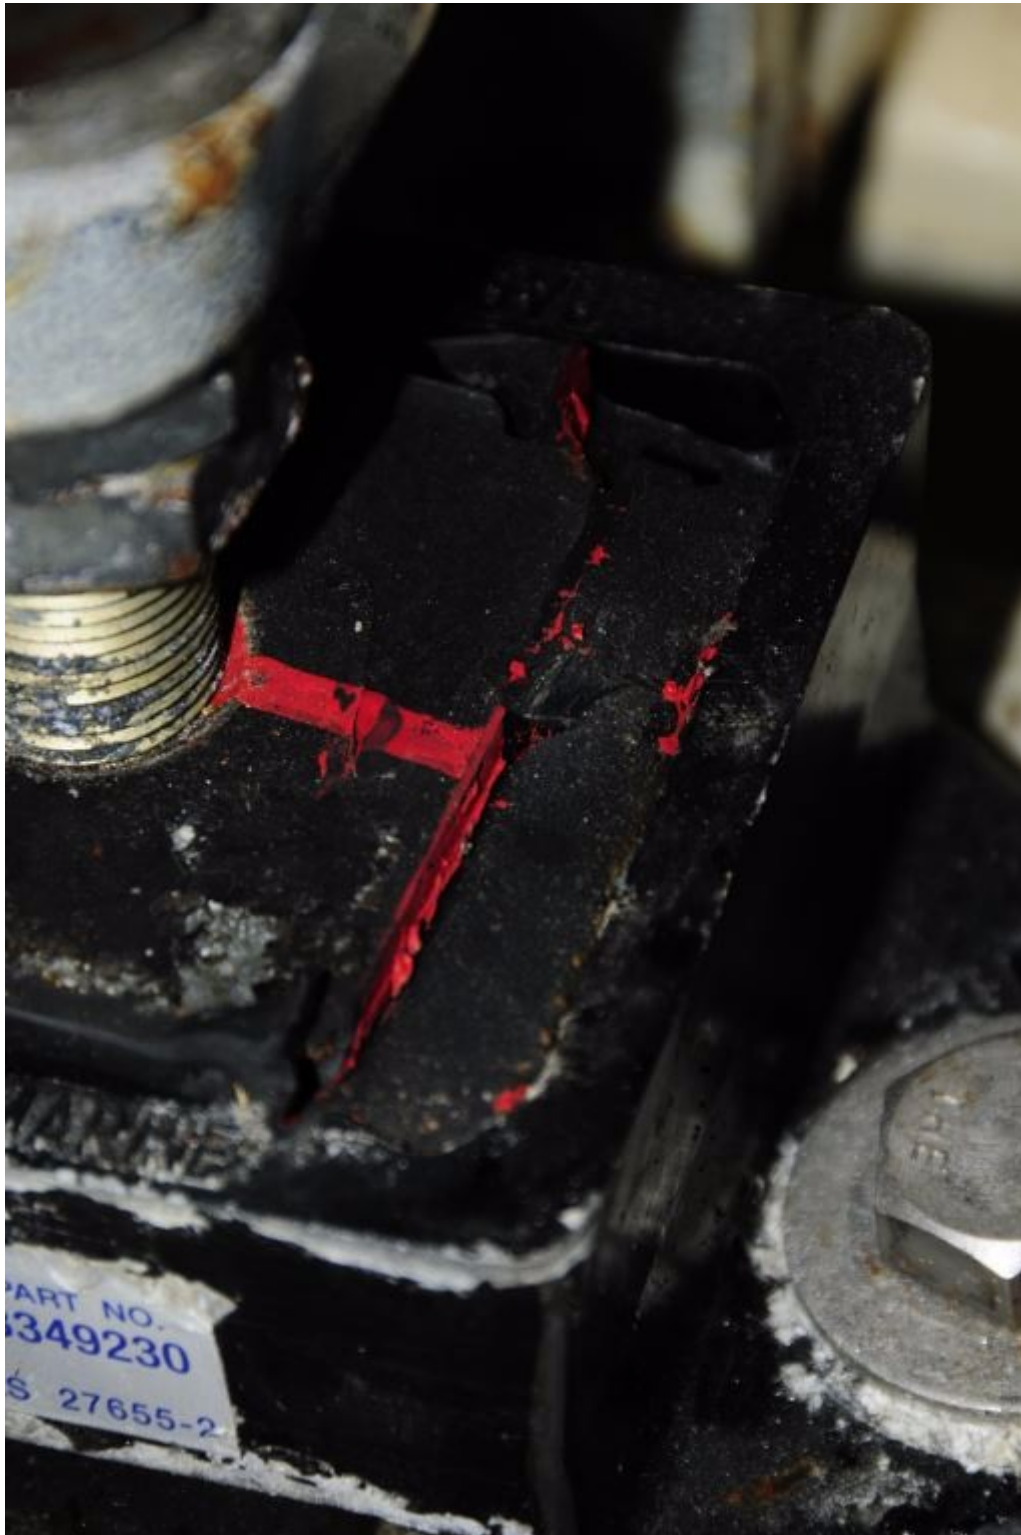
This motor mount utilizes a telltale red core to signal that it's reached the end of its life. In many cases a failure of this sort is the result of an installation error.

time (probably well past time) for their replacement. Some higher quality mounts utilize a color indicator to draw attention to failing flexible material, the outside portion is black while the core is red, if you see the latter then the mount has effectively failed, frequently because of improper installation.
