# October 2025 Newsletter – Exhaust Injection Angle

## Photo Essay: Exhaust Injection Angle

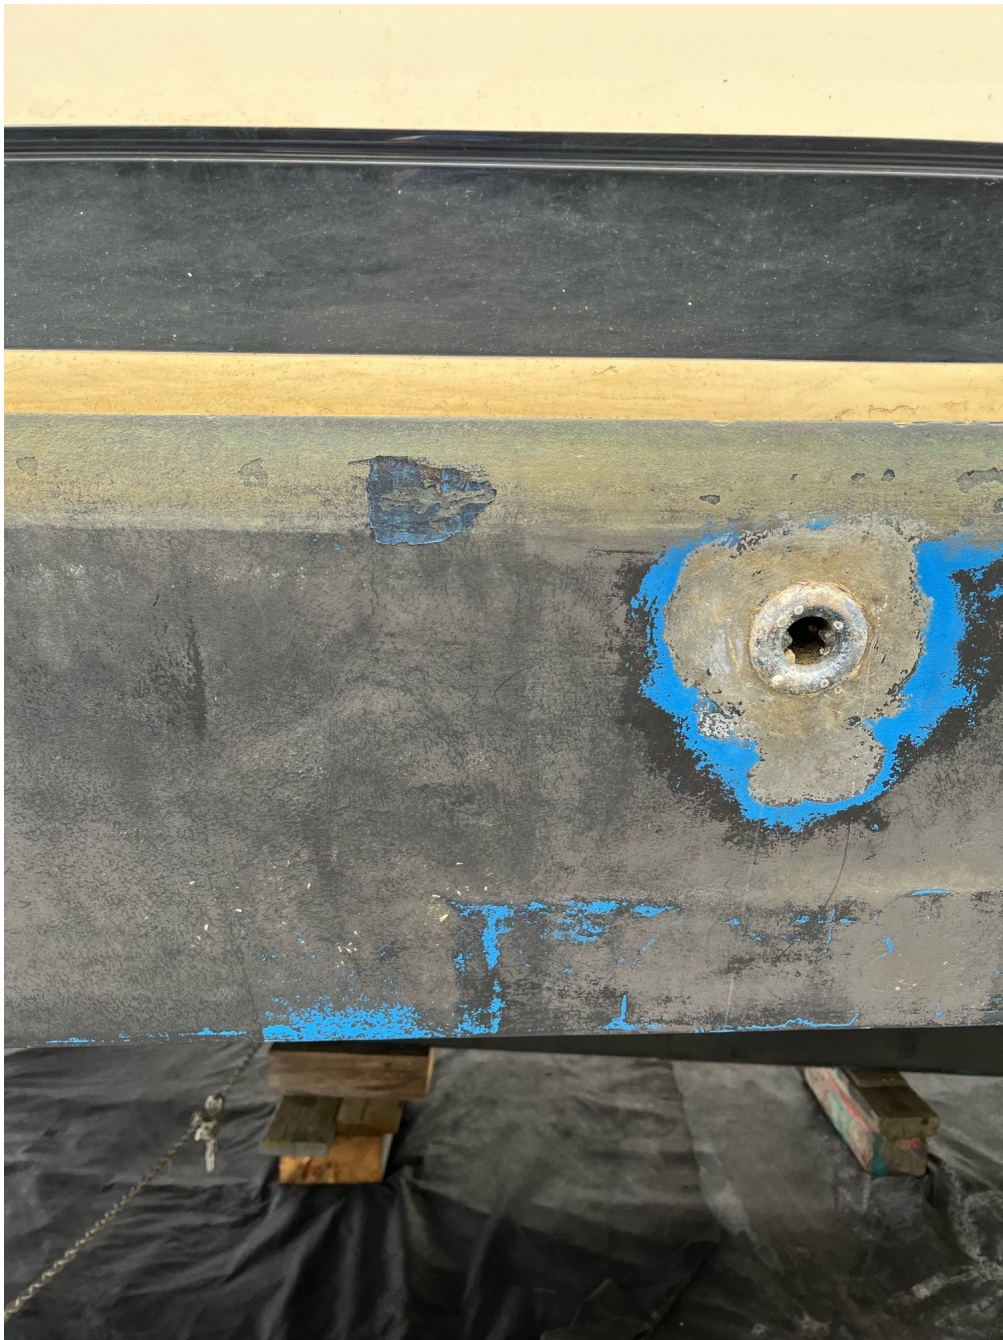
We just hauled our boat for a bottom job and have halos around the thru hulls that did not exist a year ago. Can you provide any advice as to the cause? For context, the sacrificial anodes are one year old and still very much intact; the black paint is Micron CSC, and the blue is an ablative indicator coat.

Bottom paint halos are usually not as ominous as many would-be experts claim. In the vast majority of cases, they are not associated with corrosion or "electrolysis" (a term frowned upon in corrosion professionals' circles). Instead, haloing is usually the result of cathodic over-protection, i.e., too much zinc. Over-protection results in the production of an alkaline solution at bonded, underwater metals, such as through hulls, and struts; which in turn causes the paint to lift and flake off in a circular pattern around these metallic components. While undesirable, on a fiberglass vessel, other than the damage it causes to the anti-fouling paint, cathodic over-protection is harmless. Over-protection can be harmful to timber vessels; the alkaline attacks the lignin, or pulpy material between wood grain, in a process called delignification".

The fact that your anodes are a year old, and still intact, would be consistent with either over-protection, or the anodes are not making good, low resistance, contact with the bonding system. Generally, normally functioning anodes should not last this long. Additionally, zinc anodes used in fresh or brackish water will go dormant, and therefore seemingly last a very long time. However, they are in fact ineffective; in that scenario an aluminum anode should be used.

Ultimately, what I have described above is purely a theory, and where potential corrosion is concerned theories should be backed up with solid data. I would recommend two analyses be carried out, ideally by an ABYC Certified Corrosion Technician. The first, a reference cell test, which is performed while the vessel is afloat, will confirm the protection level of your underwater metals. The second, a bonding system continuity test, is carried out while the vessel is hauled. There should be no more than one ohm of resistance between any bonded underwater metal, and any sacrificial anode that is connected to the bonding system.
