# Photo Essay – February 2016

This month's Photo Essay is a bit of a departure from the usual theme, it details the unconventional re-powering (from hybrid diesel electric to conventional diesel) and refit of Retired Sailor III, a custom-built, 73-foot motor vessel, which will be at the Miami International Boat Show. I hope you find it interesting.

## **Photo Essay – Anatomy of an Exceptional Refit**

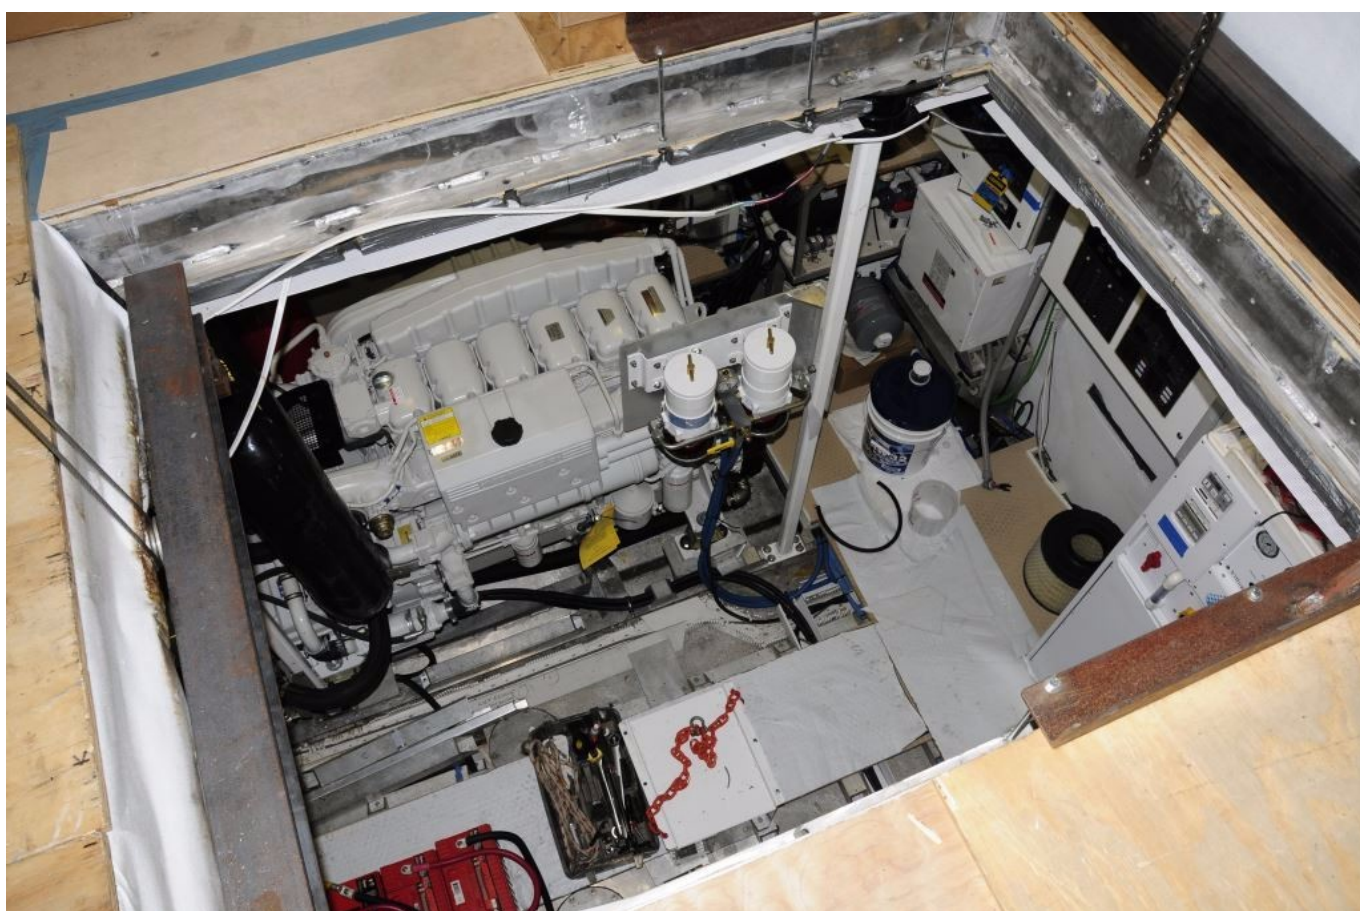
The nearly completed engine room, viewed through the soft

### **patch access hatch.**
