Photo Essay – February 2016

This month's Photo Essay is a bit of a departure from the usual theme, it details the unconventional re-powering (from hybrid diesel electric to conventional diesel) and refit of Retired Sailor III, a custom-built, 73-foot motor vessel, which will be at the Miami International Boat Show. I hope you find it interesting.

Photo Essay – Anatomy of an Exceptional Refit

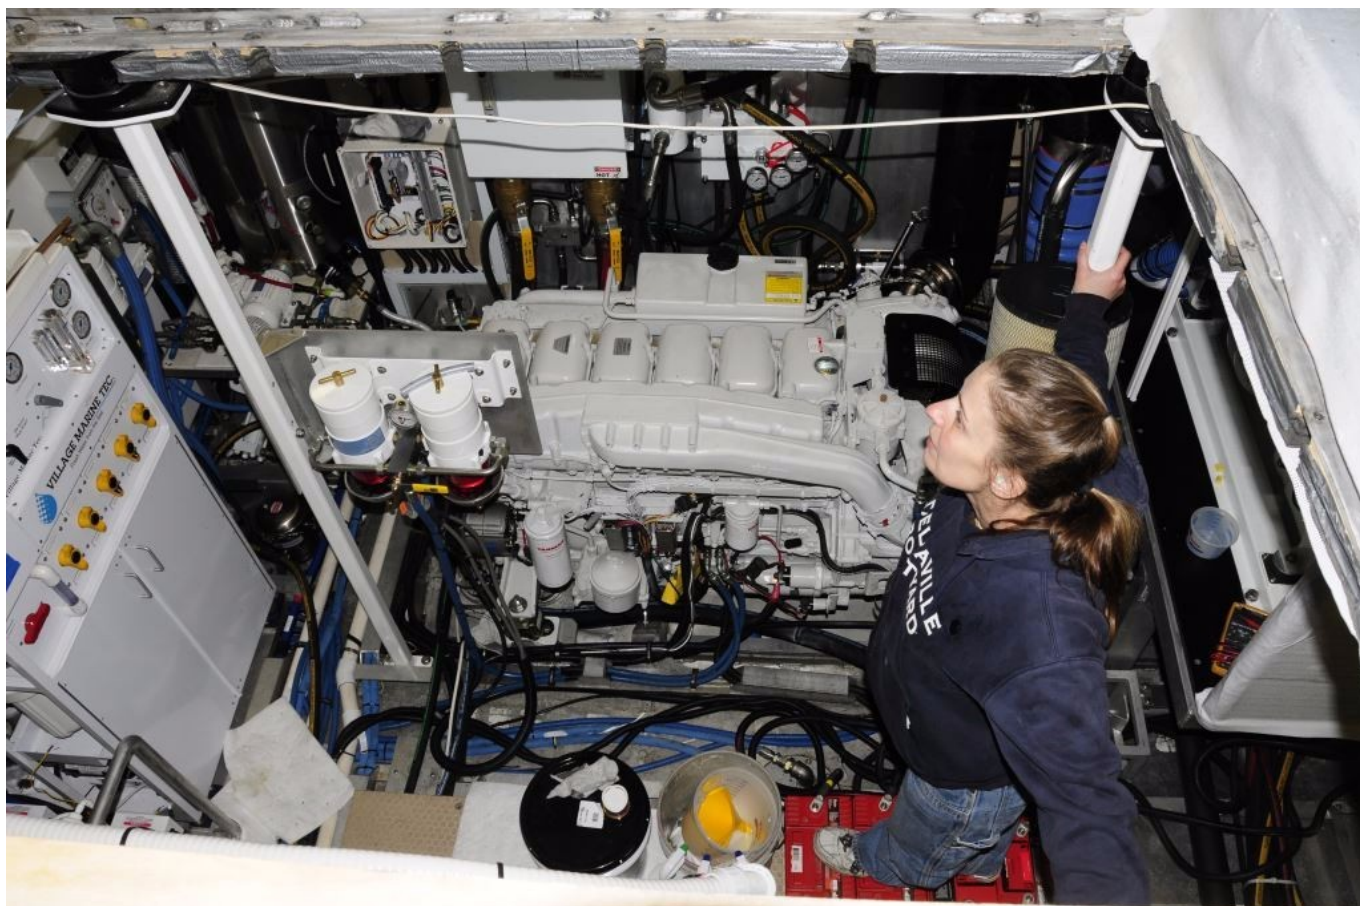
A Deltaville Boat Yard technician looks up from the “pit” what would become Retired Sailor III’s new engine room.

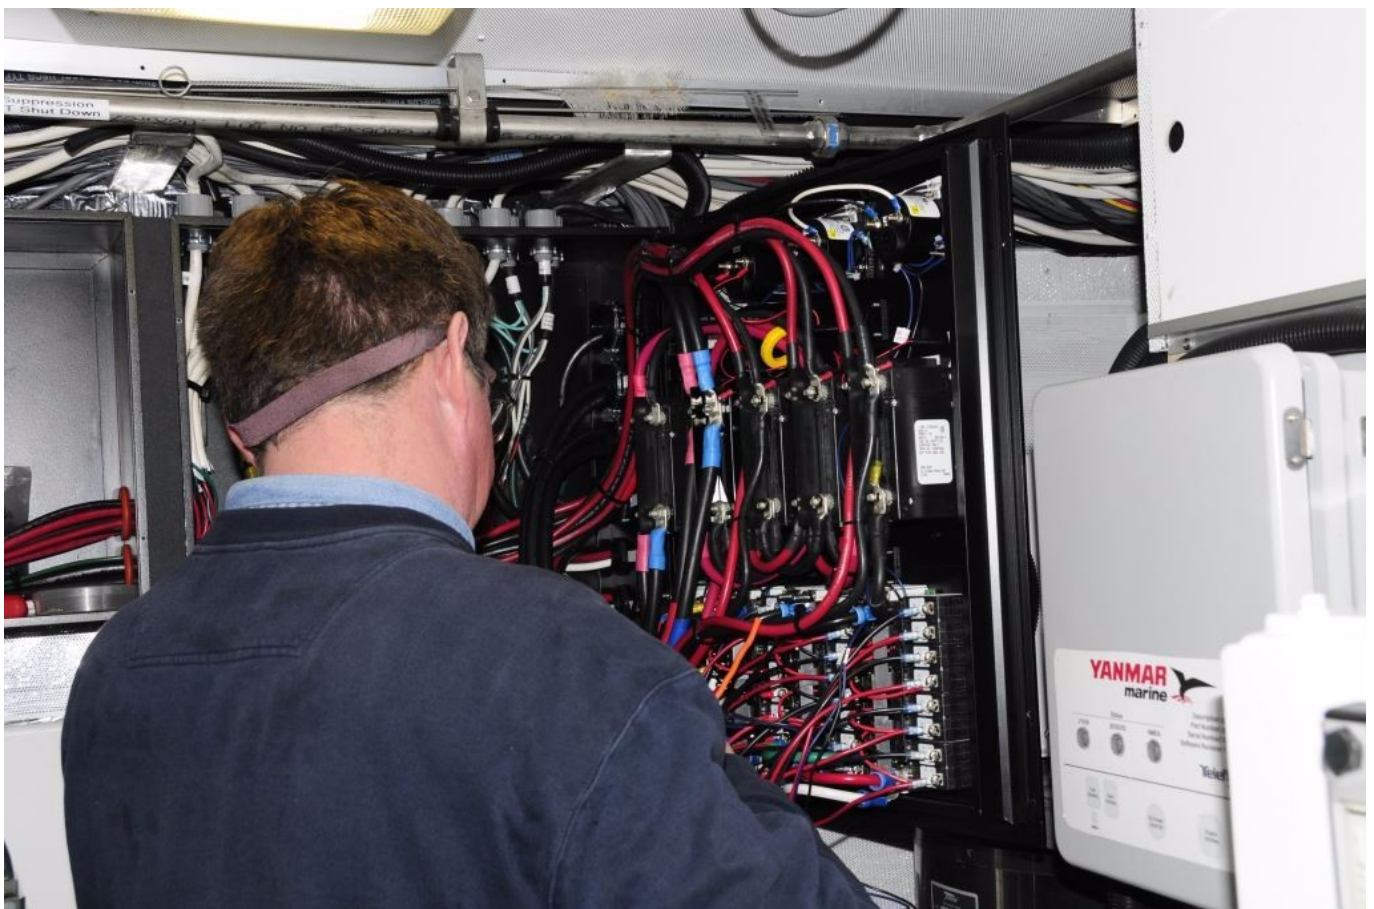
Because the original hybrid propulsion electrical system was intertwined throughout the vessel, much of it had to be

removed and replaced with conventional gear.

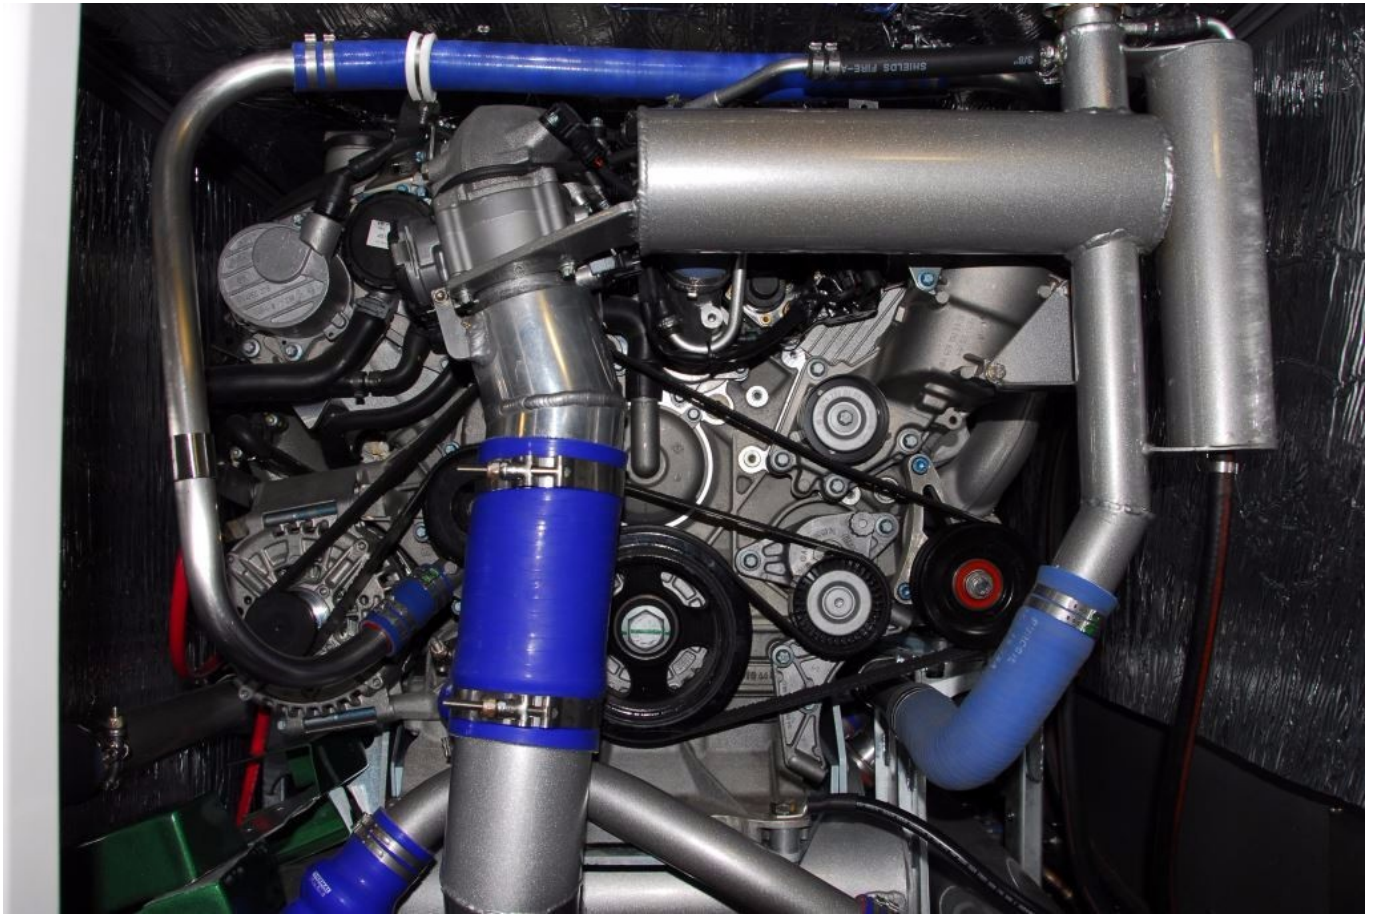
One of the five original Mercedes-based gensets that originally powered RSIII.

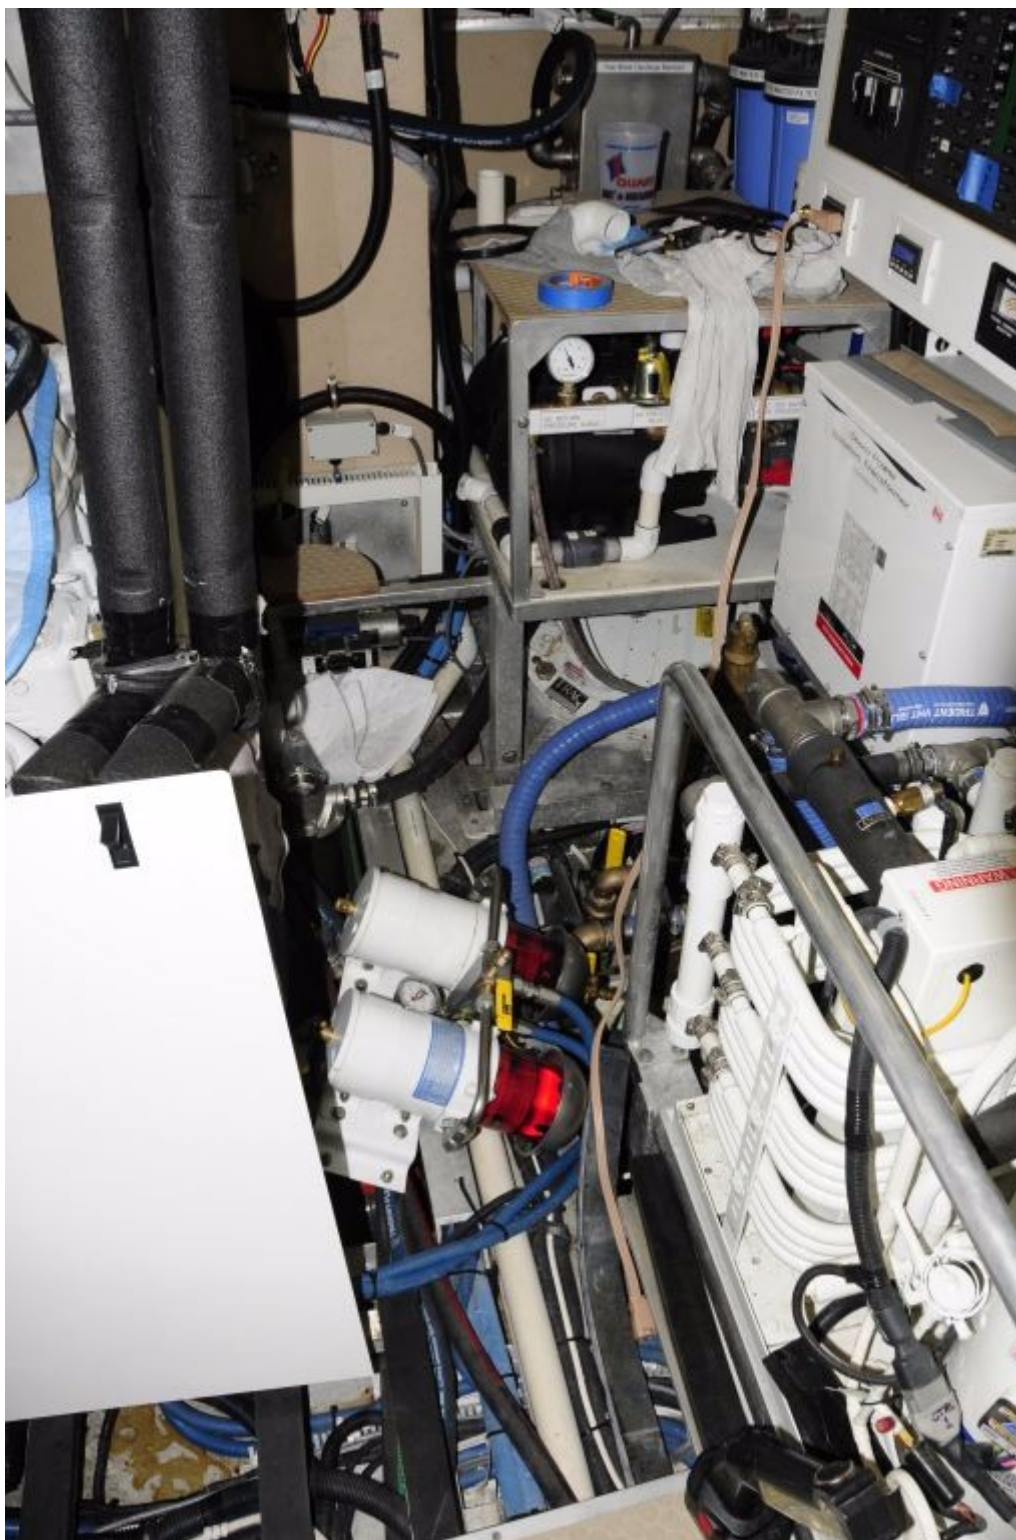
The engine room was a busy place for much of the refit, with each trade vying for space for its gear and tools.

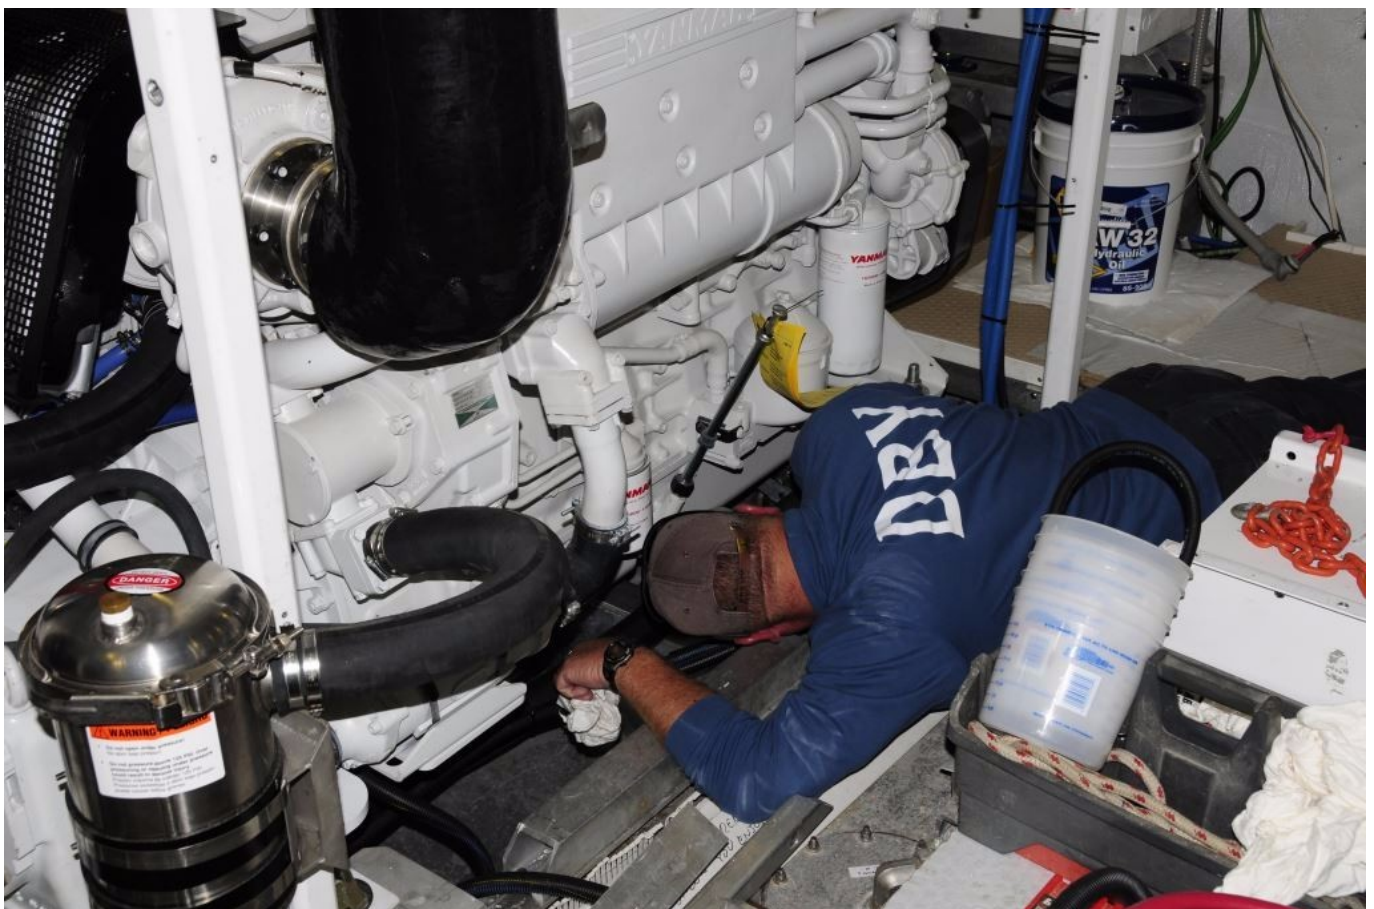
With twin in line 6-cylinder engines replacing the five gensets, each of which was enclosed in its own sound

enclosure, the new engine room is considerably roomier than the previous design.

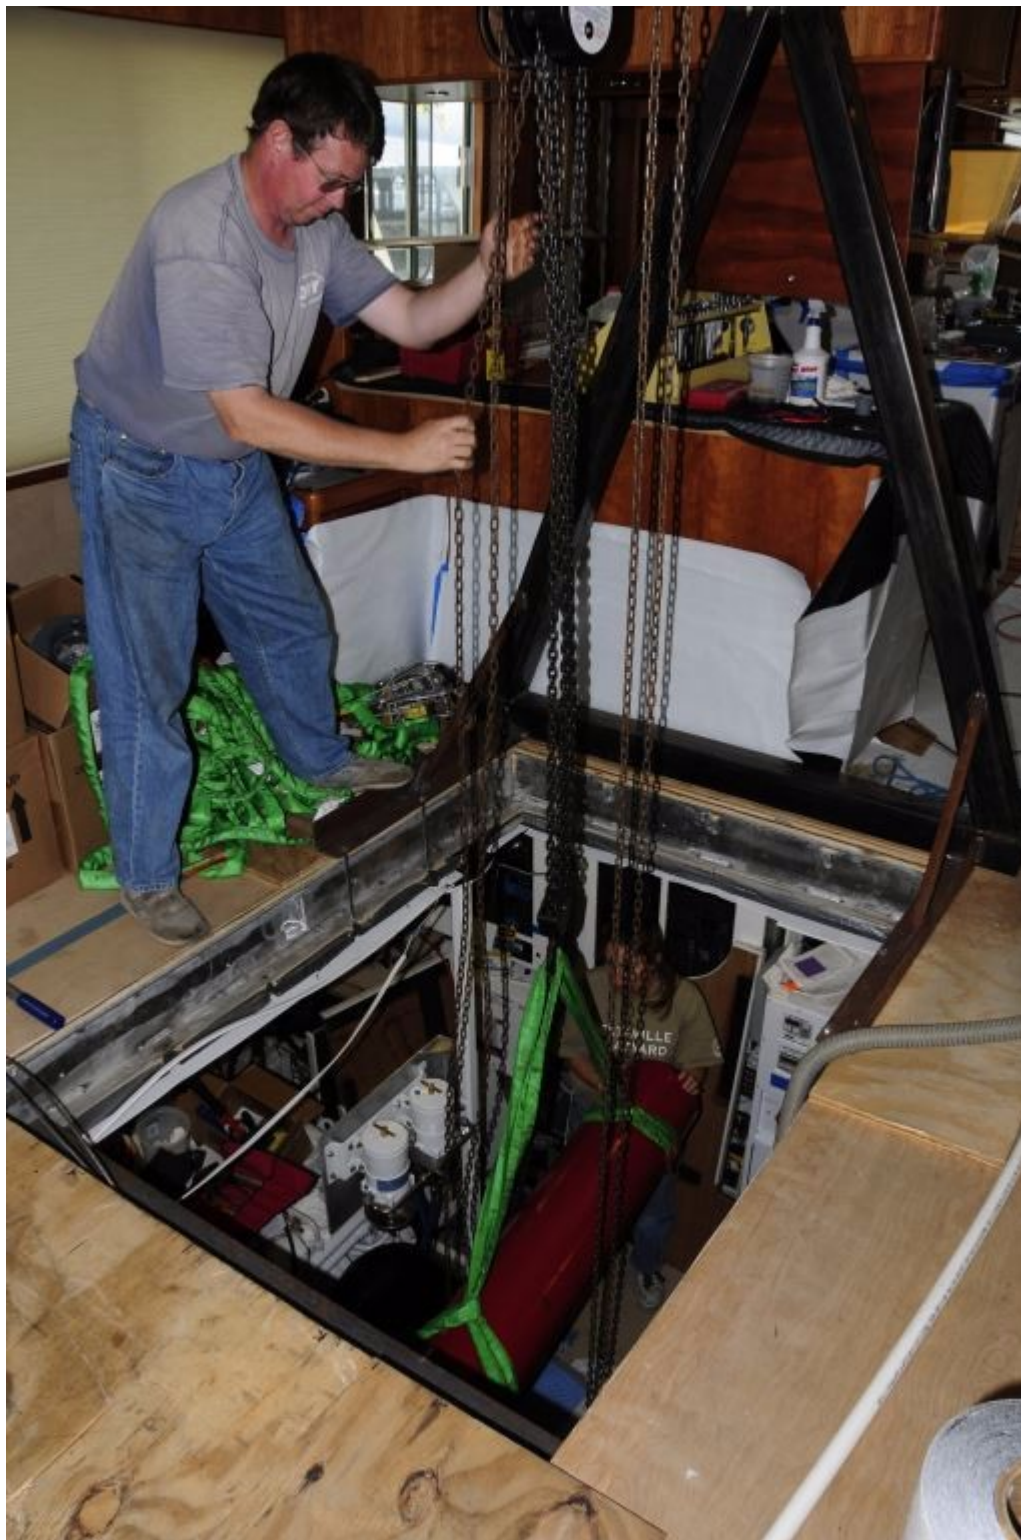
The 'soft patch' a removable hatch, designed by the vessel's naval architect, proved to be a boon to those removing and replacing gear. The vessel was padded and protected, inside and out, to prevent any damage from occurring during the refit.

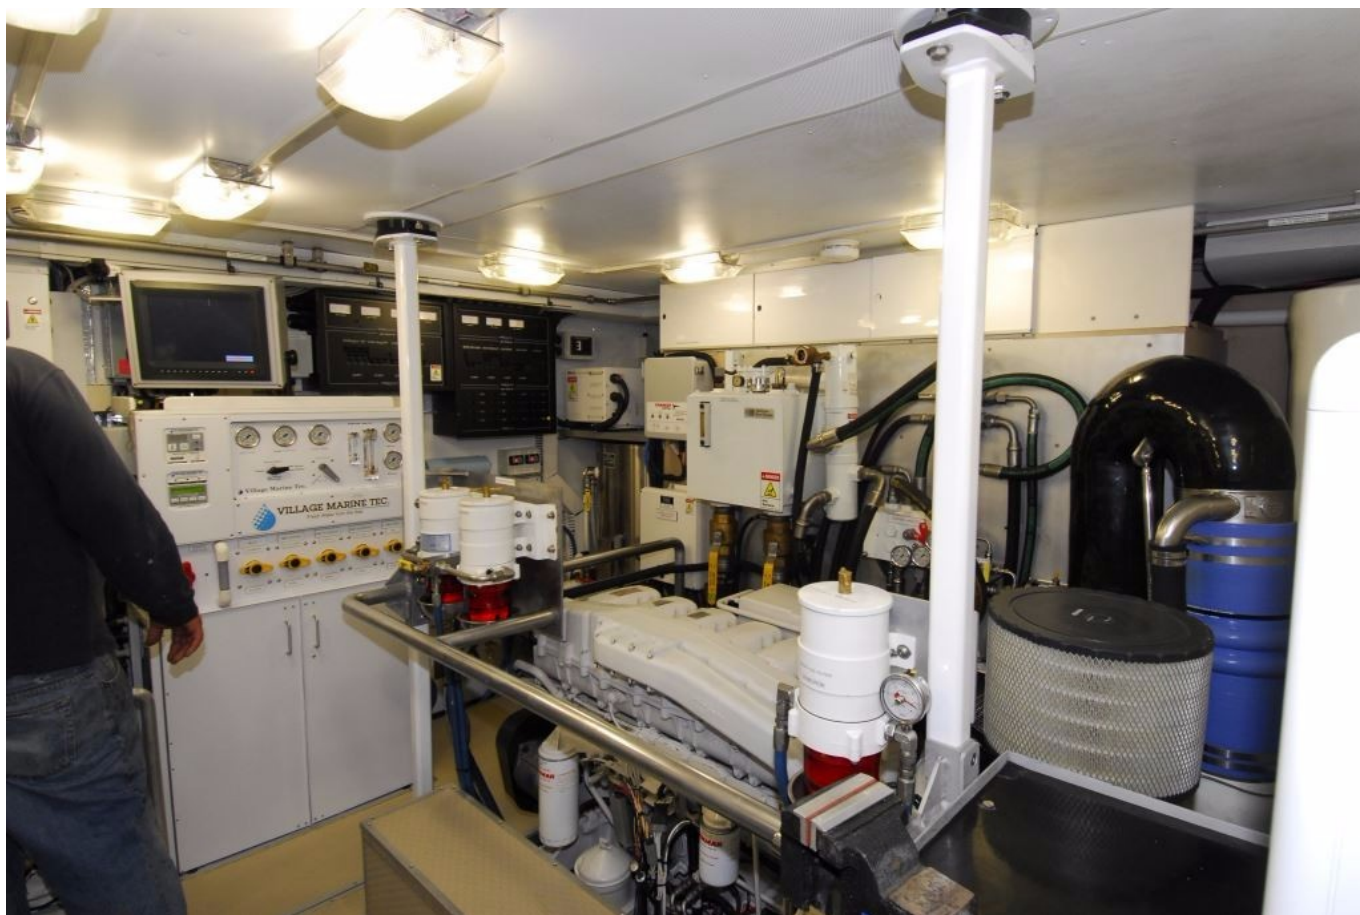
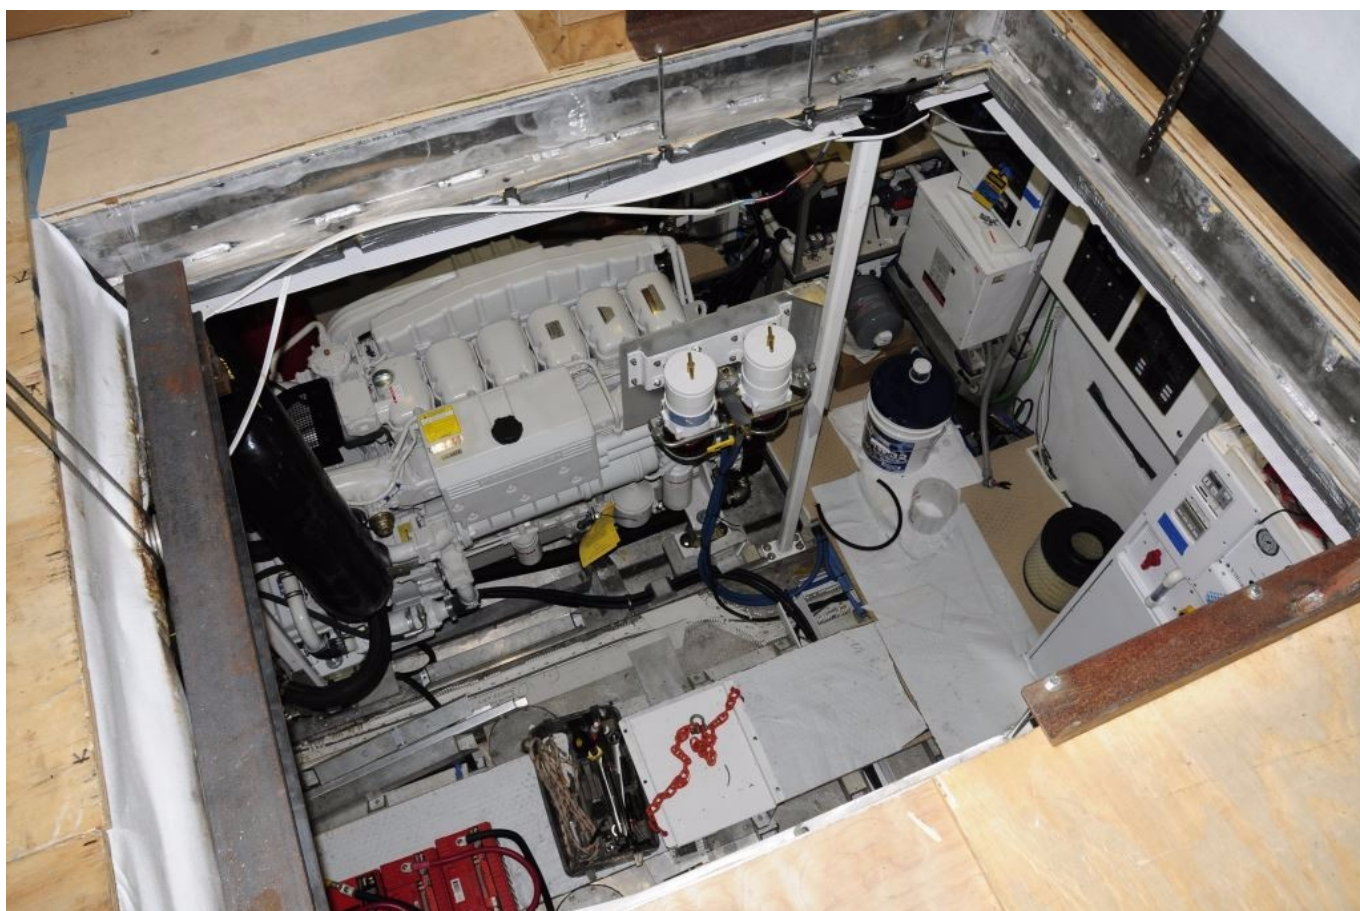
The nearly completed engine room, viewed through the soft

patch access hatch.
