Planning for and Dealing with A Sinking Ship

A strategy for managing a flooding situation aboard your vessel.

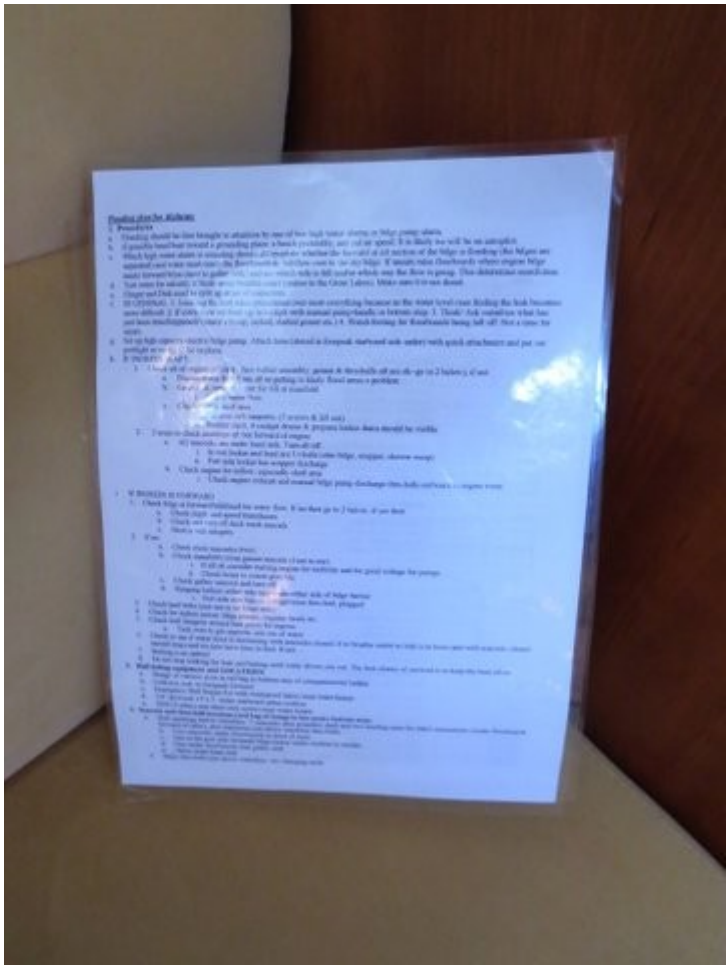
Laminated "Flooding Plan" for Alchemy left in an accessible place with other emergency procedures; regular casual perusal is encouraged.

b. From here each vessel's detailed flooding procedure plan will start to be unique to its own particular design. I am including *Alchemy's* flooding plan (shown below) as a way to address the details, the compromises, and some ancillary considerations for this serious event. The following will show how we have taken the above strategy and made an operating procedure for our vessel. Each vessel will differ in the details, but generally the principles will pertain.
