Planning for and Dealing with A Sinking Ship

By Dick Stevenson

A strategy for managing a flooding situation aboard your vessel.

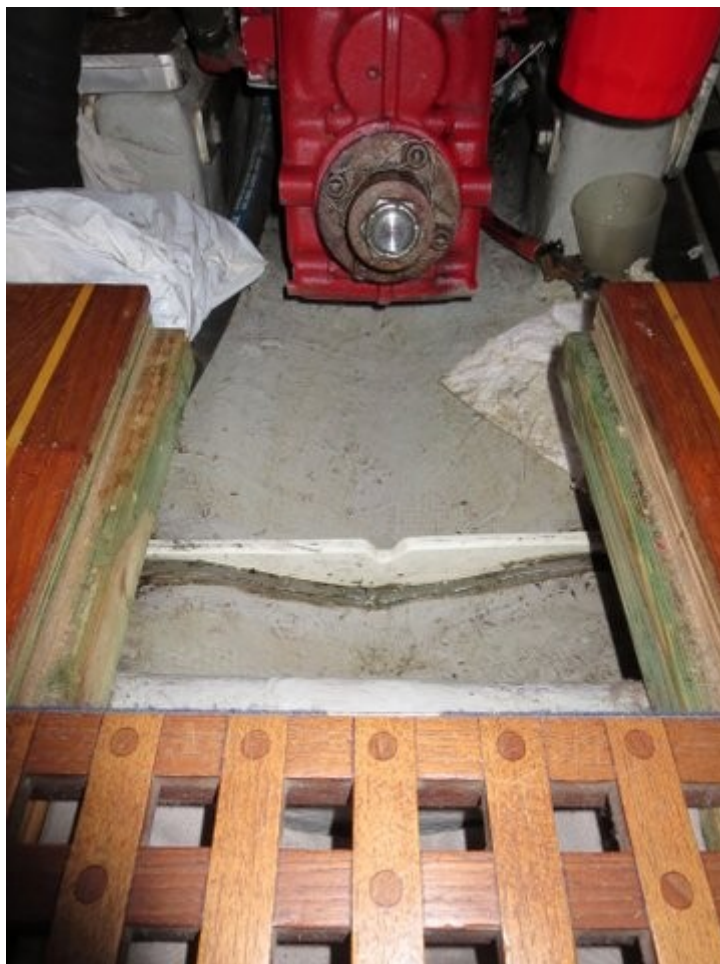
Illustrating a coffer dam (could be easily alarmed) to warn of/capture leaks in engine room (also shows early signs of oil/coolant leaks).

ii. If you have a "one bilge" boat, consider a dam at a strategic point. It does not have to be high or strong: just a water stopper. Water can and should spill over, but make it high enough to allow alarming it to narrow the search area. **

**Often, a natural area for a small dam is where the engine room bilge meets the living area bilge. As said, the dam does not have to be high, but an added benefit is that small inevitable spills of oil, diesel, coolant, etc. stay contained and are easier to clean and less likely to be pumped overboard. They also give quick notice of engine drips/leaks.
