# Planning for and Dealing with A Sinking Ship

By Dick Stevenson

A strategy for managing a flooding situation aboard your vessel.

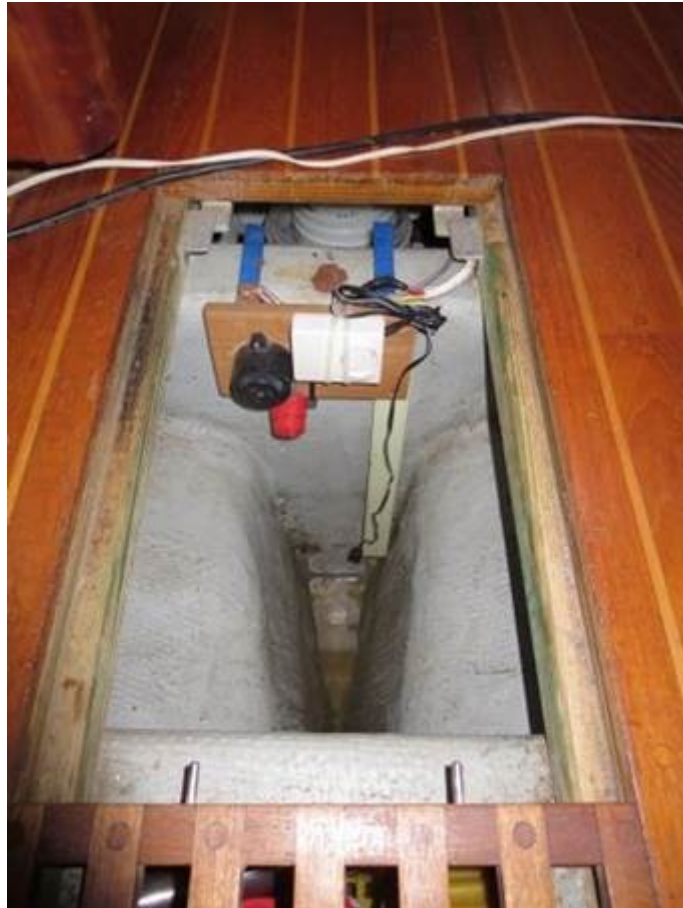
**The high water alarm (white box), 9v battery operated, with sensor at end of black wire going down deep into bilge for early warning, is visible in this image. Also shown is a buzzer (black) indicating electric bilge pump activation and a secondary sensor (orange) to detect propane fumes.**

b. Early notice: high water alarms\* are absolutely essential as they can give immediate warning of any unusual water accumulation. They must be able to be heard in the cockpit of, or anywhere aboard, any type of boat when closed up with the engine running. Many a crew has first found flooding by discovering their floorboards afloat. If we have heard that story told, the crew was generally very lucky. I suspect many who found their floorboards afloat weren't fortunate enough to relate a tale from which others might learn.

i. One option is an alarm which sounds every time the electric bilge pump operates from its float switch. We have a dry boat, so pump activation is always motivation for bilge inspection. At the very least, a conspicuous light should illuminate with each pump activation.

ii. Another option (and there is no reason not to do both) is a dedicated high water alarm ready to go off when water gets just a scooch higher (no more than 2 inches) than the level where your bilge pump activates.
