# Planning for and Dealing with A Sinking Ship

By Dick Stevenson

A strategy for managing a flooding situation aboard your vessel.

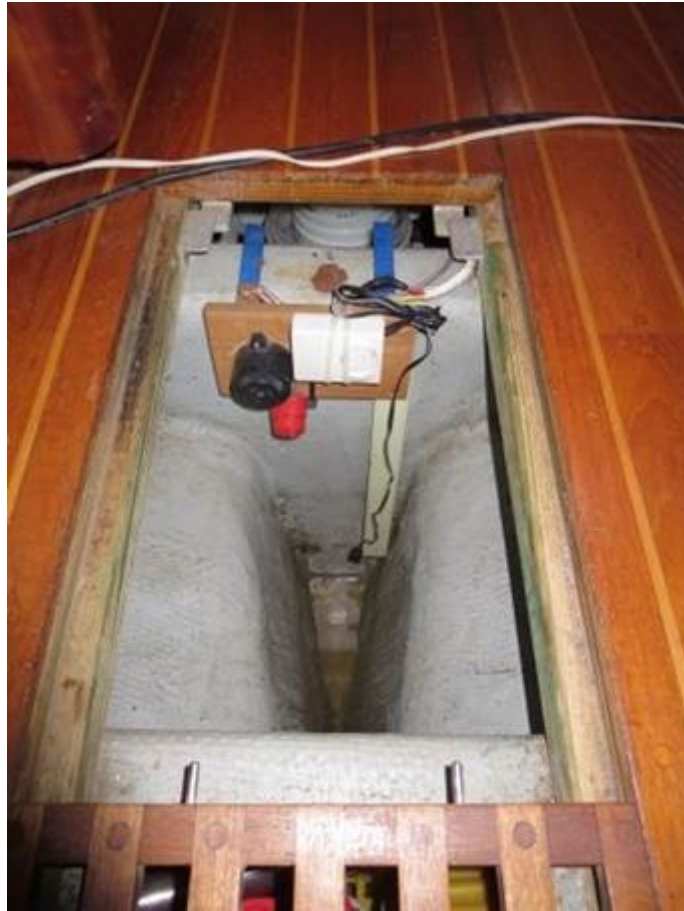
**The high water alarm (white box), 9v battery operated, with sensor at end of black wire going down deep into bilge for early warning, is visible in this image. Also shown is a buzzer (black) indicating electric bilge pump activation and a secondary sensor (orange) to detect propane fumes.**

b. Early notice: high water alarms\* are absolutely essential as they can give immediate warning of any unusual water accumulation. They must be able to be heard in the cockpit of, or anywhere aboard, any type of boat when closed up with the engine running. Many a crew has first found flooding by discovering their floorboards afloat. If we have heard that story told, the crew was generally very lucky. I suspect many who found their floorboards afloat weren't fortunate enough to relate a tale from which others might learn.

i. One option is an alarm which sounds every time the electric bilge pump operates from its float switch. We have a dry boat, so pump activation is always motivation for bilge inspection. At the very least, a conspicuous light should illuminate with each pump activation.

ii. Another option (and there is no reason not to do both) is a dedicated high water alarm ready to go off when water gets just a scooch higher (no more than 2 inches) than the level where your bilge pump activates.

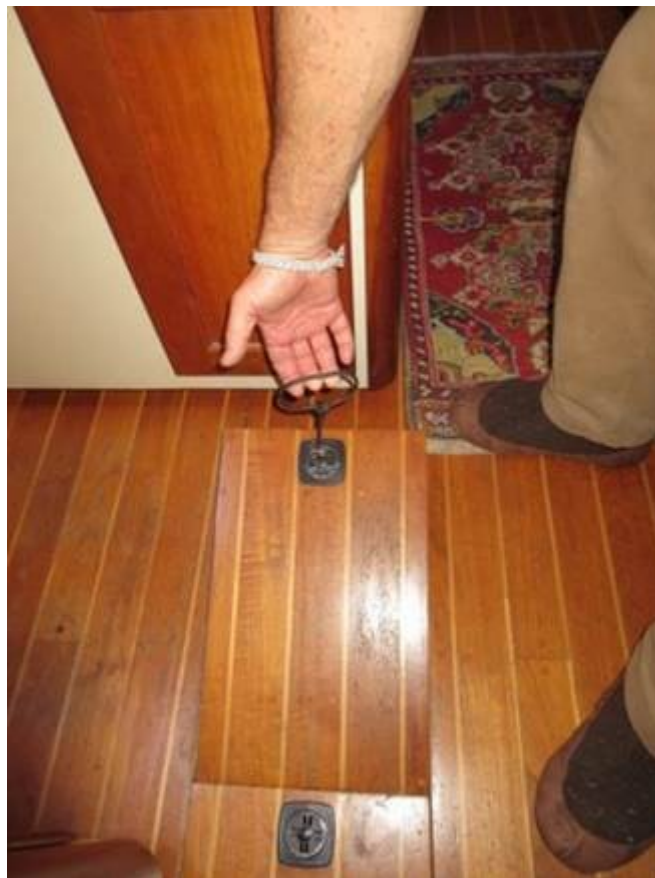
**Alchemy's locking floorboards were occasionally tough to open by finger pull, so we had a blacksmith execute this simple handle.**

ii. Review all floorboards that need to be lifted for a complete flooding inspection. If screwed down, refit to a floorboard lock that is quickly released (as a distant second best, store a charged electric screwdriver ready at hand – Phillips or Robertson square head fasteners only).

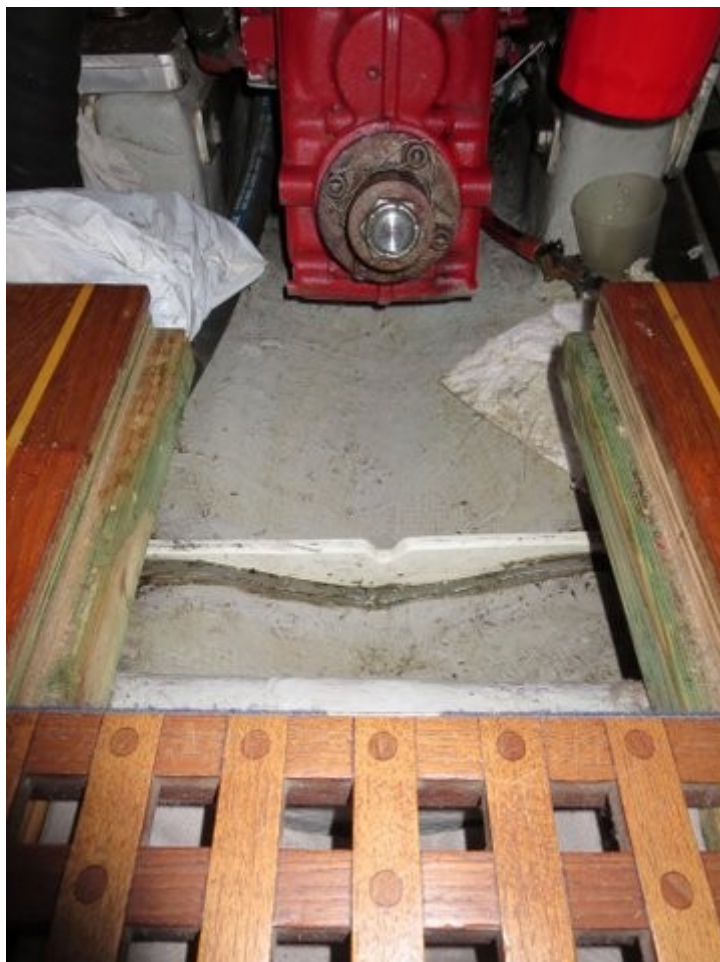
**Illustrating a coffer dam(could be easily alarmed) to warn of/capture leaks in engine room (also shows early signs of oil/coolant leaks).**

ii. If you have a "one bilge" boat, consider a dam at a strategic point. It does not have to be high or strong: just a water stopper. Water can and should spill over, but make it high enough to allow alarming it to narrow the search area. \*\*

**\*\*Often, a natural area for a small dam is where the engine room bilge meets the living area bilge. As said, the dam does not have to be high, but an added benefit is that small inevitable spills of oil, diesel, coolant, etc. stay contained and are easier to clean and less likely to be pumped overboard. They also give quick notice of engine drips/leaks.**

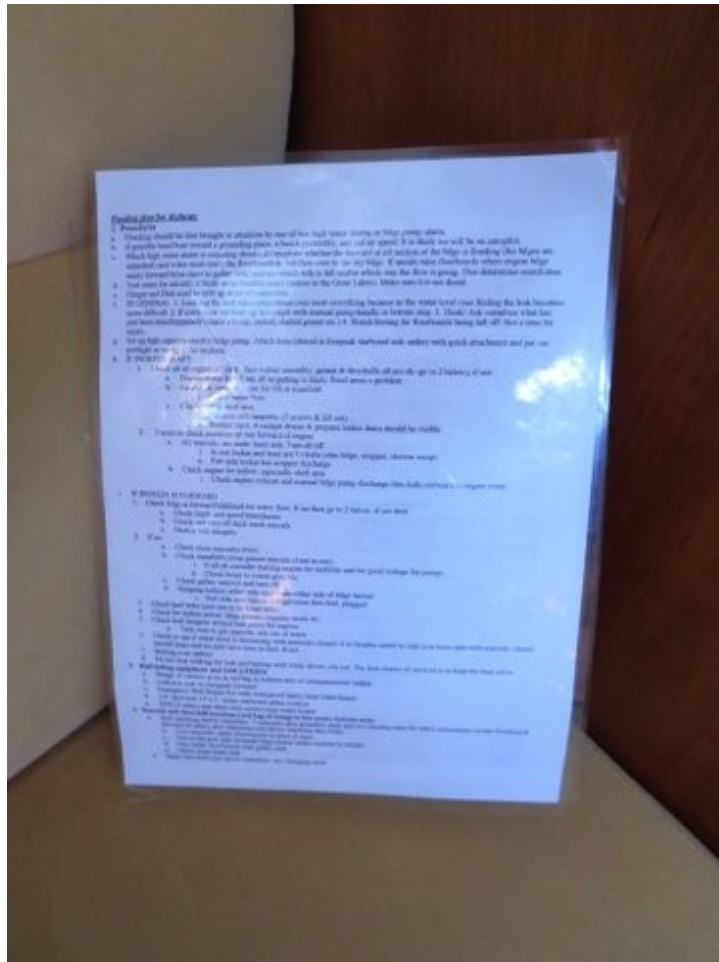
**Laminated "Flooding Plan" for Alchemy left in an accessible place with other emergency procedures; regular casual perusal is encouraged.**
