# Planning for and Dealing with A Sinking Ship

By Dick Stevenson

A strategy for managing a flooding situation aboard your vessel.

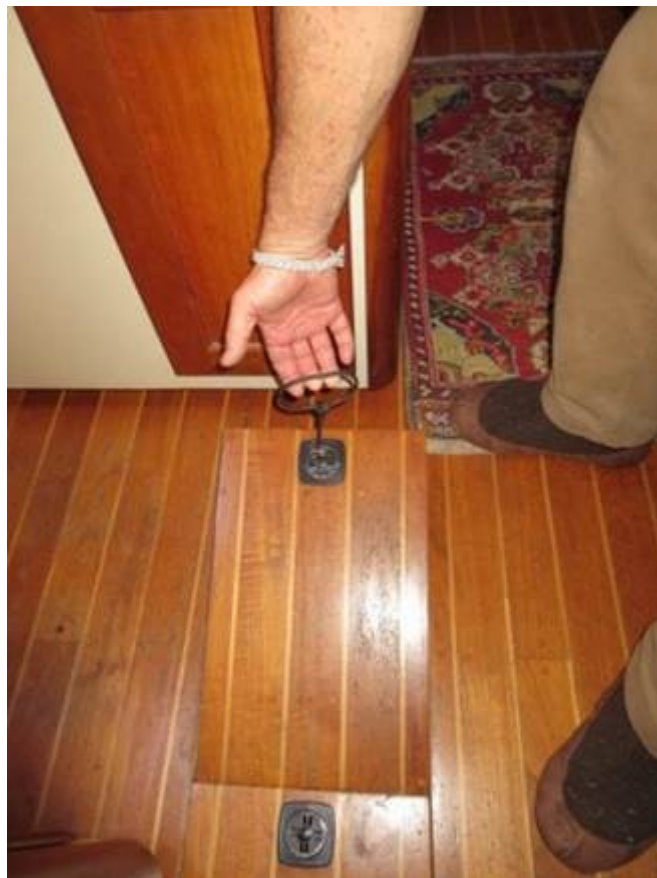
**Alchemy's locking floorboards were occasionally tough to open by finger pull, so we had a blacksmith execute this simple handle.**

ii. Review all floorboards that need to be lifted for a complete flooding inspection. If screwed down, refit to a floorboard lock that is quickly released (as a distant second best, store a charged electric screwdriver ready at hand – Phillips or Robertson square head fasteners only).

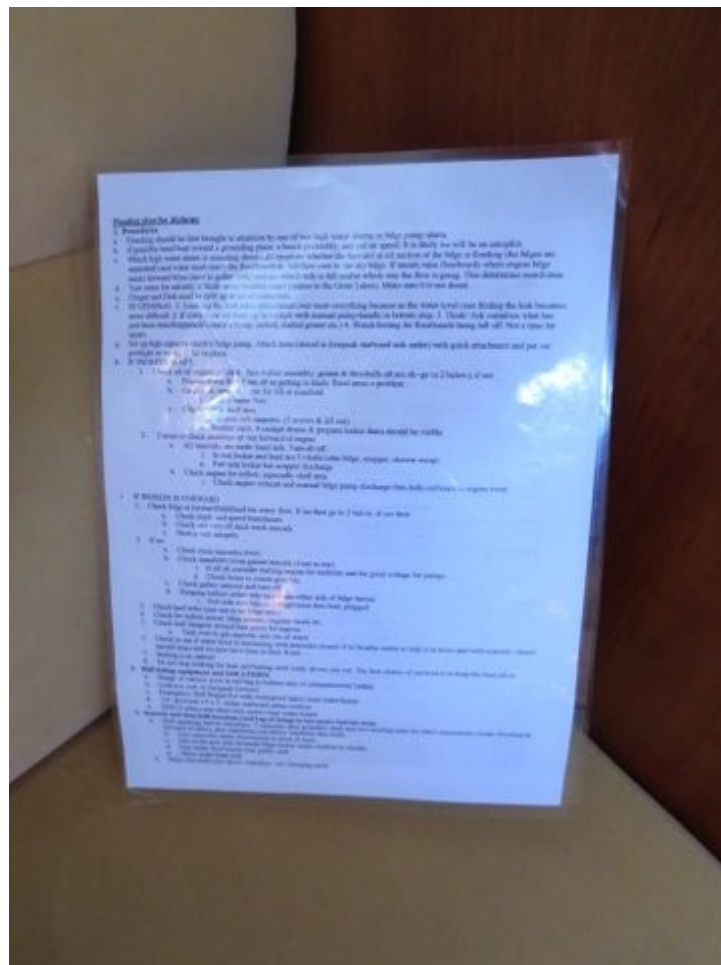
**Laminated "Flooding Plan" for Alchemy left in an accessible place with other emergency procedures; regular casual perusal is encouraged.**
