# Planning for and Dealing with A Sinking Ship

By Dick Stevenson

A strategy for managing a flooding situation aboard your vessel.

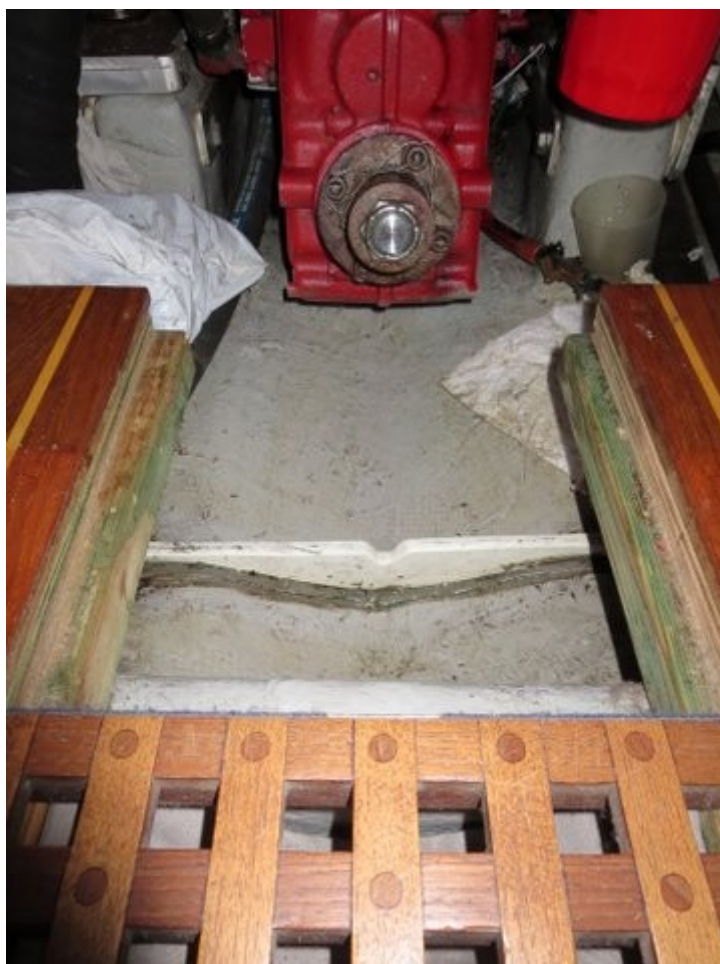
**Illustrating a coffer dam(could be easily alarmed) to warn of/capture leaks in engine room (also shows early signs of oil/coolant leaks).**

ii. If you have a "one bilge" boat, consider a dam at a strategic point. It does not have to be high or strong: just a water stopper. Water can and should spill over, but make it high enough to allow alarming it to narrow the search area. \*\*

**\*\*Often, a natural area for a small dam is where the engine room bilge meets the living area bilge. As said, the dam does not have to be high, but an added benefit is that small inevitable spills of oil, diesel, coolant, etc. stay contained and are easier to clean and less likely to be pumped overboard. They also give quick notice of engine drips/leaks.**
