# Preventing Rust Stains on and Around Stainless-Steel Hardware – Editorial: Call Me

## **Preventing Rust Stains on and Around Stainless-Steel Hardware**

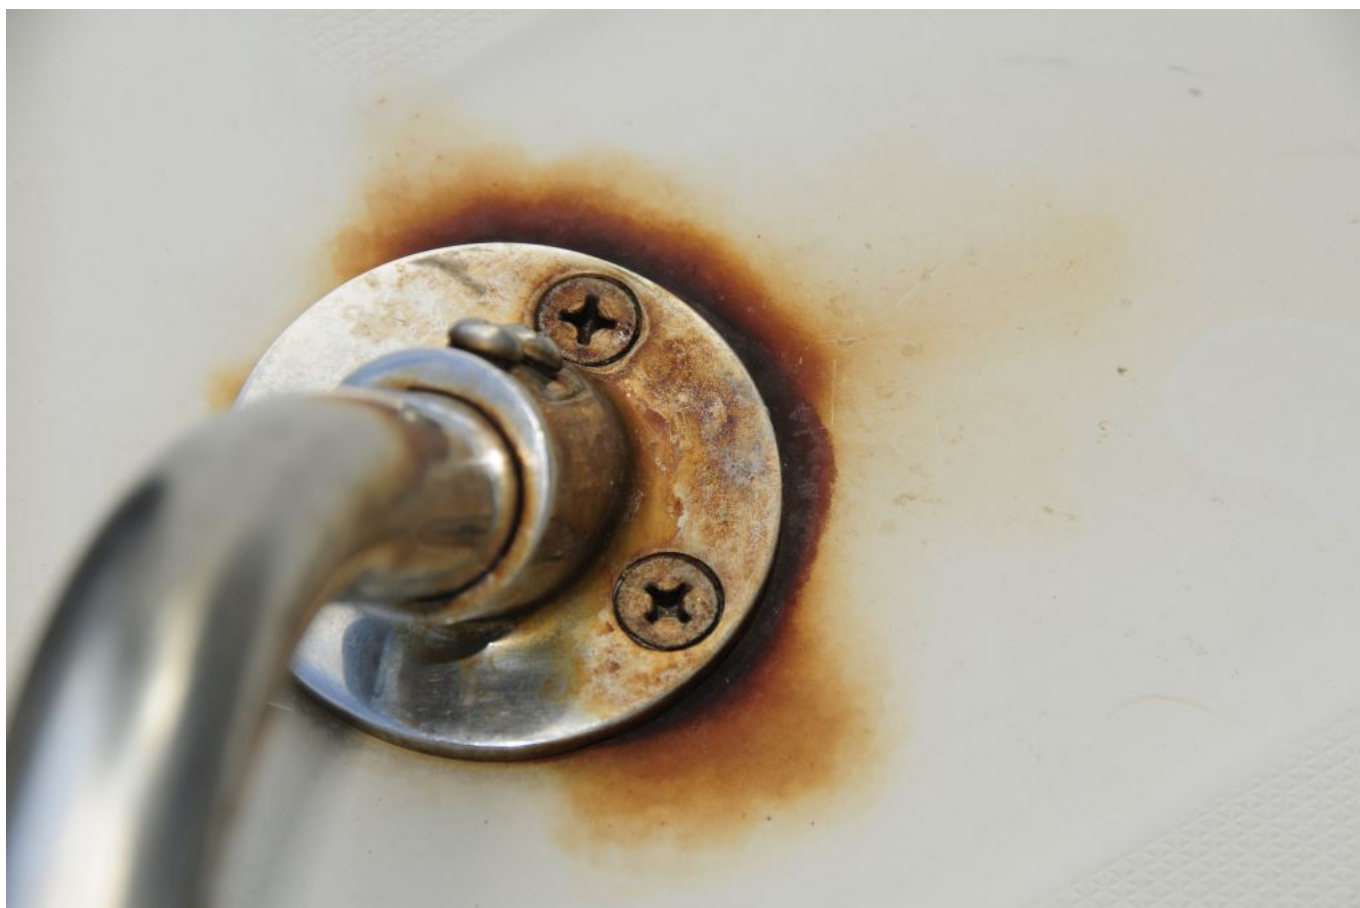
**Rust or “tea stains” like those shown here are common for stainless steel deck hardware installations; they are usually easily avoidable.**

Rust stains running across a deck or hull are nothing new. While unsightly, in many cases they are simply ignored or begrudgingly accepted as part of modern boat ownership. In some cases, however, that rust can be a message, and it's not a very good one. If the staining is occurring adjacent to stainless steel hardware, then the “rust” is often the byproduct of a process known as crevice corrosion, whereby

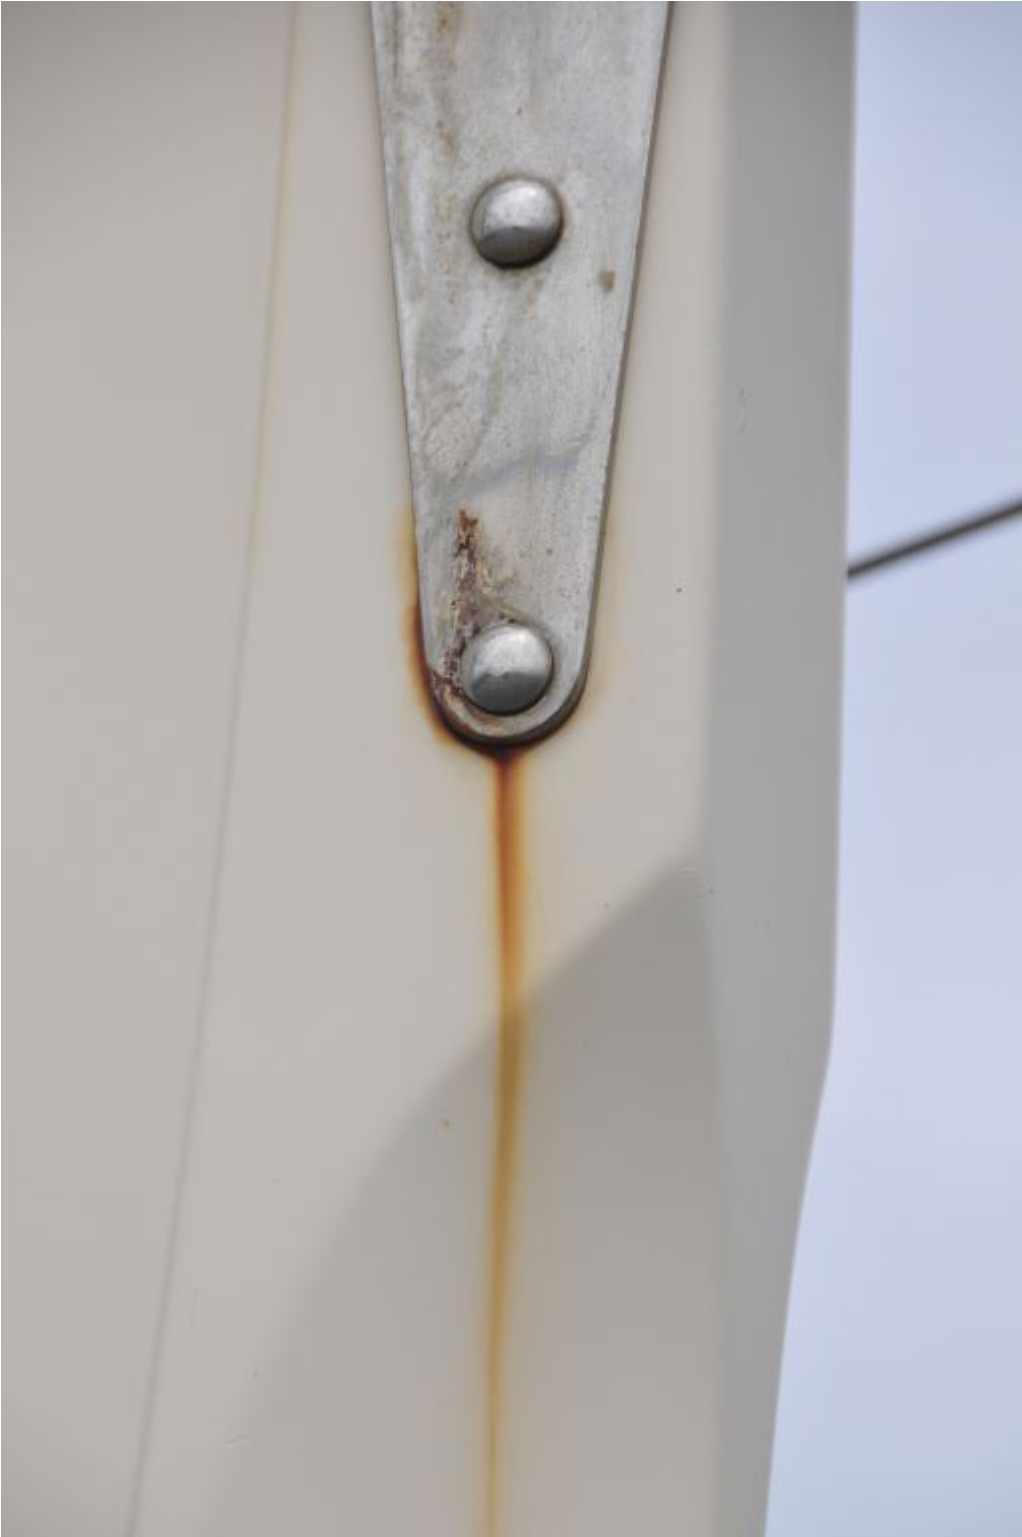
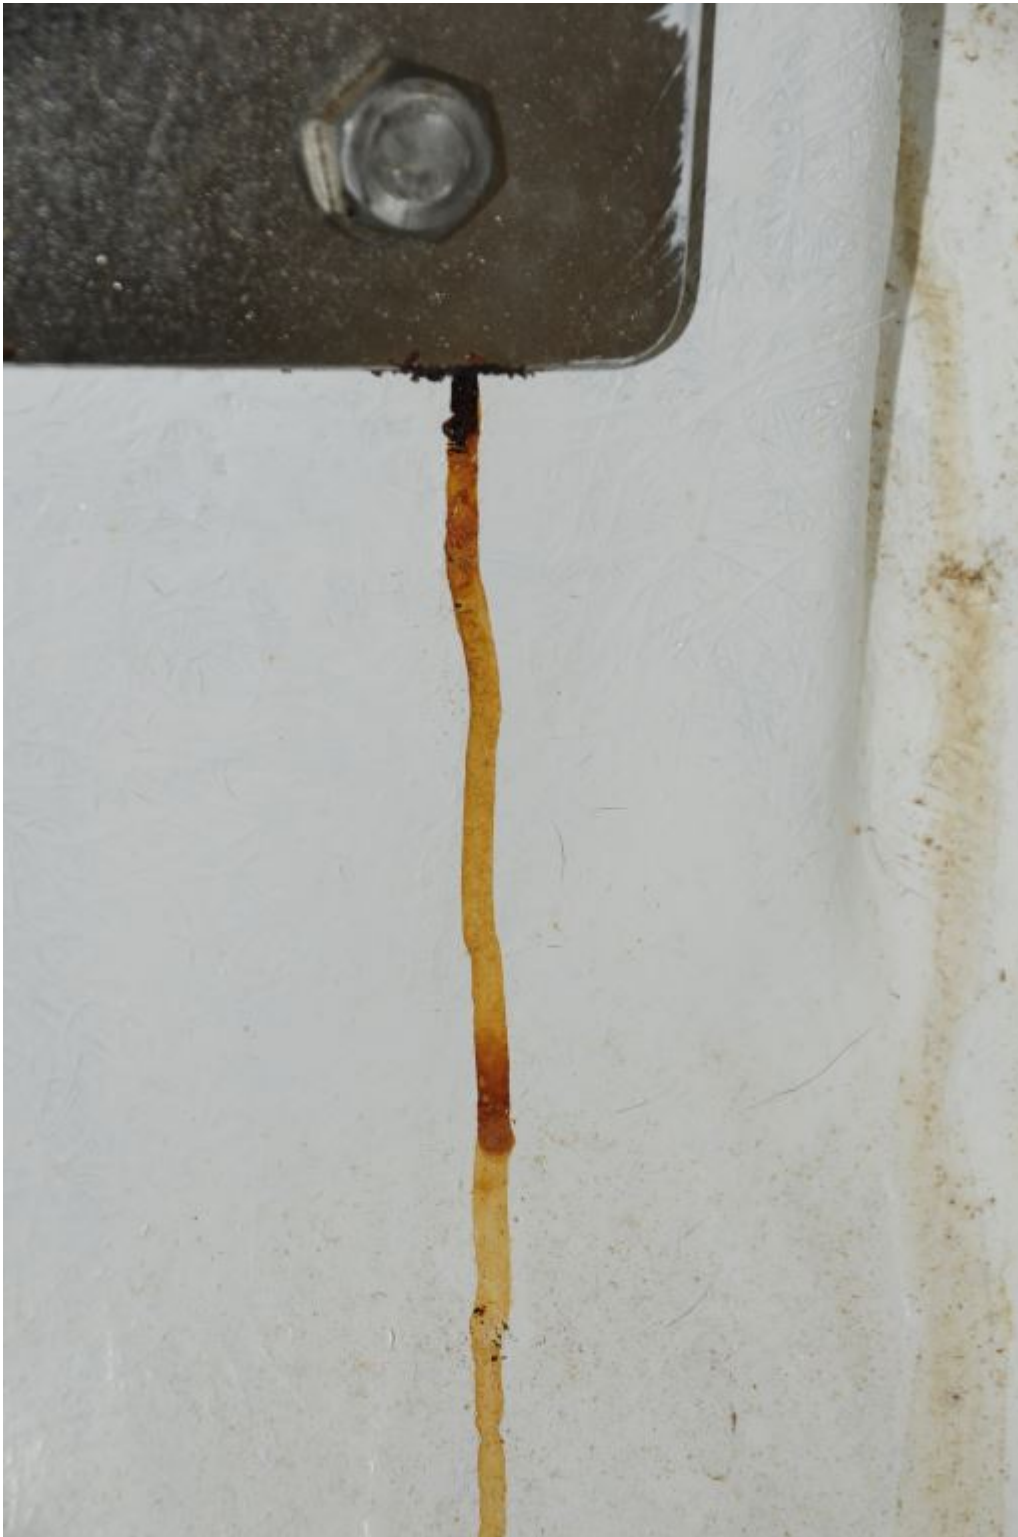
**Chain plates are especially susceptible to this issue, as are the fasteners that support them, a failure of which could be catastrophic.**

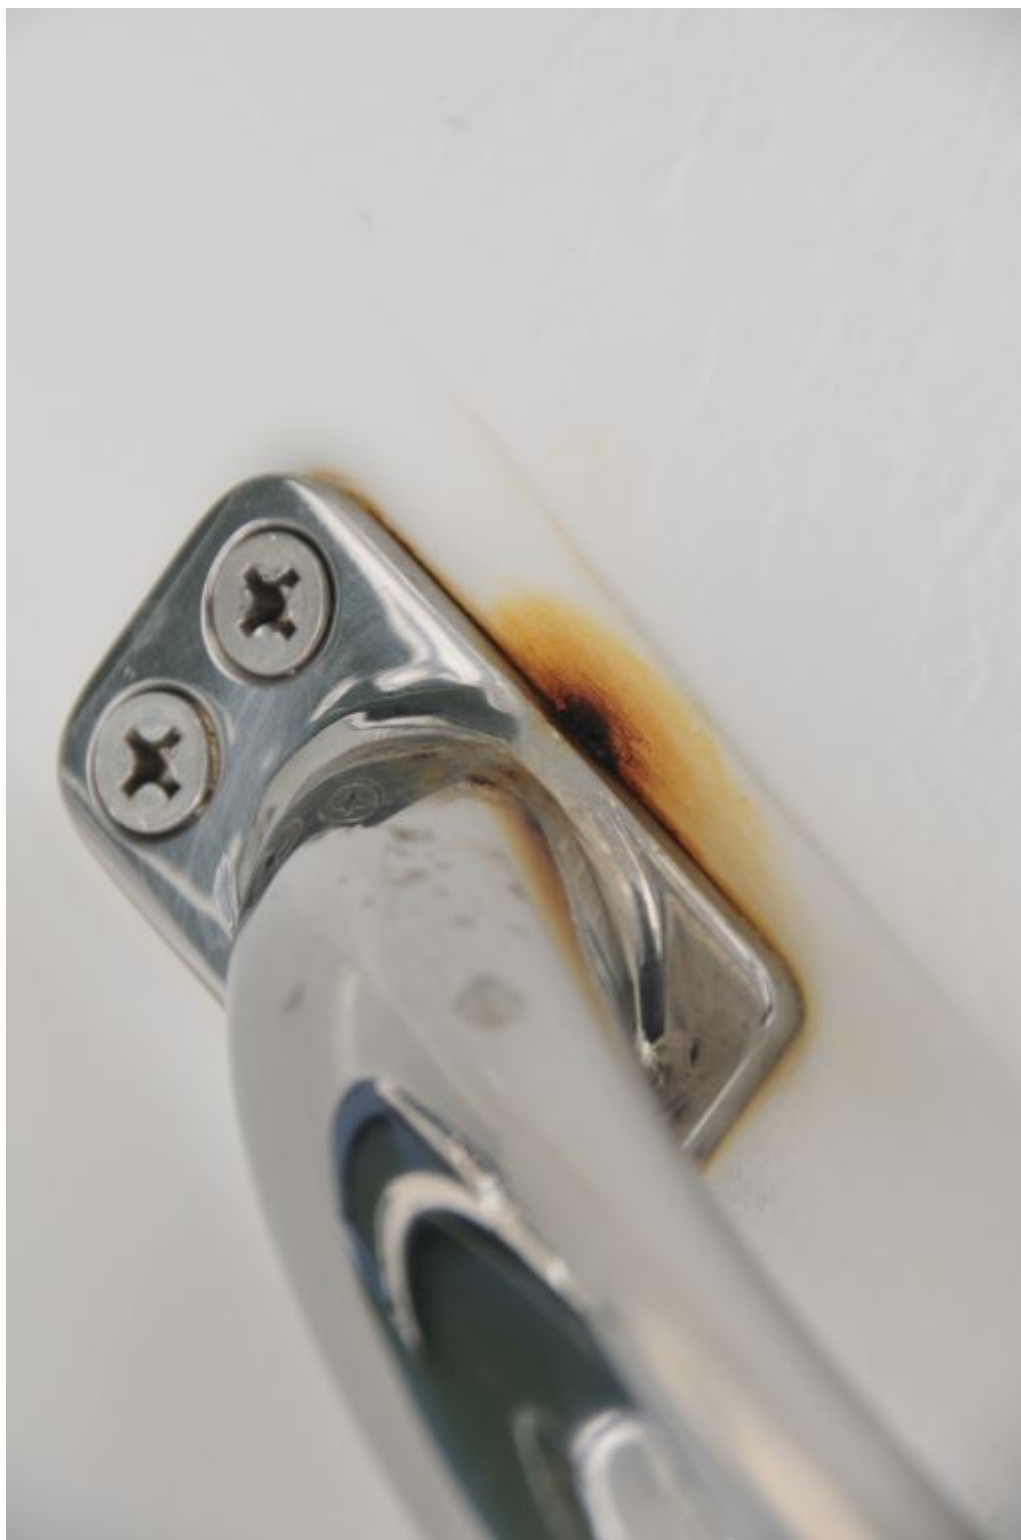
**In order to remain rust-free, stainless steel must have continuous access to oxygen, however, water trapped beneath a flange like this quickly becomes stagnant and oxygen depleted, which in turn leads to corrosion and staining.**

it must be continuously exposed to a source of oxygen. In doing so, stainless steel is able to replenish and maintain the tough oxide layer that allows it to resist rusting. Stainless steel used on deck is exposed to air, which certainly provides ample oxygen to maintain the oxide layer. Even stainless steel used below the waterline, provided the water moves freely and regularly, *may* be exposed to enough oxygen to remain passive. If, however, the stainless steel is exposed to an oxygen-poor environment, stagnant water for instance, then it's likely to enter an active state.

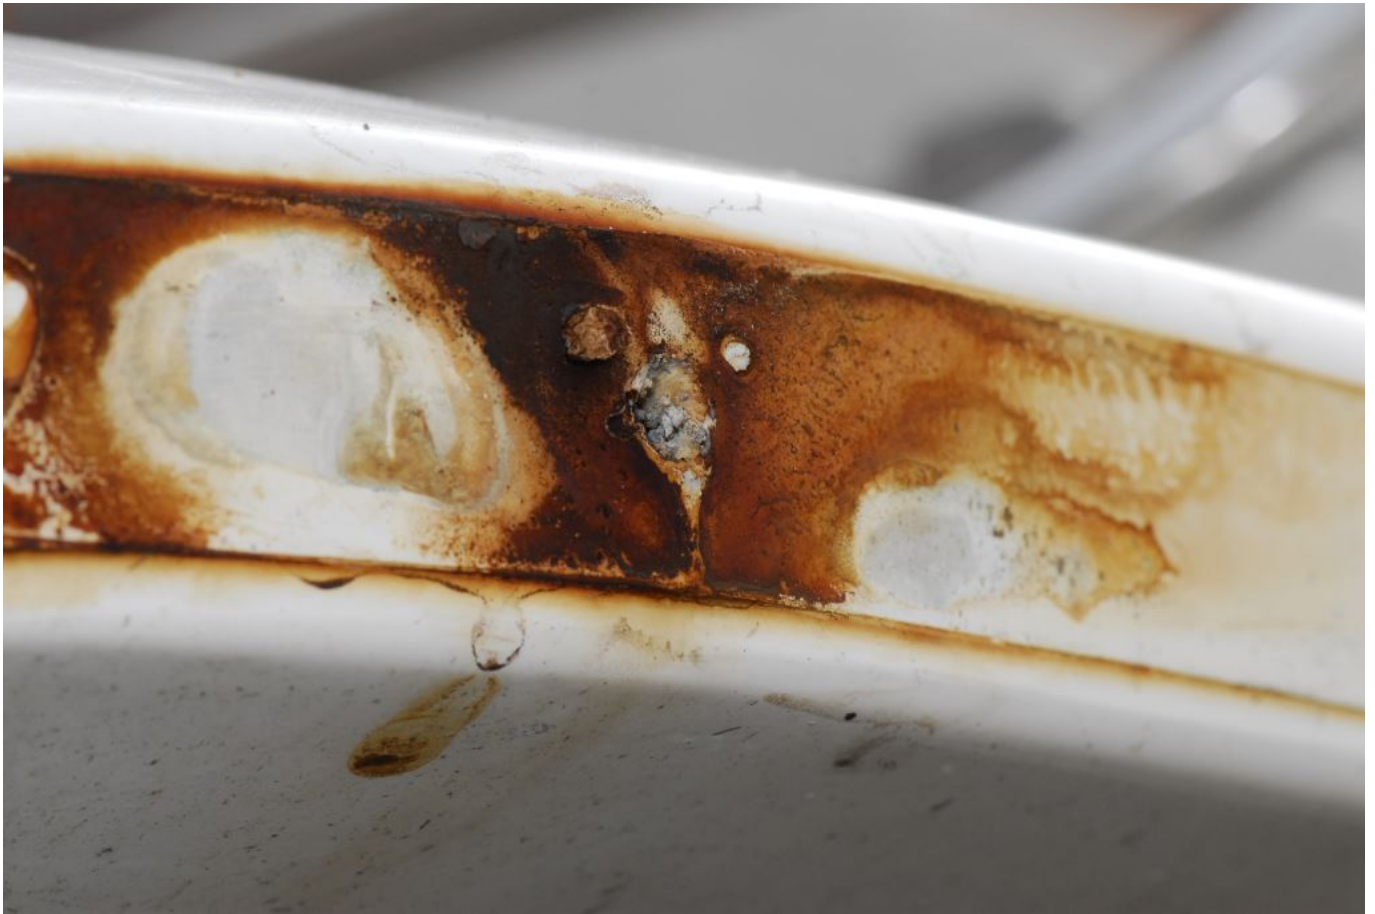
**After this rub rail “iron” was removed, the evidence of water entrapment is clear to see. Fully bedding hardware is the solution to this problem.**

The solution for this problem involves removal, thorough cleaning, de-waxing, and *fully* bedding the hardware (see SDMC MSE Caulk and Sealant). That is, instead of applying bedding compound only to the areas where fasteners pass through, the entire base of the hardware, be it a cleat, port light trim ring, grab rail flange, chock or any other hardware, should be liberally bedded with sealant that will both create a watertight seal and exclude water that could migrate beneath the hardware base. Exclusion of the water is the key to preventing staining.
