Preventing Rust Stains on and Around Stainless-Steel Hardware – Editorial: Call Me

Preventing Rust Stains on and Around Stainless-Steel Hardware

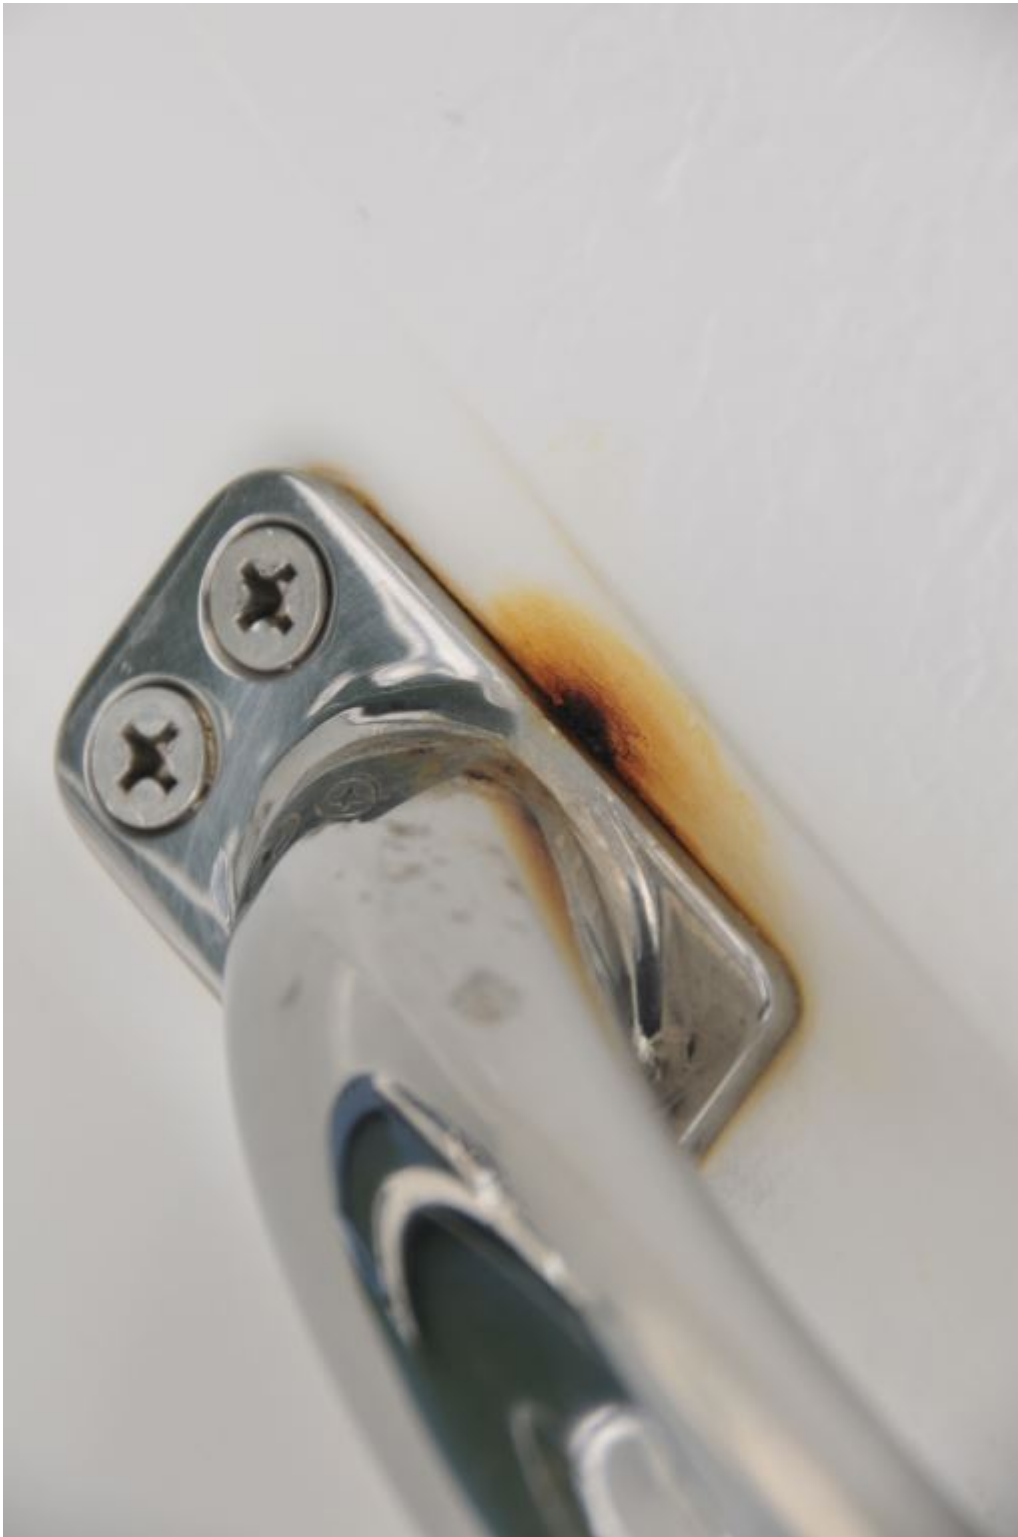
In order to remain rust-free, stainless steel must have continuous access to oxygen, however, water trapped beneath a flange like this quickly becomes stagnant and oxygen depleted, which in turn leads to corrosion and staining.

it must be continuously exposed to a source of oxygen. In doing so, stainless steel is able to replenish and maintain the tough oxide layer that allows it to resist rusting. Stainless steel used on deck is exposed to air, which certainly provides ample oxygen to maintain the oxide layer. Even stainless steel used below the waterline, provided the water moves freely and regularly, *may* be exposed to enough oxygen to remain passive. If, however, the stainless steel is exposed to an oxygen-poor environment, stagnant water for instance, then it's likely to enter an active state.

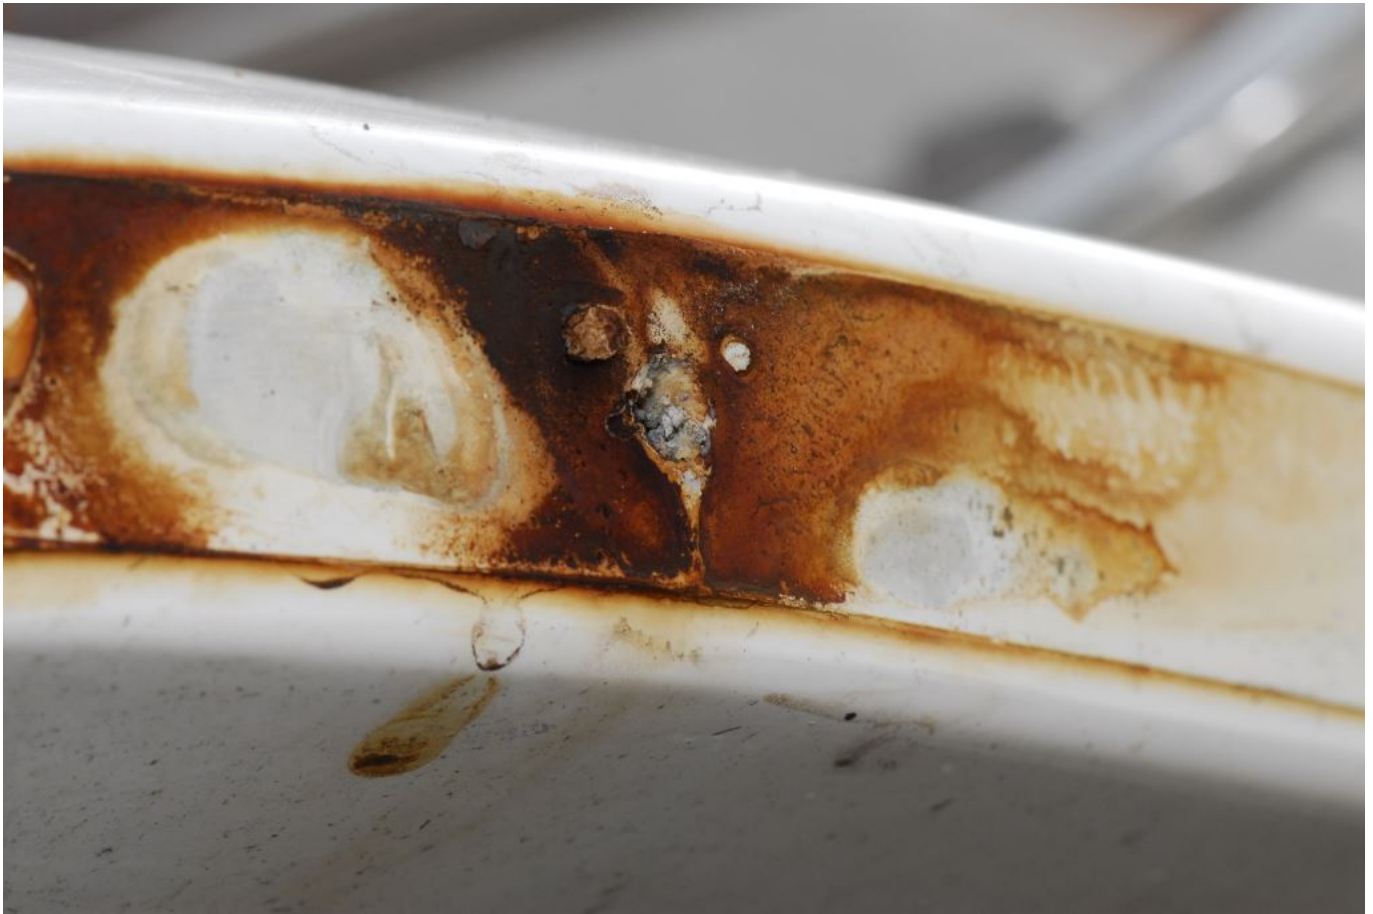
After this rub rail “iron” was removed, the evidence of water entrapment is clear to see. Fully bedding hardware is the solution to this problem.

The solution for this problem involves removal, thorough cleaning, de-waxing, and *fully* bedding the hardware (see SDMC MSE Caulk and Sealant). That is, instead of applying bedding compound only to the areas where fasteners pass through, the entire base of the hardware, be it a cleat, port light trim ring, grab rail flange, chock or any other hardware, should be liberally bedded with sealant that will both create a watertight seal and exclude water that could migrate beneath the hardware base. Exclusion of the water is the key to preventing staining.
