# Preventing Rust Stains on and Around Stainless-Steel Hardware – Editorial: Call Me

## Preventing Rust Stains on and Around Stainless-Steel Hardware

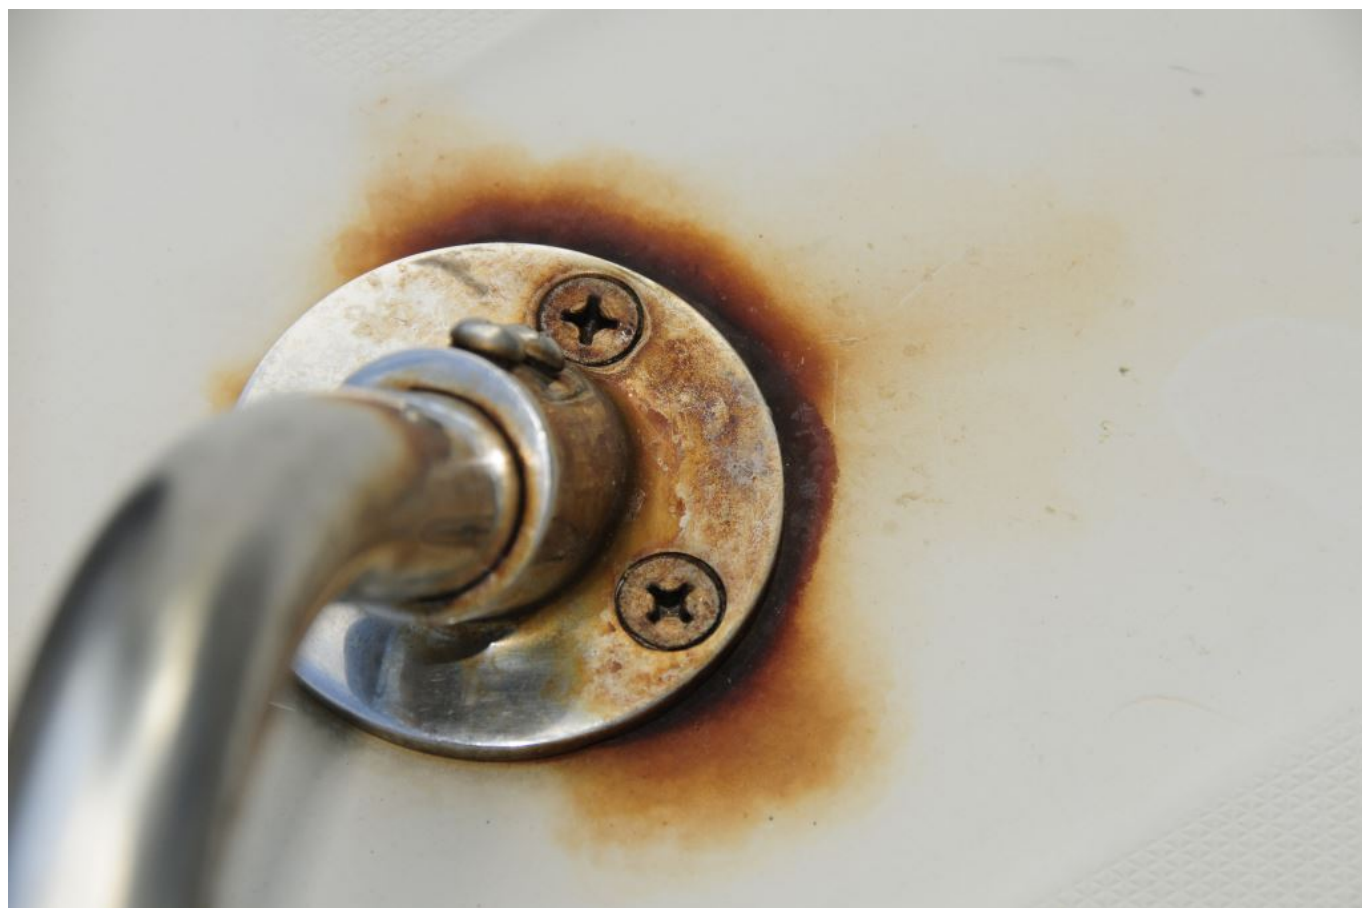
**Rust or “tea stains” like those shown here are common for stainless steel deck hardware installations; they are usually easily avoidable.**

Rust stains running across a deck or hull are nothing new. While unsightly, in many cases they are simply ignored or begrudgingly accepted as part of modern boat ownership. In some cases, however, that rust can be a message, and it's not a very good one. If the staining is occurring adjacent to stainless steel hardware, then the “rust” is often the byproduct of a process known as crevice corrosion, whereby

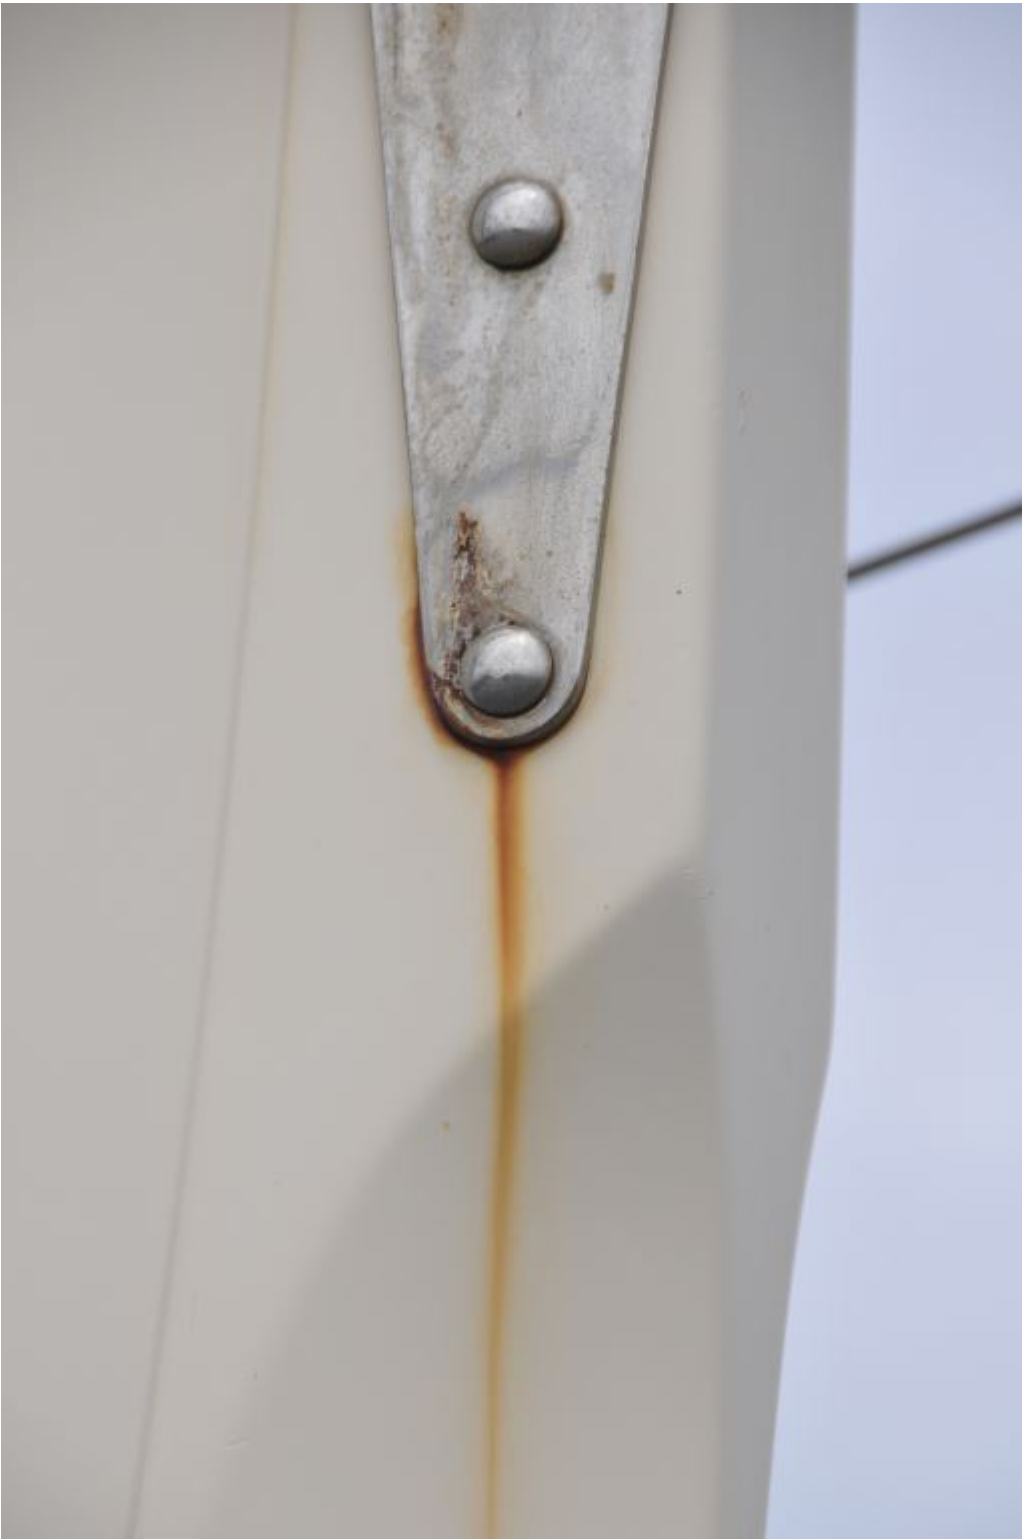
**Chain plates are especially susceptible to this issue, as are the fasteners that support them, a failure of which could be catastrophic.**
