Preventing Rust Stains on and Around Stainless-Steel Hardware – Editorial: Call Me

Preventing Rust Stains on and Around Stainless-Steel Hardware

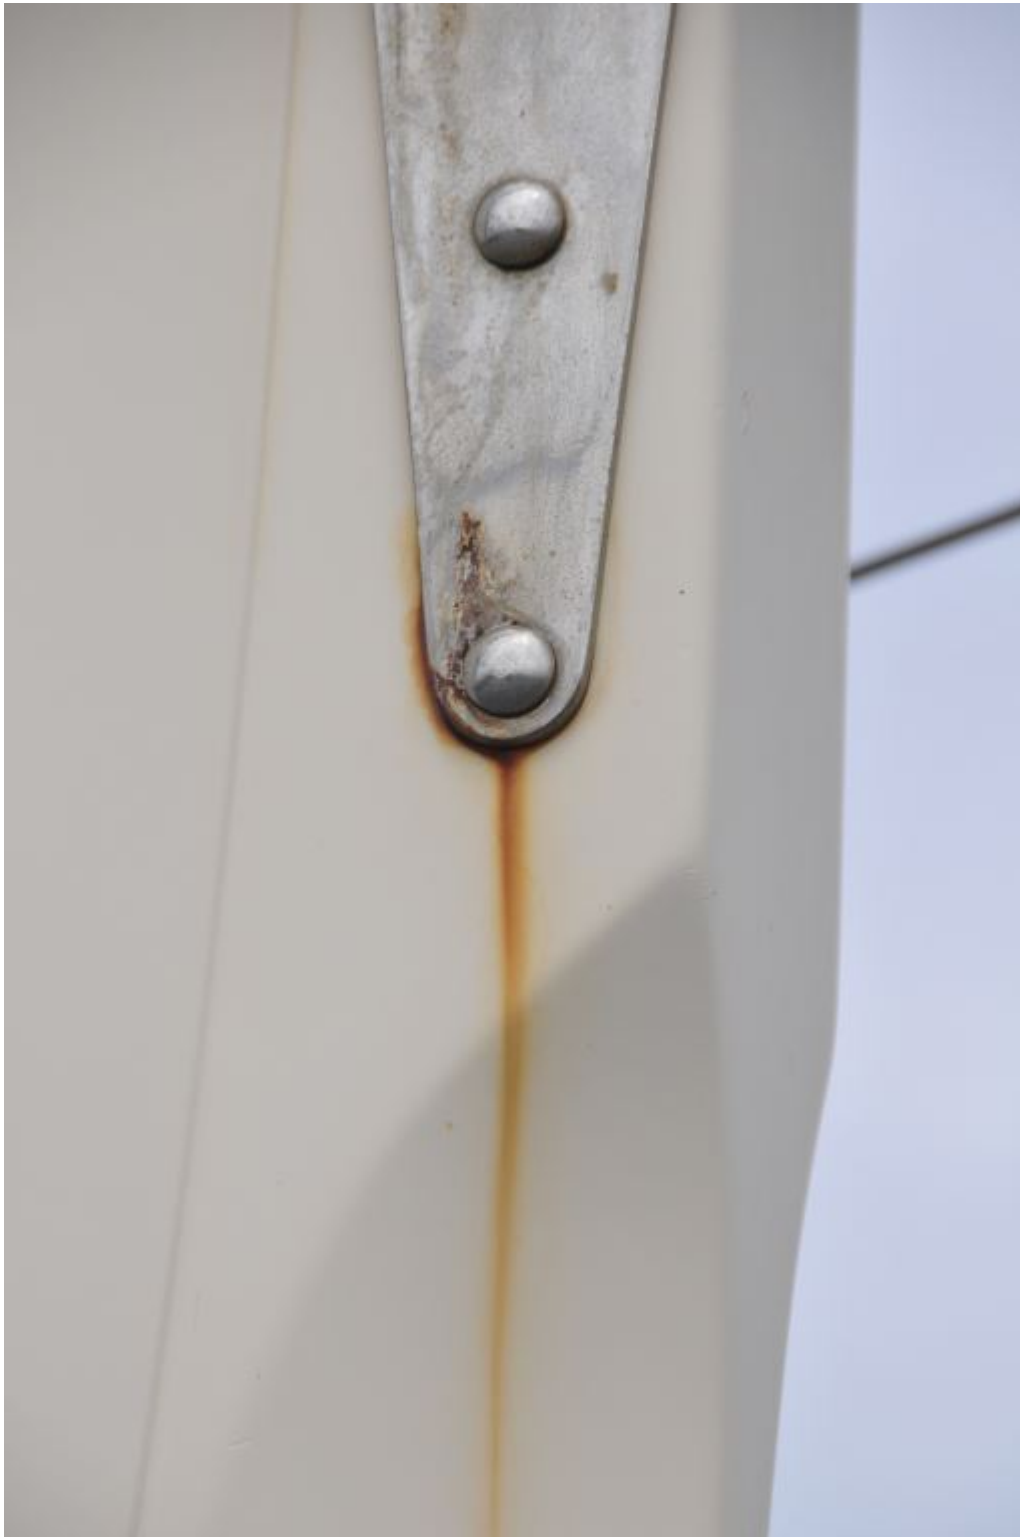
Chain plates are especially susceptible to this issue, as are the fasteners that support them, a failure of which could be catastrophic.
