# Seacock Selection, Service, and Avoiding the Pitfalls

By Steve D'Antonio

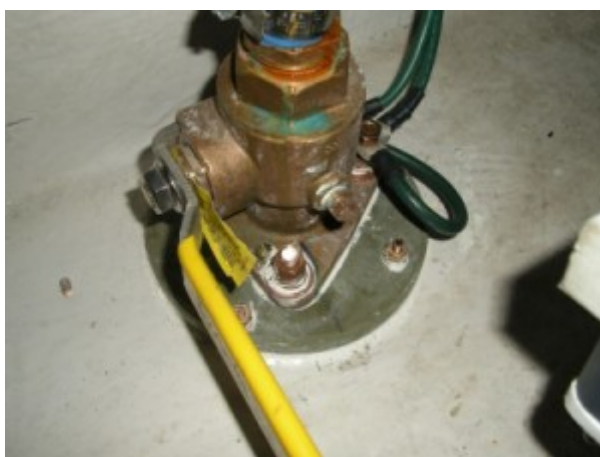
**Proper seacock installations, like the one shown here, are robust and reliable. Many, on the other hand, fail to make the grade.**

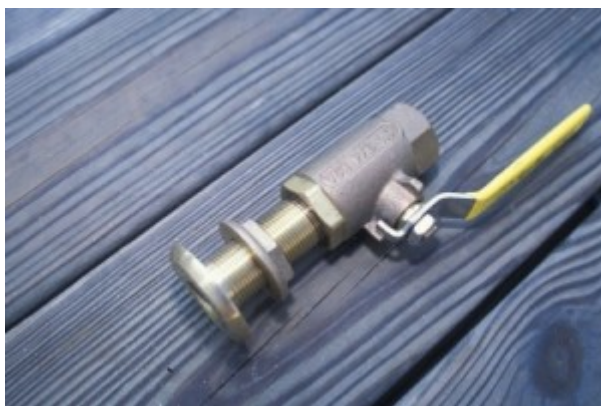
**This arrangement, a ball valve mated to a through hull fitting often passes for a seacock, however, it's anything but.**

A reliable, robust seacock installation begins with selecting the right components. Far too often, what passes for a seacock is in fact a mismatched collection of plumbing components. The most common hardware faux pas, mentioned in the previous paragraph, involves the mating of a through hull fitting, the mushroom-shaped male-threaded component, with an in-line ball valve. Make no mistake about it, regardless of the quality of the construction, these components were never designed by their respective manufacturers to be mated to each other for one exceedingly simple reason, the threads are entirely incompatible. Through hull fittings utilize straight

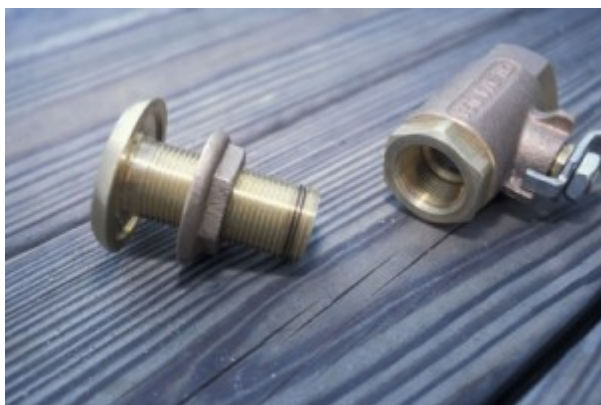
**The primary reason for this assembly's failure to meet seacock**

**standards is very simple, the threads are incompatible. The black line indicates the woefully inadequate engagement.**

or NPS threads, while in-line ball valves rely on tapered or NPT threads. The two may initially engage, however, it's difficult to obtain more than two or three threads of engagement. Make certain your through hull fittings are attached to purpose made, flanged marine sea valves, all of which utilize properly mating NPS threads.

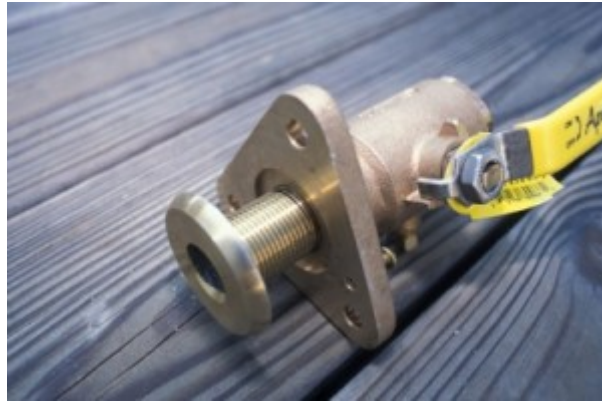
**Through hull fittings and proper, flanged seacocks share the same thread type, NPS or straight.**

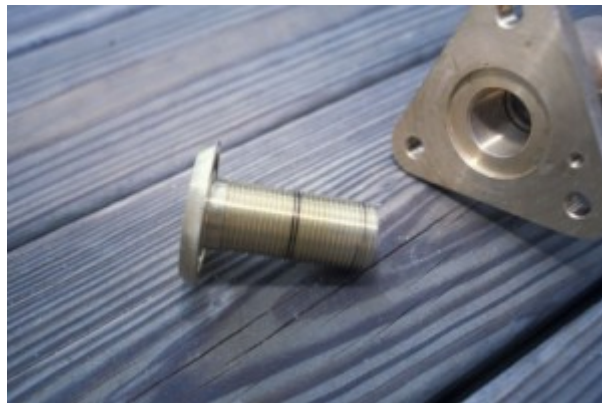
**The black line on this through hull fitting indicates the substantial thread engagement this assembly achieves, making it exceptionally strong.**

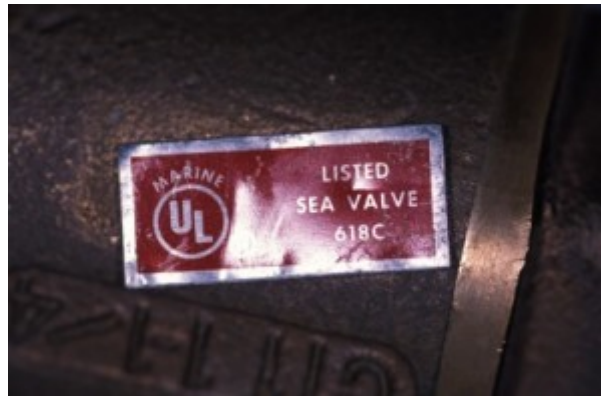
**Not all UL Listed valves are UL Listed Marine Sea Valves.**

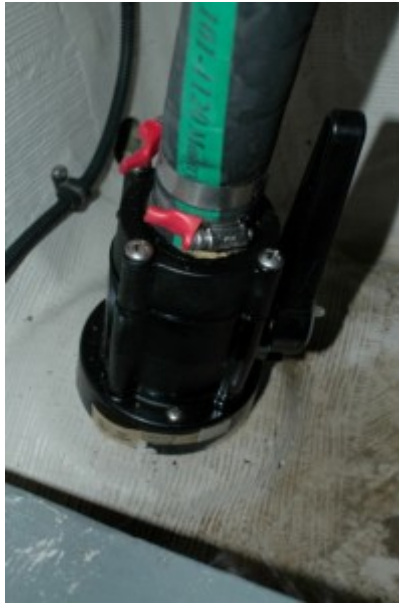
**The stringent requirements for metallic as well as non-metallic seacocks means very few carry UL Marine approval or meet ABYC standards.**

Seacocks are primarily available in two materials, bronze and non-metallic or plastic. There's much more to the story than simply selecting one of the two. Bronze seacocks must be made of the proper alloy, one that contains little or no zinc (bronzes are often referred to as zinc-free copper alloys.) Determining what a seacock is made of can be difficult if not impossible. If, however, it carries a UL Marine Sea Valve symbol or name plate, then you can be certain it's made of the proper alloy. (Beware, a UL Listed valve is not the same as a UL Listed Sea Valve; many valves carry a UL listing, very few are Sea Valves or seacocks.) Brass, on the other hand is, because of its high zinc content, strictly forbidden for use in any raw water application. An exception to this rule being leaded red brass which is used for manufacturing many pipe nipples (straight pipe lengths that are threaded on both ends), it contains, or should contain no more than 15% zinc.

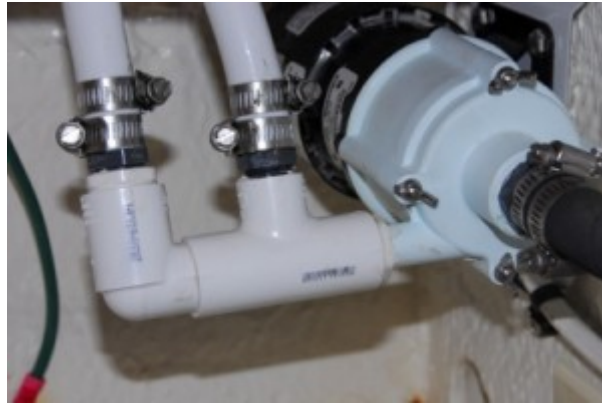
**Conventional PVC plumbing is ill-suited for raw water use and should be avoided in locations where its failure will lead to flooding.**

Plastic or non-metallic seacocks and through hull fittings, on the other hand, should utilize glass reinforced polymers (Forespar's Marelon is one example) for their construction. Like brass, plastics such as PVC and nylon should never be used in any raw water applications, seacocks or otherwise. It's telling that no seacocks made from those materials carry a UL Marine Sea Valve rating. Among other locations, I often see conventional plastics employed in air conditioning system and water makers installations. In those cases, many manufacturers, particularly those making watermakers, utilize PVC and other non-metallic plumbing fittings. If one of their fittings fails and leads to flooding, or worse, you or your insurance company may have a case against that manufacturer. If on the other hand you, your boat builder, or a subcontractor use PVC for installation of a water maker, air conditioning system, seacock or any other raw water component, and it fails, you may be left holding the proverbial bag.

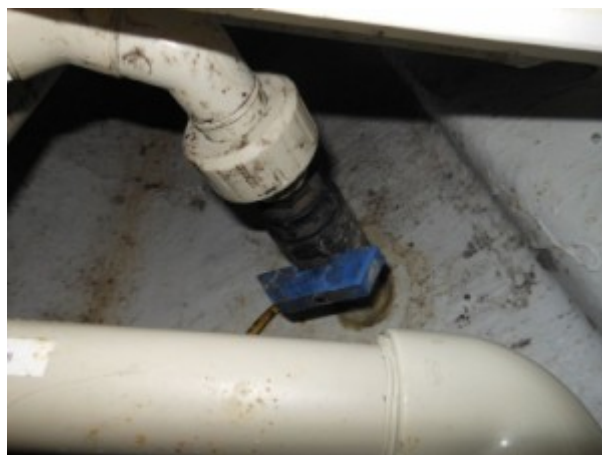
**This “seacock” is in fact a polyethylene irrigation valve, making it inappropriate for use as a sea valve. The rigidly attached PVC plumbing imparts leverage to the installation, further jepordizing its reliability.**

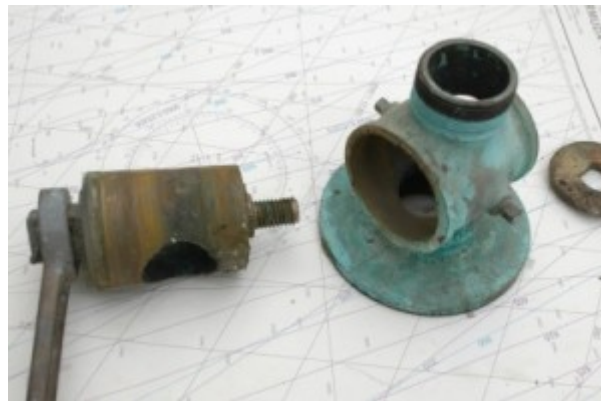
**Traditional cone valves are extremely rugged and capable of being rebuilt over and over again.**

Traditional cone-style seacocks may be disassembled and rebuilt, or at the very least lubricated, over and over again (I've successfully serviced 40-year old units.) Depending on their service environment this may be necessary from every one to five years. They may be taken apart, cleaned with a solvent such as mineral spirits, sanded with emery cloth to remove irregularities, lapped using valve grinding compound, lubricated and then reassembled. Some seacocks may be temporarily fit with grease or zerk fittings, which can be installed in place of the drain plugs. With the seacock in the open position, grease may be pumped into the cone area. Because most zerk fittings are made of mild steel, they should not be left in place after greasing is complete and make

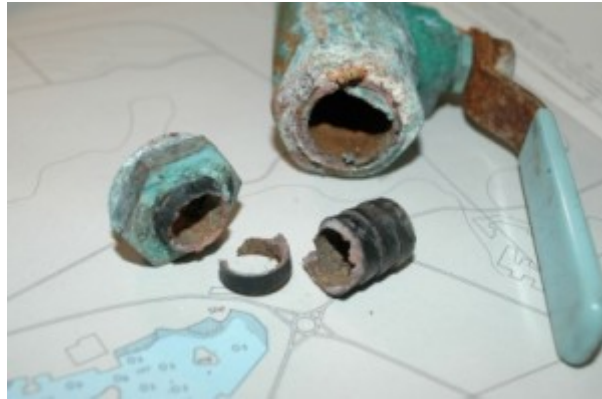
**Don't make the brass mistake. Because of its susceptibility to dezincification, brass should never be used in any raw water plumbing application. True, zinc-free bronze, on the other hand is ideal.**

certain the drain plug is not corroded before it's reinstalled. If the plug must be replaced it, like drain plugs on all raw water equipment such as sea strainers and water pumps, must be made of bronze rather than brass.
