Seacock Selection, Service, and Avoiding the Pitfalls

By Steve D'Antonio

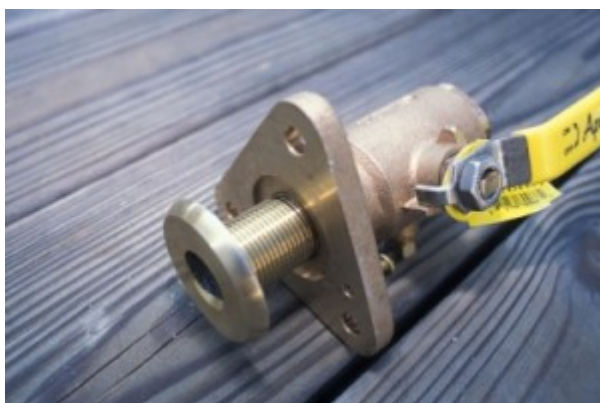
Through hull fittings and proper, flanged seacocks share the same thread type, NPS or straight.

or NPS threads, while in-line ball valves rely on tapered or NPT threads. The two may initially engage, however, it's difficult to obtain more than two or three threads of engagement. Make certain your through hull fittings are attached to purpose made, flanged marine sea valves, all of which utilize properly mating NPS threads.

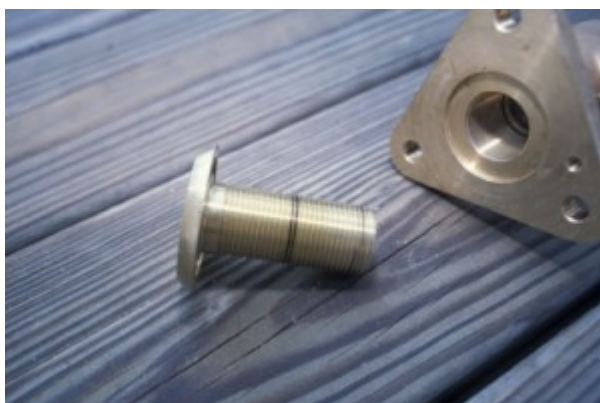
The black line on this through hull fitting indicates the substantial thread engagement this assembly achieves, making it exceptionally strong.

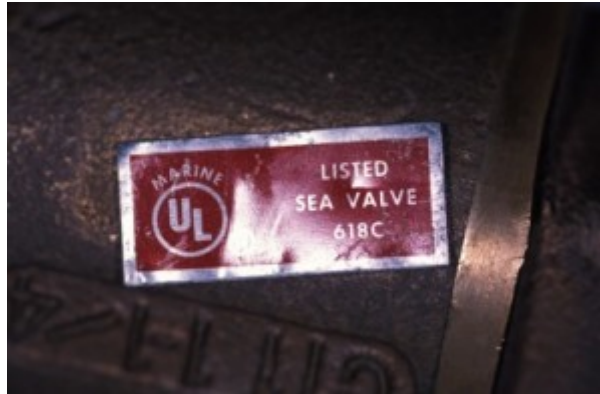
Not all UL Listed valves are UL Listed Marine Sea Valves.

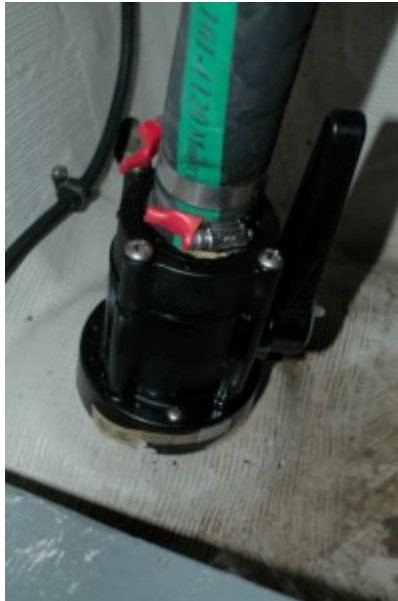
The stringent requirements for metallic as well as non-metallic seacocks means very few carry UL Marine approval or meet ABYC standards.

Seacocks are primarily available in two materials, bronze and non-metallic or plastic. There's much more to the story than simply selecting one of the two. Bronze seacocks must be made of the proper alloy, one that contains little or no zinc (bronzes are often referred to as zinc-free copper alloys.) Determining what a seacock is made of can be difficult if not impossible. If, however, it carries a UL Marine Sea Valve symbol or name plate, then you can be certain it's made of the proper alloy. (Beware, a UL Listed valve is not the same as a UL Listed Sea Valve; many valves carry a UL listing, very few are Sea Valves or seacocks.) Brass, on the other hand is, because of its high zinc content, strictly forbidden for use in any raw water application. An exception to this rule being leaded red brass which is used for manufacturing many pipe nipples (straight pipe lengths that are threaded on both ends), it contains, or should contain no more than 15% zinc.

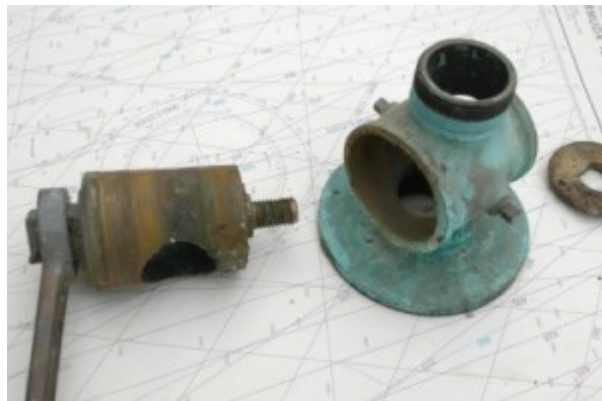
Traditional cone valves are extremely rugged and capable of being rebuilt over and over again.

Traditional cone-style seacocks may be disassembled and rebuilt, or at the very least lubricated, over and over again (I've successfully serviced 40-year old units.) Depending on their service environment this may be necessary from every one to five years. They may be taken apart, cleaned with a solvent such as mineral spirits, sanded with emery cloth to remove irregularities, lapped using valve grinding compound, lubricated and then reassembled. Some seacocks may be temporarily fit with grease or zerk fittings, which can be installed in place of the drain plugs. With the seacock in the open position, grease may be pumped into the cone area. Because most zerk fittings are made of mild steel, they should not be left in place after greasing is complete and make

certain the drain plug is not corroded before it's reinstalled. If the plug must be replaced it, like drain plugs on all raw water equipment such as sea strainers and water pumps, must be made of bronze rather than brass.
