# Seacock Selection, Service, and Avoiding the Pitfalls

By Steve D'Antonio

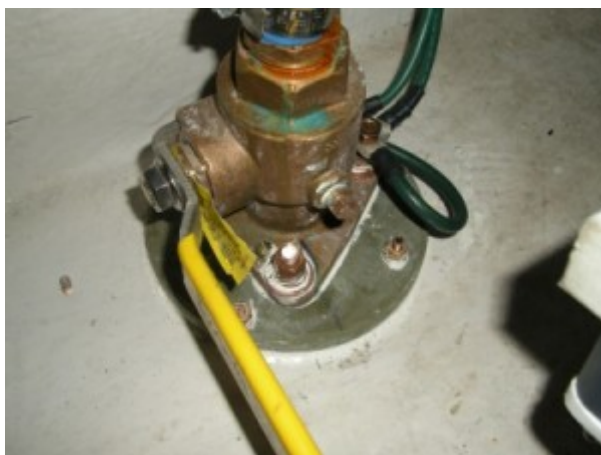
**Proper seacock installations, like the one shown here, are robust and reliable. Many, on the other hand, fail to make the grade.**

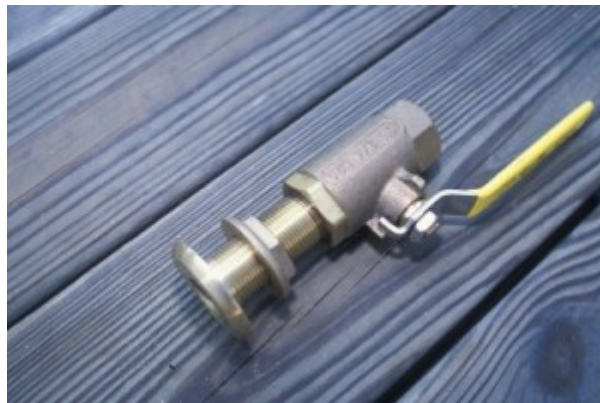
This arrangement, a ball valve mated to a through hull fitting often passes for a seacock, however, it's anything but.

A reliable, robust seacock installation begins with selecting the right components. Far too often, what passes for a seacock is in fact a mismatched collection of plumbing components. The most common hardware faux pas, mentioned in the previous paragraph, involves the mating of a through hull fitting, the mushroom-shaped male-threaded component, with an in-line ball valve. Make no mistake about it, regardless of the quality of the construction, these components were never designed by their respective manufacturers to be mated to each other for one exceedingly simple reason, the threads are entirely incompatible. Through hull fittings utilize straight

or NPS threads, while in-line ball valves rely on tapered or NPT threads. The two may initially engage, however, it's difficult to obtain more than two or three threads of engagement. Make certain your through hull fittings are attached to purpose made, flanged marine sea valves, all of which utilize properly mating NPS threads.

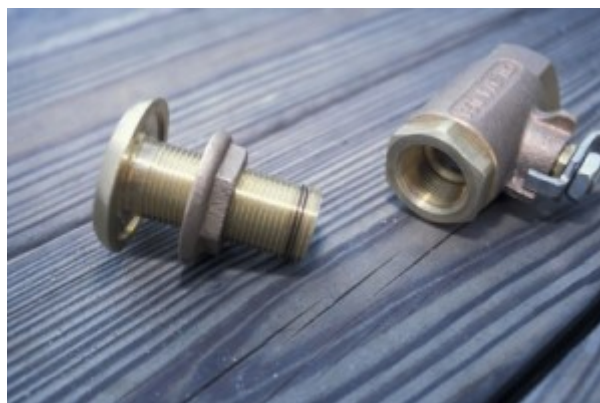
The primary reason for this assembly's failure to meet seacock

**standards is very simple, the threads are incompatible. The black line indicates the woefully inadequate engagement.**

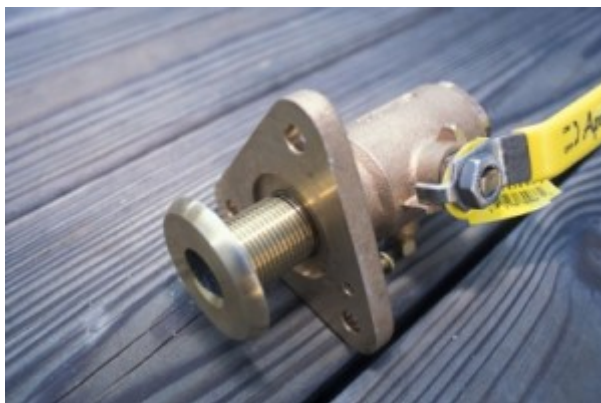
**Through hull fittings and proper, flanged seacocks share the same thread type, NPS or straight.**

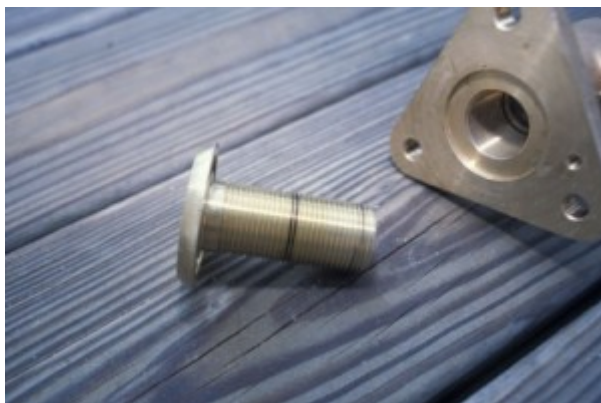
**The black line on this through hull fitting indicates the substantial thread engagement this assembly achieves, making it exceptionally strong.**

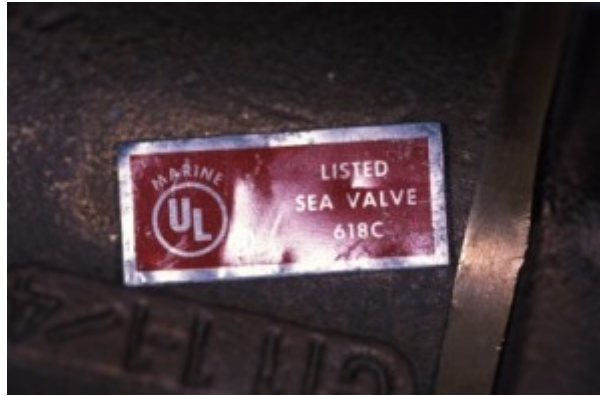
**Not all UL Listed valves are UL Listed Marine Sea Valves.**

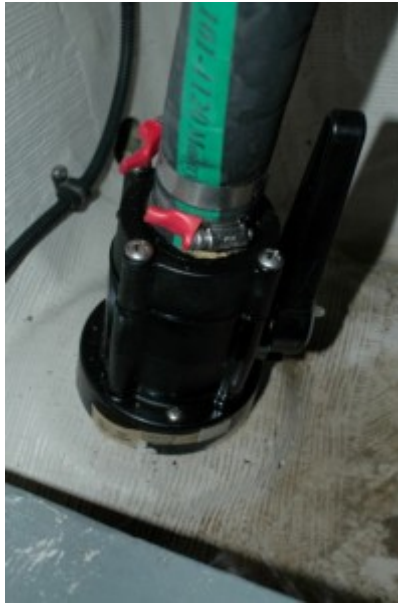
**The stringent requirements for metallic as well as non-metallic seacocks means very few carry UL Marine approval or meet ABYC standards.**

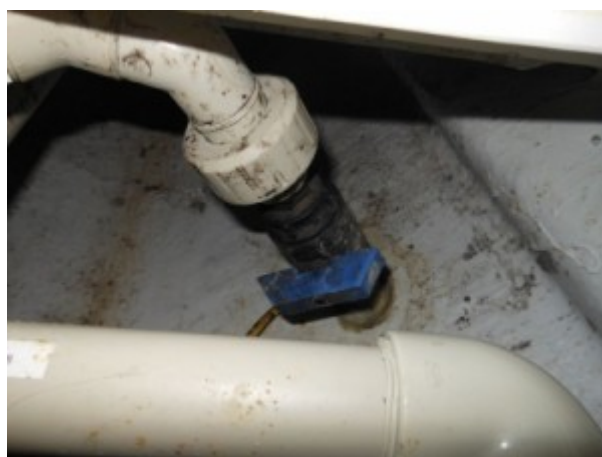
**This “seacock” is in fact a polyethylene irrigation valve, making it inappropriate for use as a sea valve. The rigidly attached PVC plumbing imparts leverage to the installation, further jepordizing its reliability.**

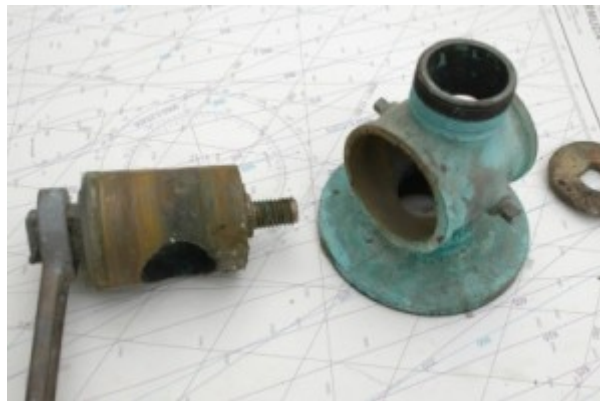
**Traditional cone valves are extremely rugged and capable of being rebuilt over and over again.**

Traditional cone-style seacocks may be disassembled and rebuilt, or at the very least lubricated, over and over again (I've successfully serviced 40-year old units.) Depending on their service environment this may be necessary from every one to five years. They may be taken apart, cleaned with a solvent such as mineral spirits, sanded with emery cloth to remove irregularities, lapped using valve grinding compound, lubricated and then reassembled. Some seacocks may be temporarily fit with grease or zerk fittings, which can be installed in place of the drain plugs. With the seacock in the open position, grease may be pumped into the cone area. Because most zerk fittings are made of mild steel, they should not be left in place after greasing is complete and make

certain the drain plug is not corroded before it's reinstalled. If the plug must be replaced it, like drain plugs on all raw water equipment such as sea strainers and water pumps, must be made of bronze rather than brass.

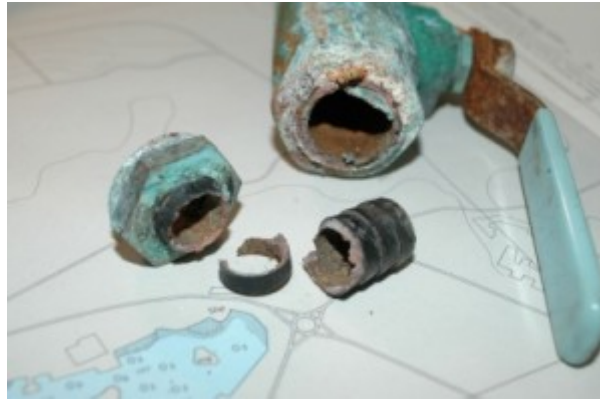
**Don't make the brass mistake. Because of its susceptibility to dezincification, brass should never be used in any raw water plumbing application. True, zinc-free bronze, on the other hand is ideal.**
