## September 2019 Newsletter

### Photo Essay: Hydraulic Steering Relief Valve

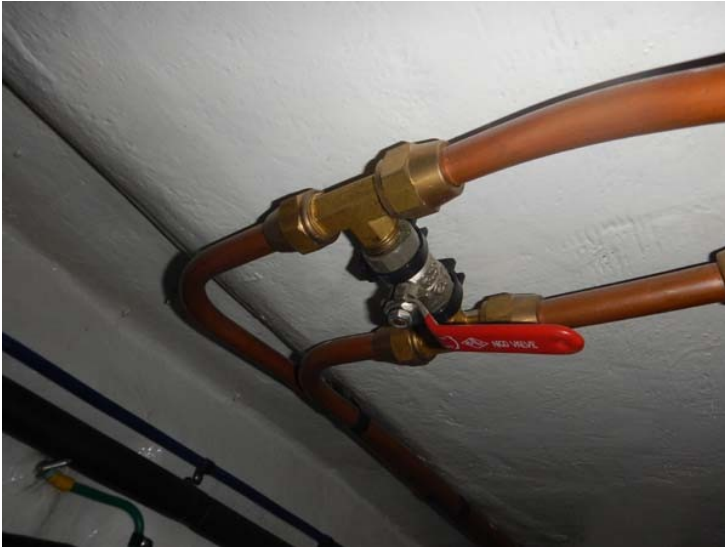
The preferred alternative involves the installation of a relief valve. This could be thought of as a bypass for the steering system's check valves. When it's opened the piston can be pushed by the emergency tiller, making it possible to steer manually, along with retaining the cylinder's attributes as a damper and rudder stop. The valve shown here will allow the user to do just that, however, it has two flaws. One, it's not labeled, and two, its nickel-plated brass body is rated for just 600 psi, most manual steering systems have a relief pressure of 1,000 psi and some 1,500 psi. Make sure your hydraulic steering system has a relief valve, one that's clearly marked and rated for the application pressure.

One area where they can present a challenge, however, is if it becomes necessary to revert to manual steering, using a manual tiller. If the hydraulic cylinder remains charged with fluid, it is impossible to move the piston using a manual tiller (it is for this reason they hydraulic steering systems have no 'feed back' or pressure on the wheel transmitted from the rudder). Without proper planning the alternatives are not very attractive, and neither are they quick. You could remove the hydraulic lines from the cylinder, which would spill hydraulic fluid. Or, you could separate the piston from the rudder tiller arm, a process that is time consuming, and could be dangerous in a seaway; and, if the piston is also the rudder stop, as many are, the rudder could swing wildly into the prop or jam against the hull.
