Stainless Steel – Miracle Metal?

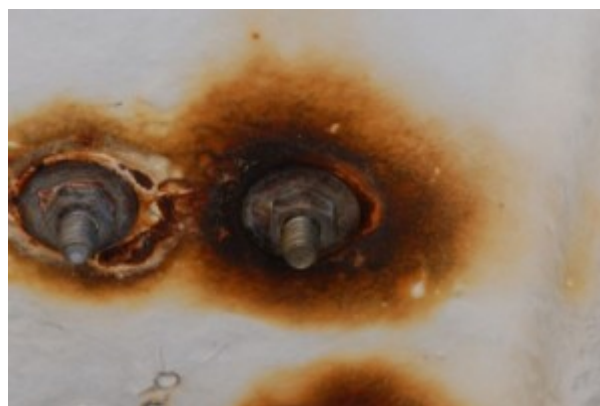
Some grades of stainless steel are more corrosion

resistant than others. These fasteners are likely 304 series and as such are staining, a clear indication that crevice corrosion is occurring

By far, the most common variety of, "marine grade" stainless steel is 304 or 18-8. As one might expect, this is a function of expense. Because of the alloying element content, 304 is less expensive to manufacture than 316. Nearly all commonly available stainless fasteners, from the smallest tapping screw to large nuts and bolts, are manufactured from 304 alloys. Fasteners, machine screws, nuts and bolts manufactured from 316 alloy stainless steel are available; however, they must nearly always be special ordered, which, once again, is a reflection of their expense.

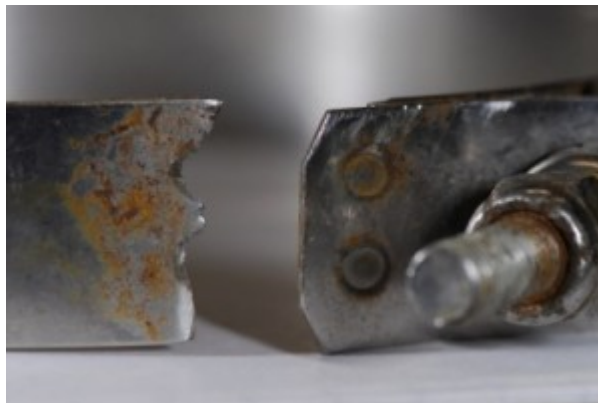
Stainless T-Bolt hose clamps are usually very strong, however, the folded design traps water, creating an ideal environment for crevice corrosion.

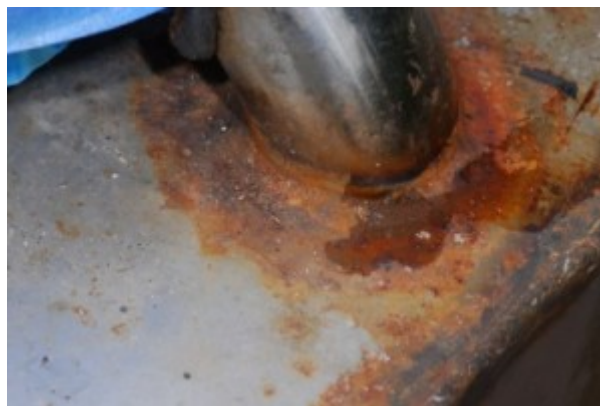
The use of the incorrect stainless alloy, it wasn't "L" or low carbon, precipitated an early end for this tank.

There exists yet another designation where marine grade stainless alloys are concerned and it involves their carbon content. Stainless alloys that are to be welded for rails, brackets, water and fuel tanks, port light frames, swim platform supports or anything else, must utilize only low carbon alloy stainless steel, which is identified with an "L" suffix, such as 304L and 316L. The reason for this requirement is a peculiarity of stainless steel known as carbide precipitation or weld decay. When stainless or any metal is welded, it's heated to high temperatures. This high temperature can cause a migration of chromium away from the weld area, leaving behind a zone adjacent to the weld of what ultimately behaves like ordinary carbon steel, i.e. it rusts. Weld migration that is a result of fabrication using the incorrect grade of or non-low carbon stainless steel sometimes becomes evident early on in the life of the part by a clearly defined, discolored or darkened "path" that encompasses the weld. Depending upon its exposure to moisture and whether that moisture is fresh or seawater-based, the area adjacent, usually about an eighth of an inch on either side of the weld may begin to show signs of corrosion or discoloration within months or even weeks.

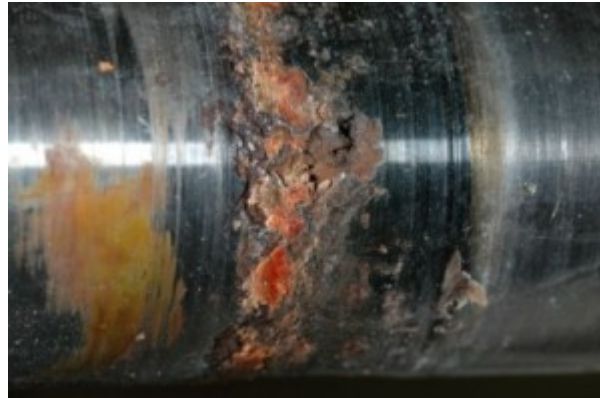
Less corrosion resistant stainless shaft alloys often suffer from crevice corrosion, especially in the oxygen deprived stuffing box region, shaft log and under cutless bearings, all areas that aren't readily visible.

Propeller shafts fall into a special category. Because they require both exceptional strength and corrosion resistance, propeller shafts are *typically* fabricated from a proprietary stainless alloy that includes a host of other trace elements. These mixtures yield the ideal combination for the environment in which shafts operate. Trade names such as Aquamet, Aquatech and Aqualoy among others are available in several strength and corrosion resistance grades. The most corrosion resistant of which, and therefore the most desirable for recreational applications where use and oxygen exposure is limited, is designated as 22. Shafts made of this alloy and grade are as close as a boat builder can get to corrosion-proof where steel-based alloys are concerned. Shafts manufactured from ordinary stainless steel, on the other hand, even 316 alloy, frequently suffer from crevice corrosion attacks, occasionally within less than a year of being placed in service beneath cutless bearings and stuffing box packing,

once again, where the damage cannot be easily observed. In order to avoid corrosion and failures, use stainless steel where it works best and specify the right alloy for the job.
