Stainless Steel – Miracle Metal?

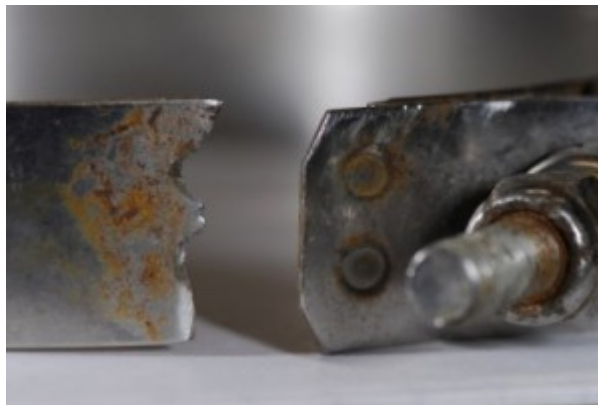
Stainless T-Bolt hose clamps are usually very strong, however, the folded design traps water, creating an ideal environment for crevice corrosion.
