# Stainless Steel – Miracle Metal?

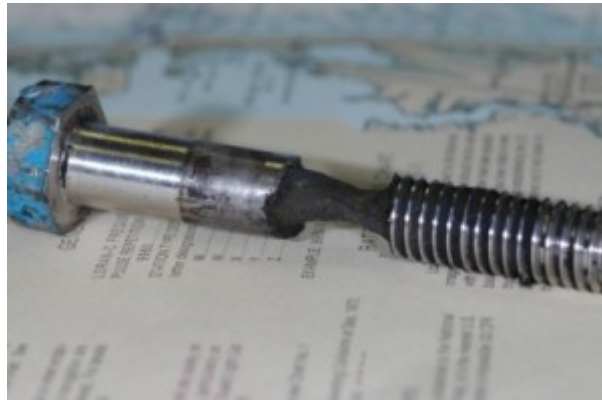
**This “wasp-waisted” strut bolt represents a classic example of crevice corrosion**

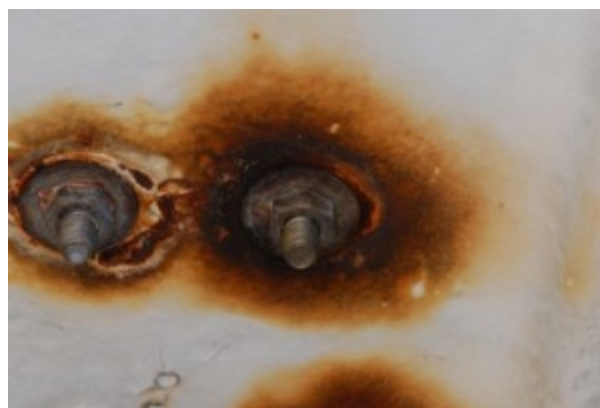
**Some grades of stainless steel are more corrosion**

**resistant than others. These fasteners are likely 304 series and as such are staining, a clear indication that crevice corrosion is occurring**

By far, the most common variety of, "marine grade" stainless steel is 304 or 18-8. As one might expect, this is a function of expense. Because of the alloying element content, 304 is less expensive to manufacture than 316. Nearly all commonly available stainless fasteners, from the smallest tapping screw to large nuts and bolts, are manufactured from 304 alloys. Fasteners, machine screws, nuts and bolts manufactured from 316 alloy stainless steel are available; however, they must nearly always be special ordered, which, once again, is a reflection of their expense.

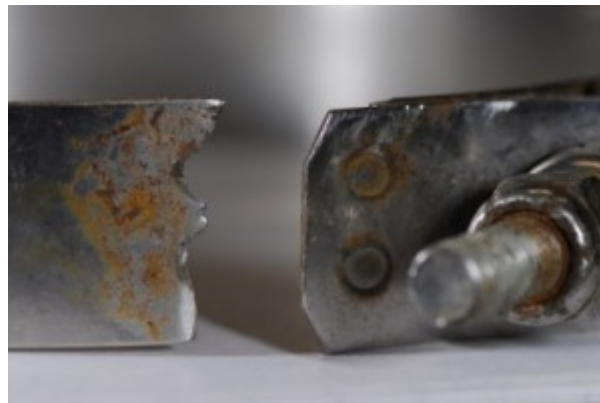
**StainlessT-Bolt hose clamps are usually very strong, however, the folded design traps water, creating an ideal environment for crevice corrosion.**

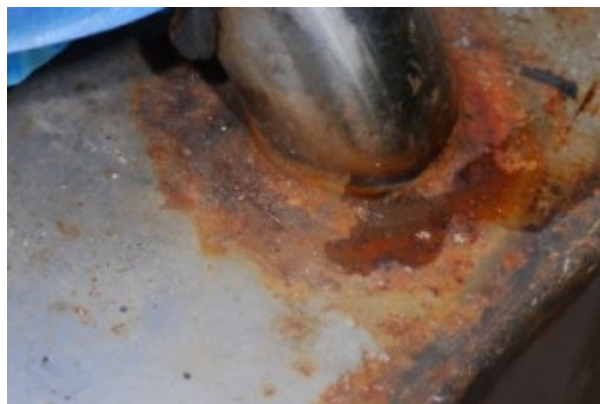
**The use of the incorrect stainless alloy, it wasn't "L" or low carbon, precipitated an early end for this tank.**

There exists yet another designation where marine grade stainless alloys are concerned and it involves their carbon content. Stainless alloys that are to be welded for rails, brackets, water and fuel tanks, port light frames, swim platform supports or anything else, must utilize only low carbon alloy stainless steel, which is identified with an "L" suffix, such as 304L and 316L. The reason for this requirement is a peculiarity of stainless steel known as carbide precipitation or weld decay. When stainless or any metal is welded, it's heated to high temperatures. This high temperature can cause a migration of chromium away from the weld area, leaving behind a zone adjacent to the weld of what ultimately behaves like ordinary carbon steel, i.e. it rusts. Weld migration that is a result of fabrication using the incorrect grade of or non-low carbon stainless steel sometimes becomes evident early on in the life of the part by a clearly defined, discolored or darkened "path" that encompasses the weld. Depending upon its exposure to moisture and whether that moisture is fresh or seawater-based, the area adjacent, usually about an eighth of an inch on either side of the weld may begin to show signs of corrosion or discoloration within months or even weeks.

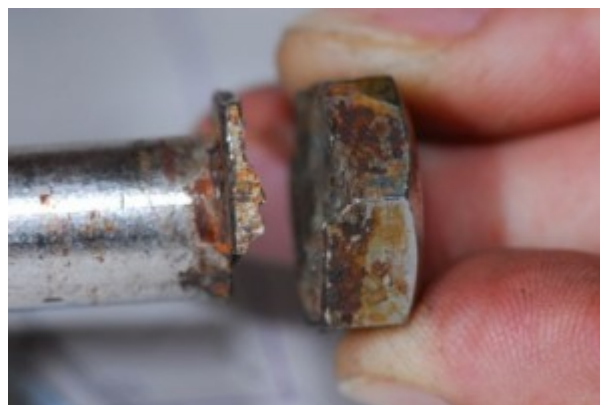
**There wasn't much strength left in this corroded bolt head.  
Corrosion gains a foot hold in micro-cracks or crevices that  
form in highly stressed components**

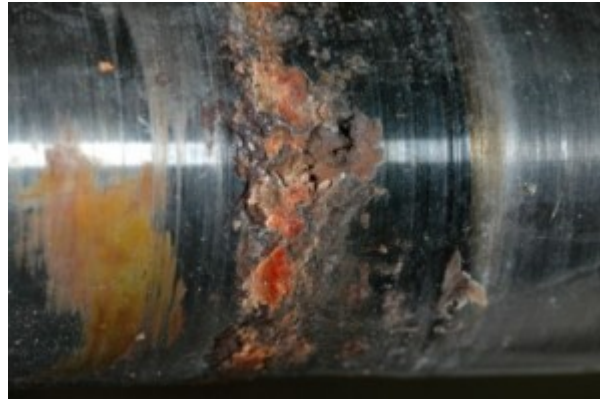
**Less corrosion resistant stainless shaft alloys often suffer from crevice corrosion, especially in the oxygen deprived stuffing box region, shaft log and under cutless bearings, all areas that aren't readily visible.**

Propeller shafts fall into a special category. Because they require both exceptional strength and corrosion resistance, propeller shafts are *typically* fabricated from a proprietary stainless alloy that includes a host of other trace elements. These mixtures yield the ideal combination for the environment in which shafts operate. Trade names such as Aquamet, Aquatech and Aqualoy among others are available in several strength and corrosion resistance grades. The most corrosion resistant of which, and therefore the most desirable for recreational applications where use and oxygen exposure is limited, is designated as 22. Shafts made of this alloy and grade are as close as a boat builder can get to corrosion-proof where steel-based alloys are concerned. Shafts manufactured from ordinary stainless steel, on the other hand, even 316 alloy, frequently suffer from crevice corrosion attacks, occasionally within less than a year of being placed in service beneath cutless bearings and stuffing box packing,

once again, where the damage cannot be easily observed. In order to avoid corrosion and failures, use stainless steel where it works best and specify the right alloy for the job.

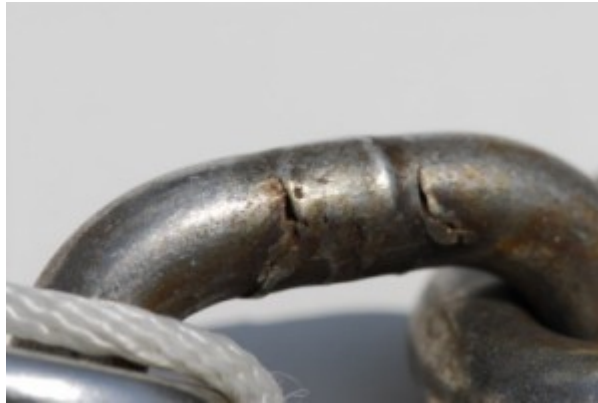
**One would think that stainless steel anchor chain would be the Cadillac of ground tackle. However, just like many other stainless steel alloys it can fall prey to corrosion under the right circumstances.**
