Troubleshooting Overheating Scenarios – Editorial: Blisters and Drying Bottoms

Troubleshooting Overheating Scenarios

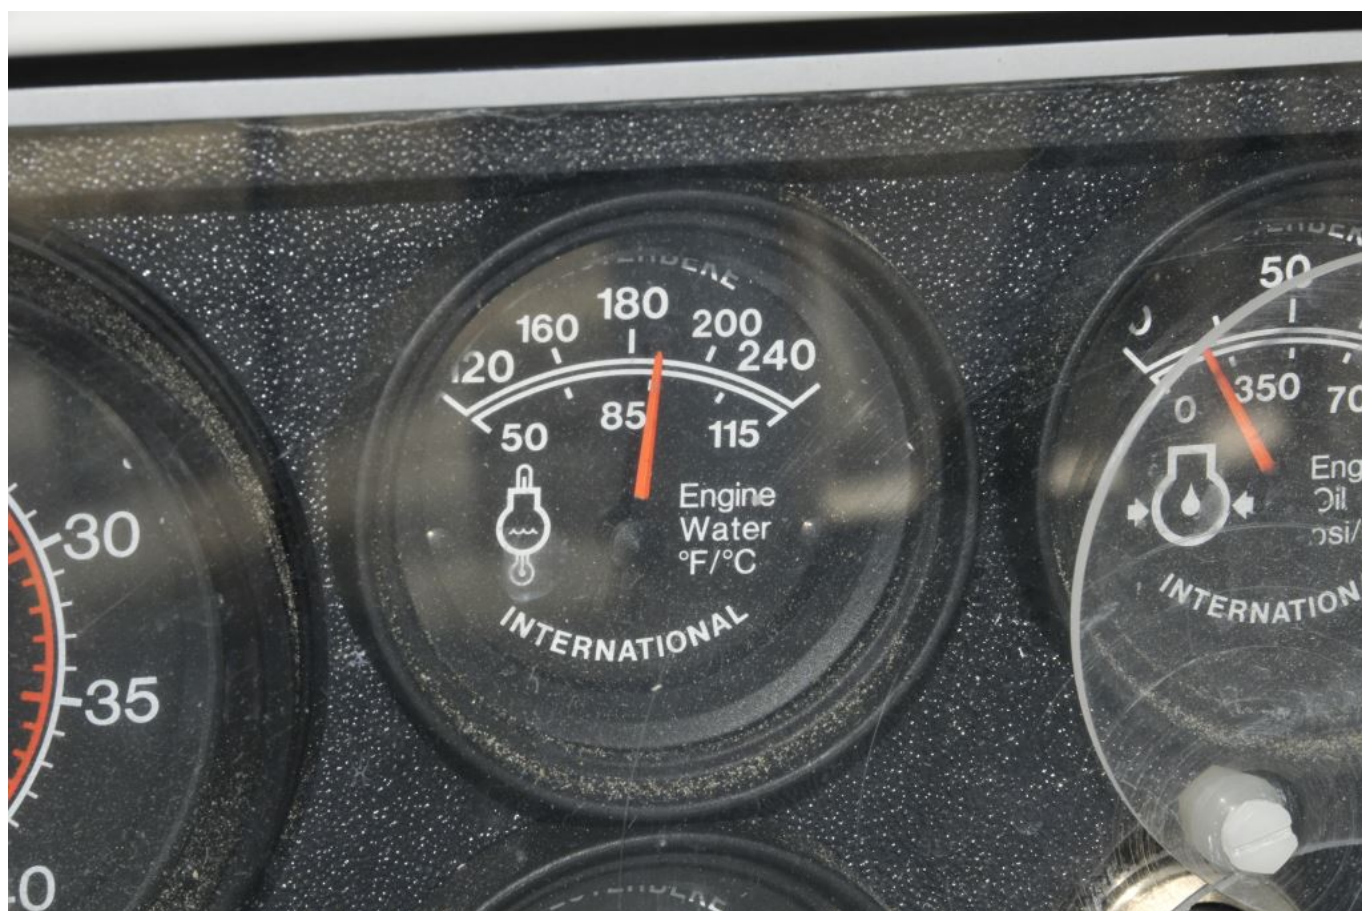
Pay close attention to your engine's temperature gauge, if it runs higher than usual, even if not overheating, it's an early indication of a problem.

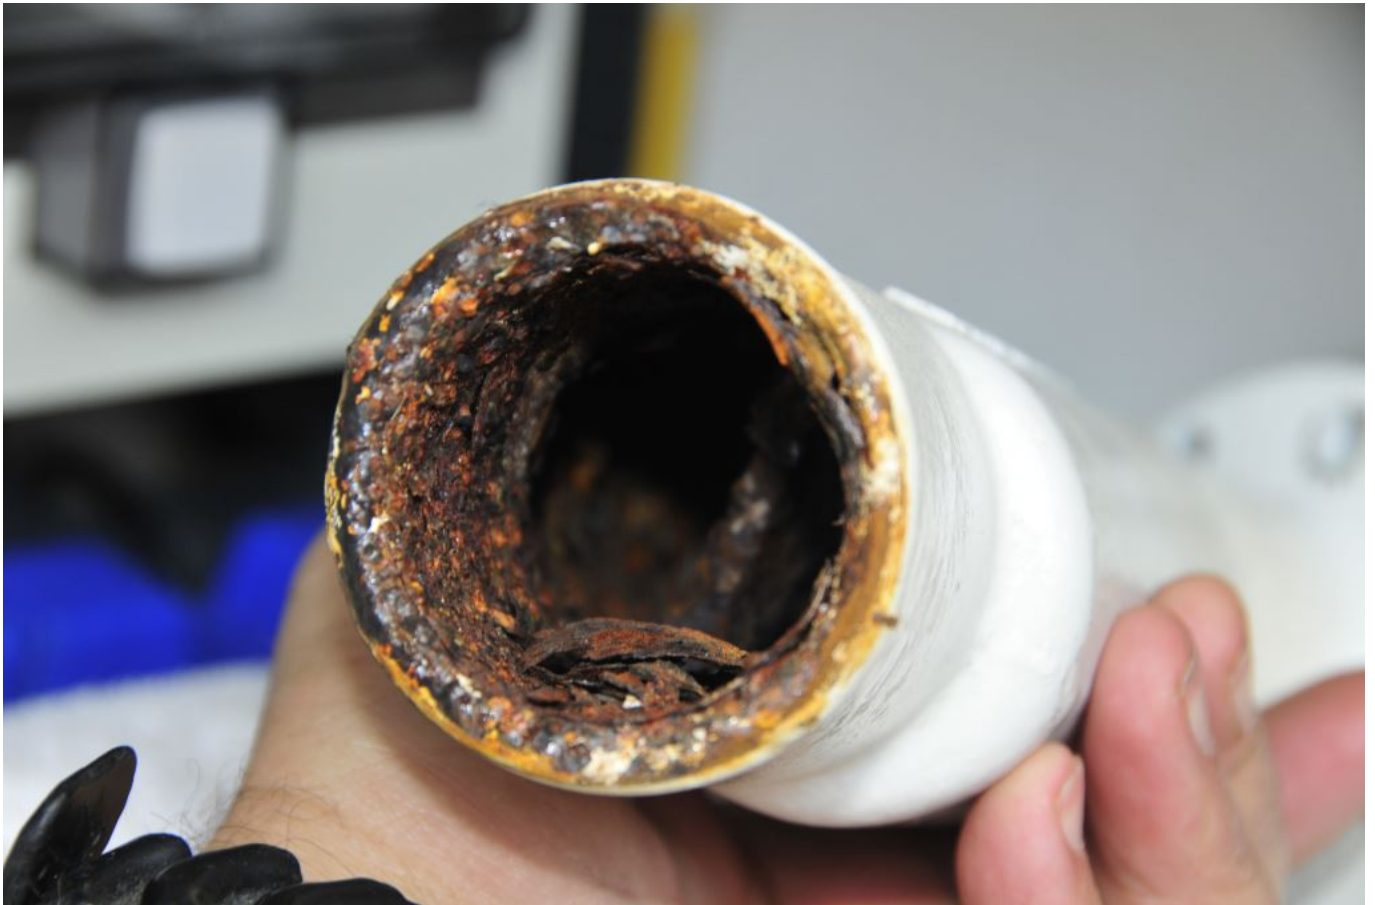
Exhaust elbows, especially those made of cast iron, are prone to scaling, which impedes water flow, which in turn leads to overheating.

Next, check the injected elbow. These are notorious for

becoming clogged with corrosion, acting like a bottle neck, a restriction slows down water flow through the entire raw water-cooling system. One test you can perform to determine of this is the culprit involves temperature differential; what is the difference between the temperature of the water entering the engine, i.e., seawater temperature, and that leaving the engine at the exhaust outlet? It comes as a surprise to many that the delta should not exceed about 20° Fahrenheit (11C). If it's greater, there's a possibility you are dealing with a restriction in the exhaust elbow, or water supply to the elbow. More on wet exhaust systems here.

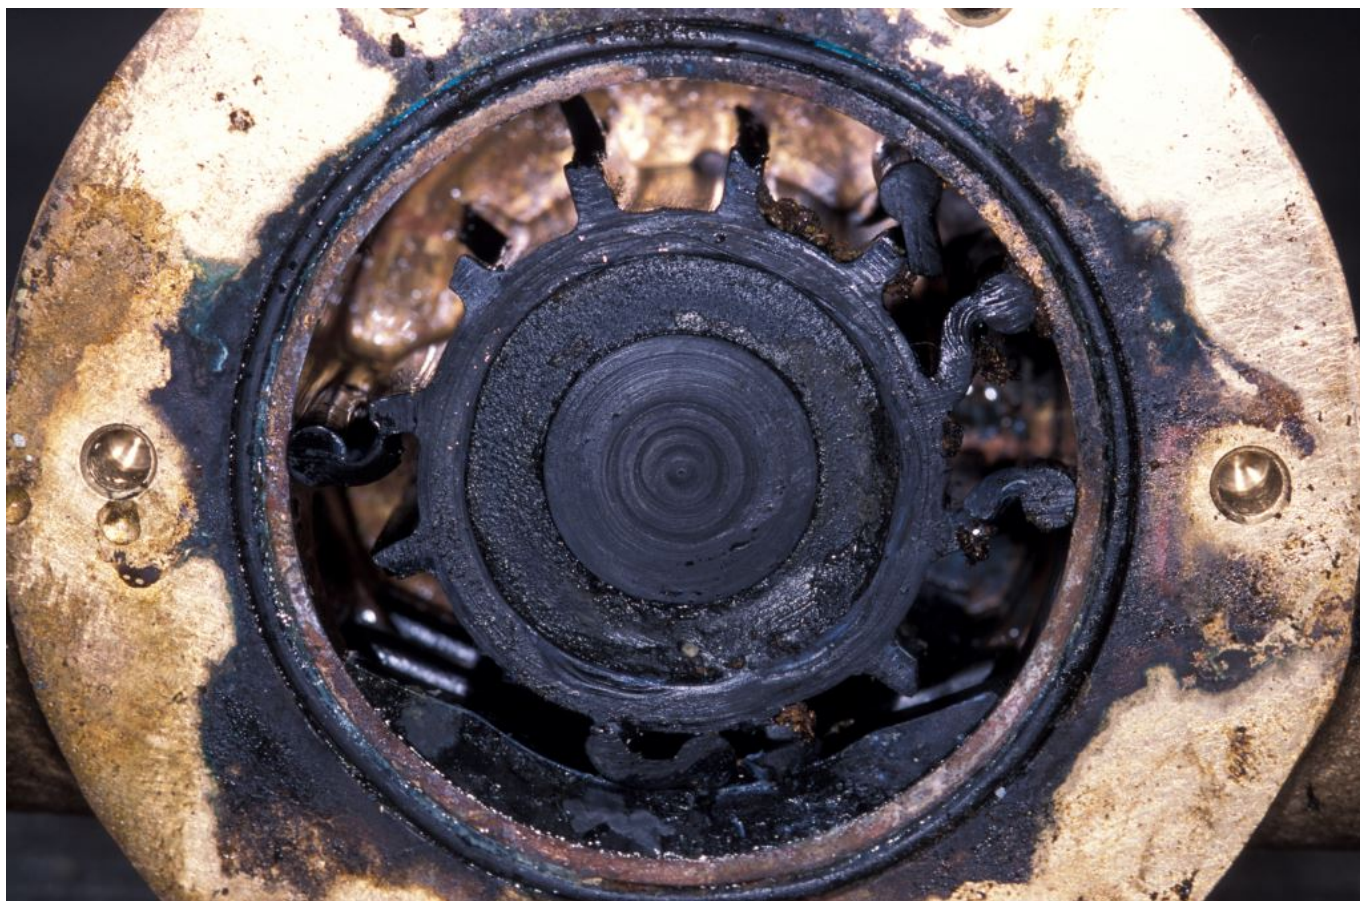
Impellers should be replaced annually, doing so virtually eliminates the possibility of a failure. If your impeller should come to grief, make certain you retrieve the pieces it has shed.

Check the raw water pump by removing the impeller cover (be ready with a replacement O ring or gasket), is the impeller intact, with no cracks or missing blades, and does it turn when the engine is cranked (without actually starting if you can help it)? If belt driven, make sure the belt is not slipping. Is the inside of the cover plate smooth? If it is grooved or scored, it must be replaced. Is the cam, the part that actually compresses the impeller blades, effecting the pumping action, worn? You may not be able to tell unless you can compare it to a new one side by side.

If the impeller is damaged torn or missing blades, clearly it needs to be replaced. If parts are missing, you'll need to go in search of them. Fortunately, in most cases these become

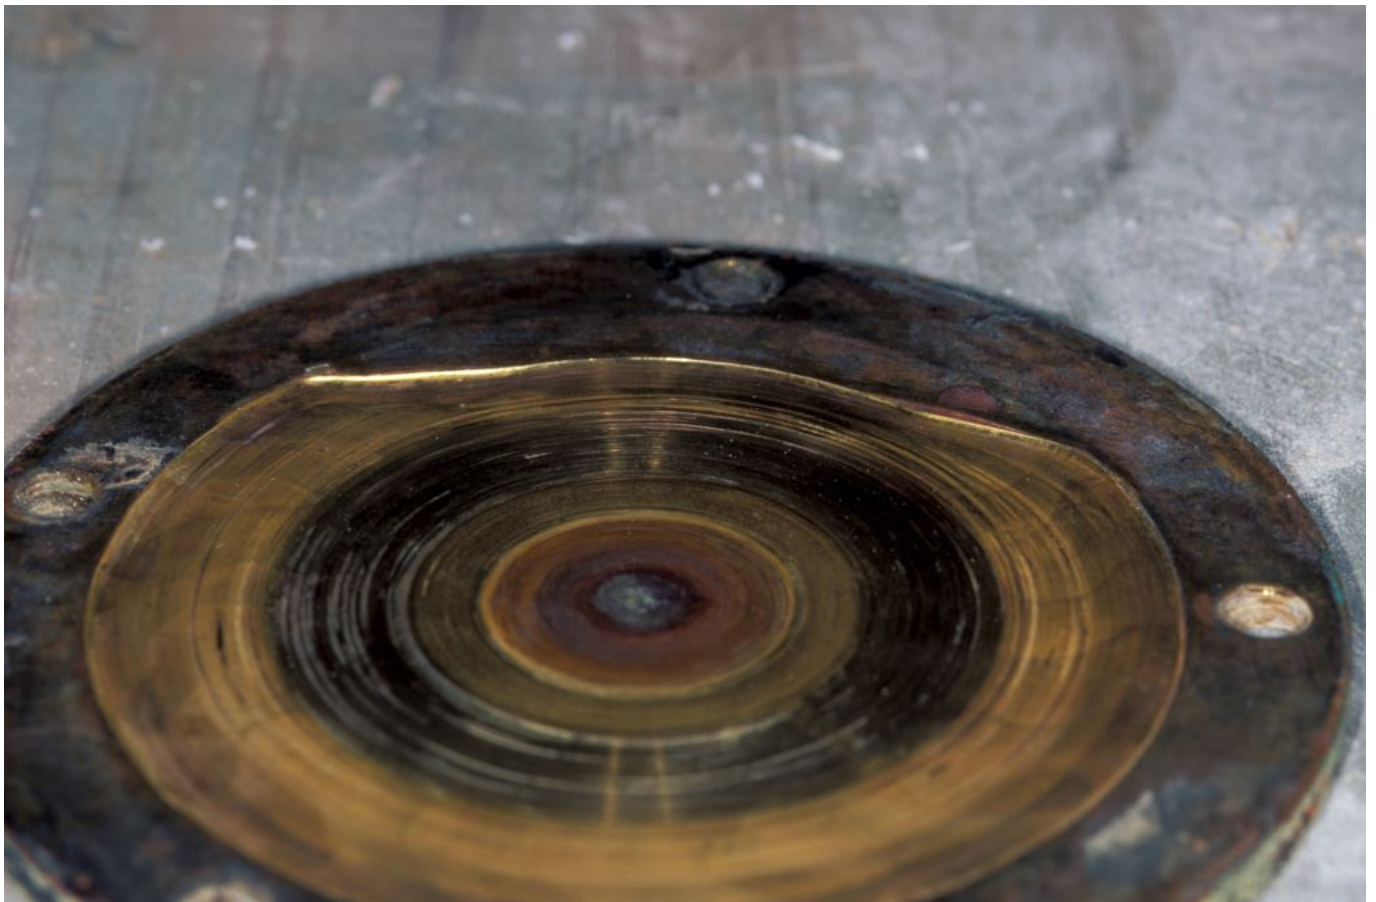
If you can feel a ridge in your water pump's cover plate, it's time for it to be replaced.

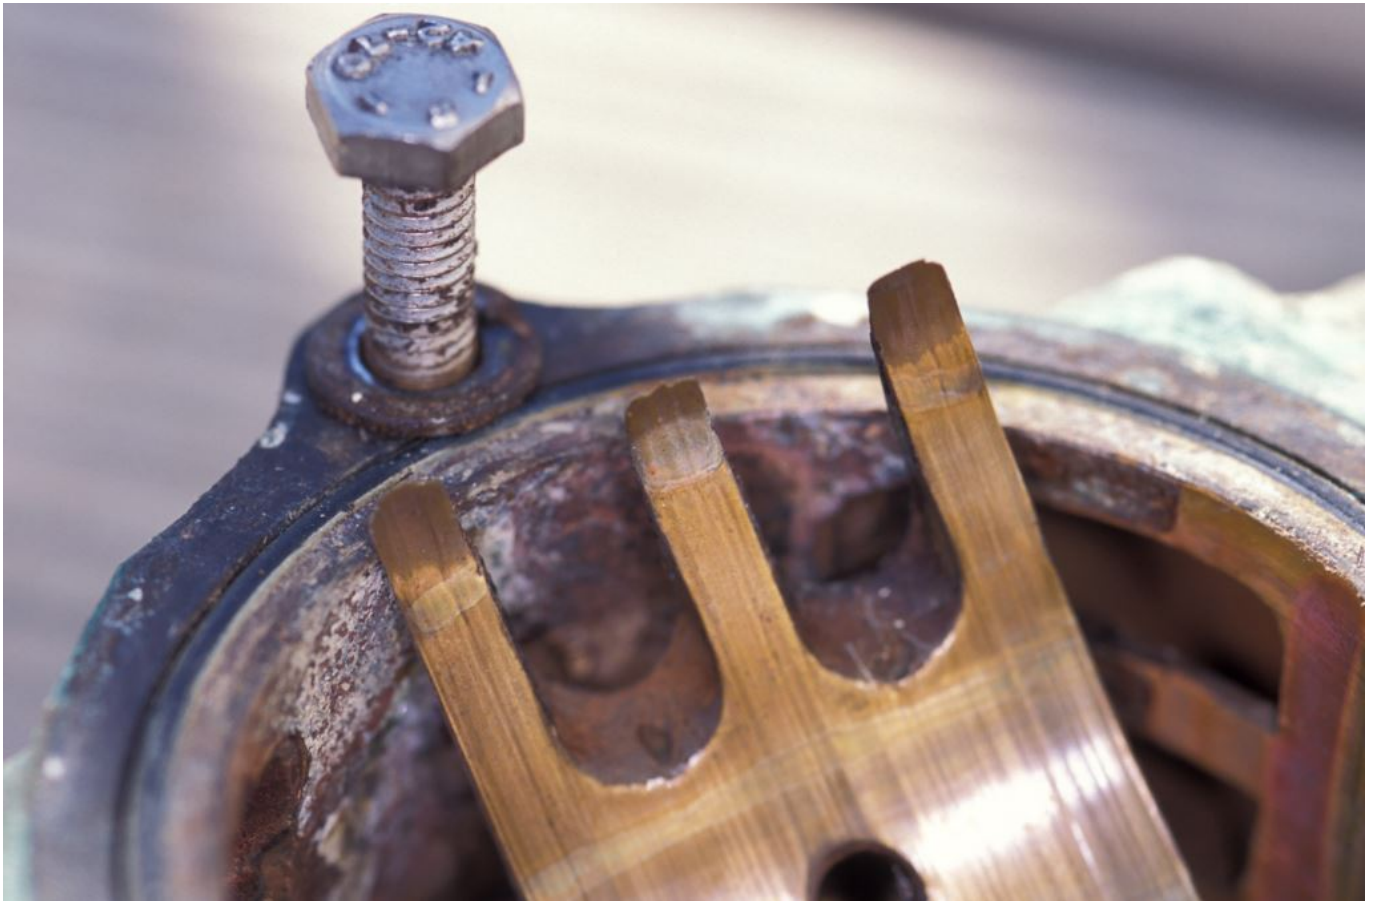
It's often difficult to gauge wear on water pump parts until they are compared to new components.

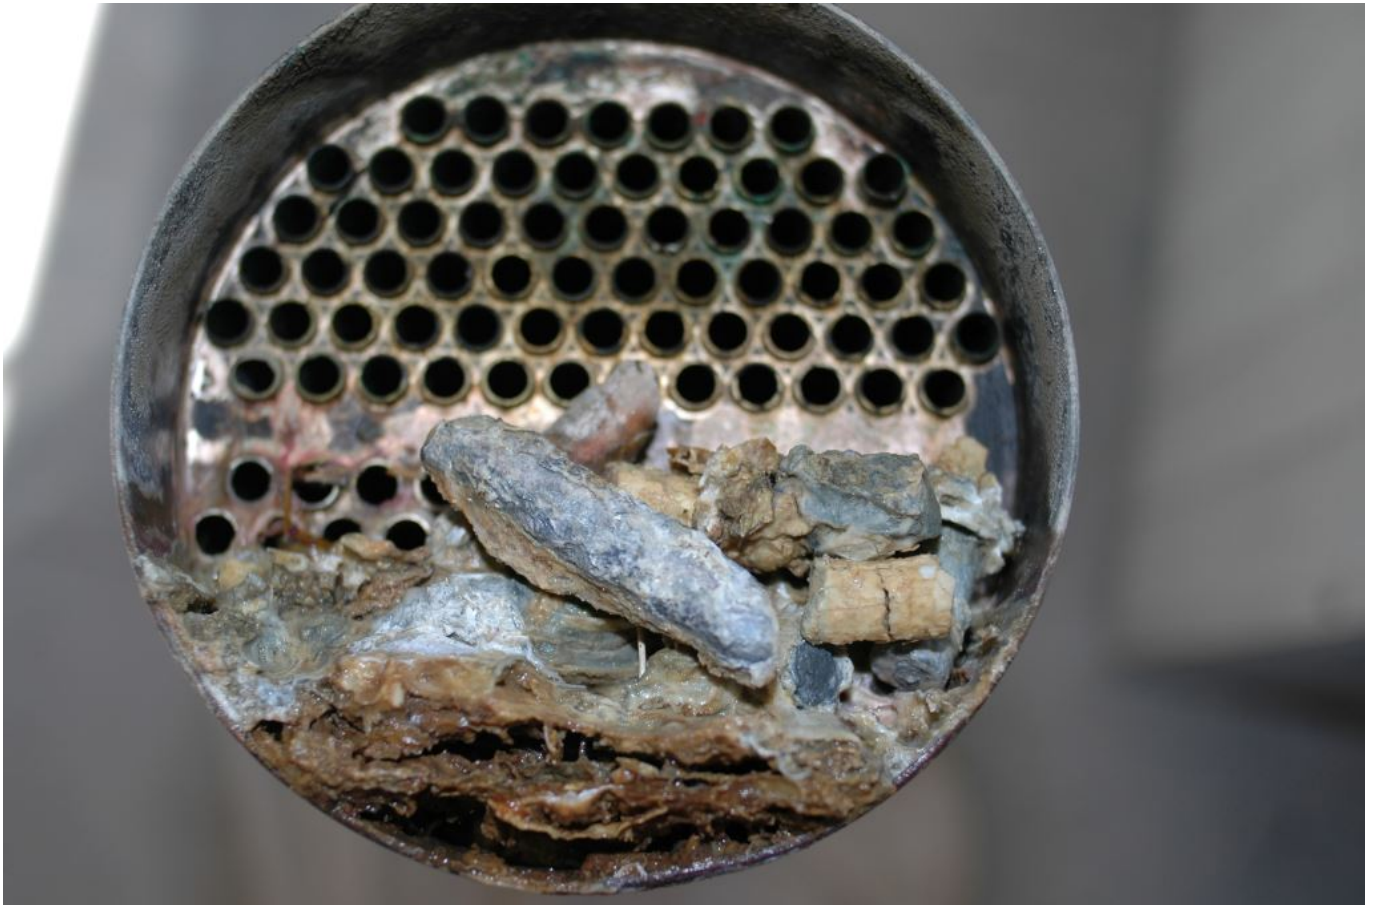
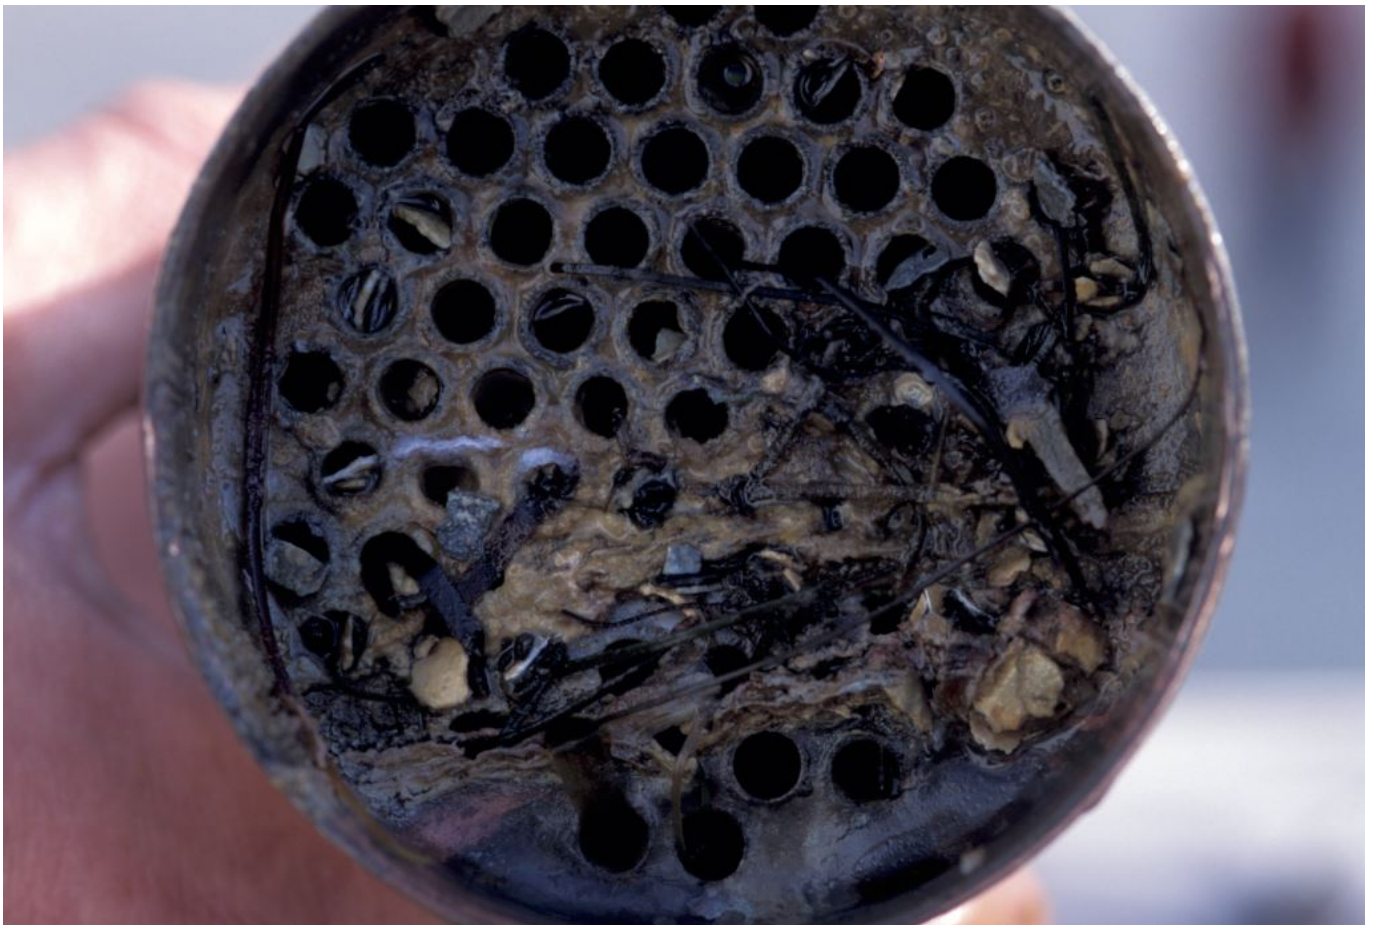
Heat exchangers should be inspected for debris accumulation

**about every two years, even if overheating isn't an issue;
it's not unusual to find depleted anodes.**

Next, remove the end caps of the heat exchanger, and check for debris, depleted pencil anodes, as well as clogged or scaled tubes (the thinnest scale accumulation can have a dramatic effect on the ability of the heat exchanger to transfer heat). If scaled the heat exchanger will require flushing with a descaling solution.

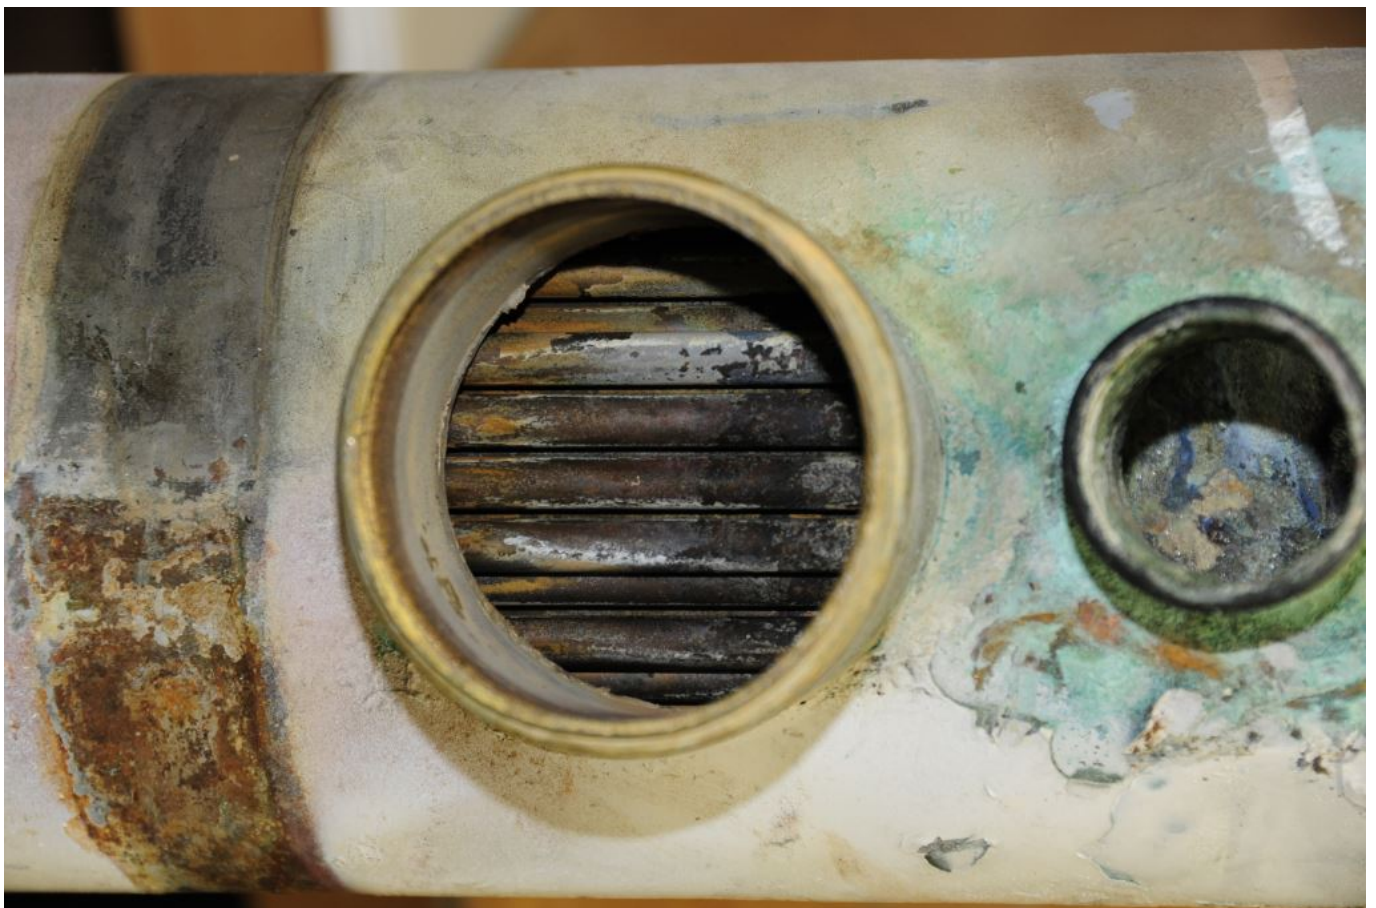
**In the event of an overheat, it's possible for an undetectable
film to develop on the coolant side of the heat exchanger,
which in turn will lead to poor heat transfer and overheating.**

Finally, if your engine does suffer a serious overheat, it's a good idea to replace the coolant and flush/descale the closed (coolant) side of the cooling system. Overheating can permanently degrade the coolant, while leaving an insulating film on the coolant side of the heat exchanger's tubes.

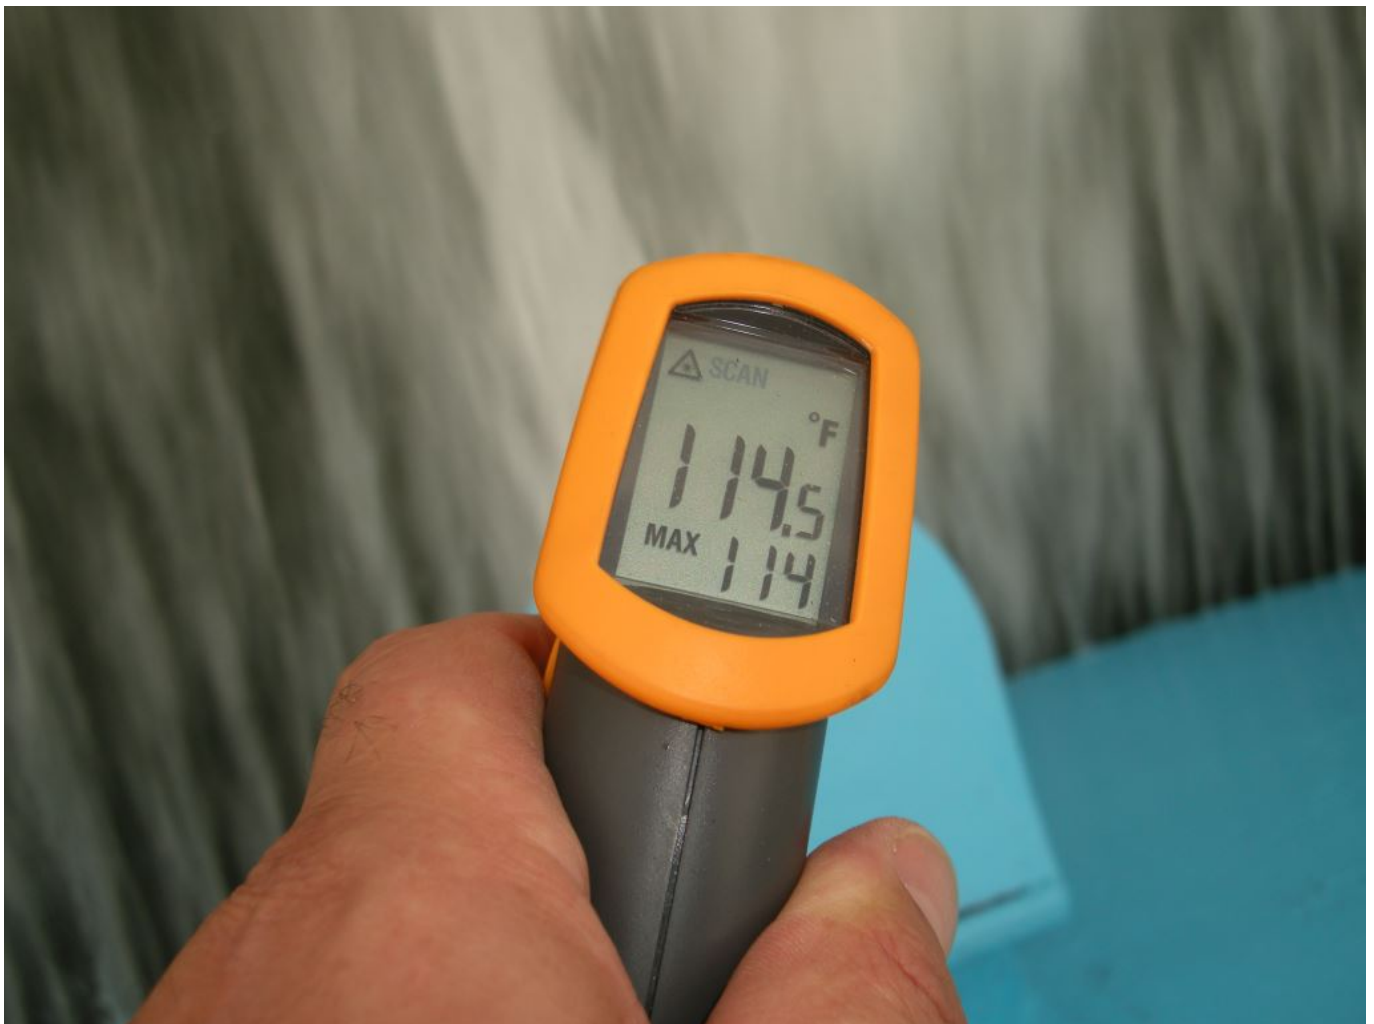
There should be no more than about a 20° Fahrenheit (11°C) differential between the temperature of water entering, and the temperature of water leaving your engine. More than that is an indication of cooling system problems.

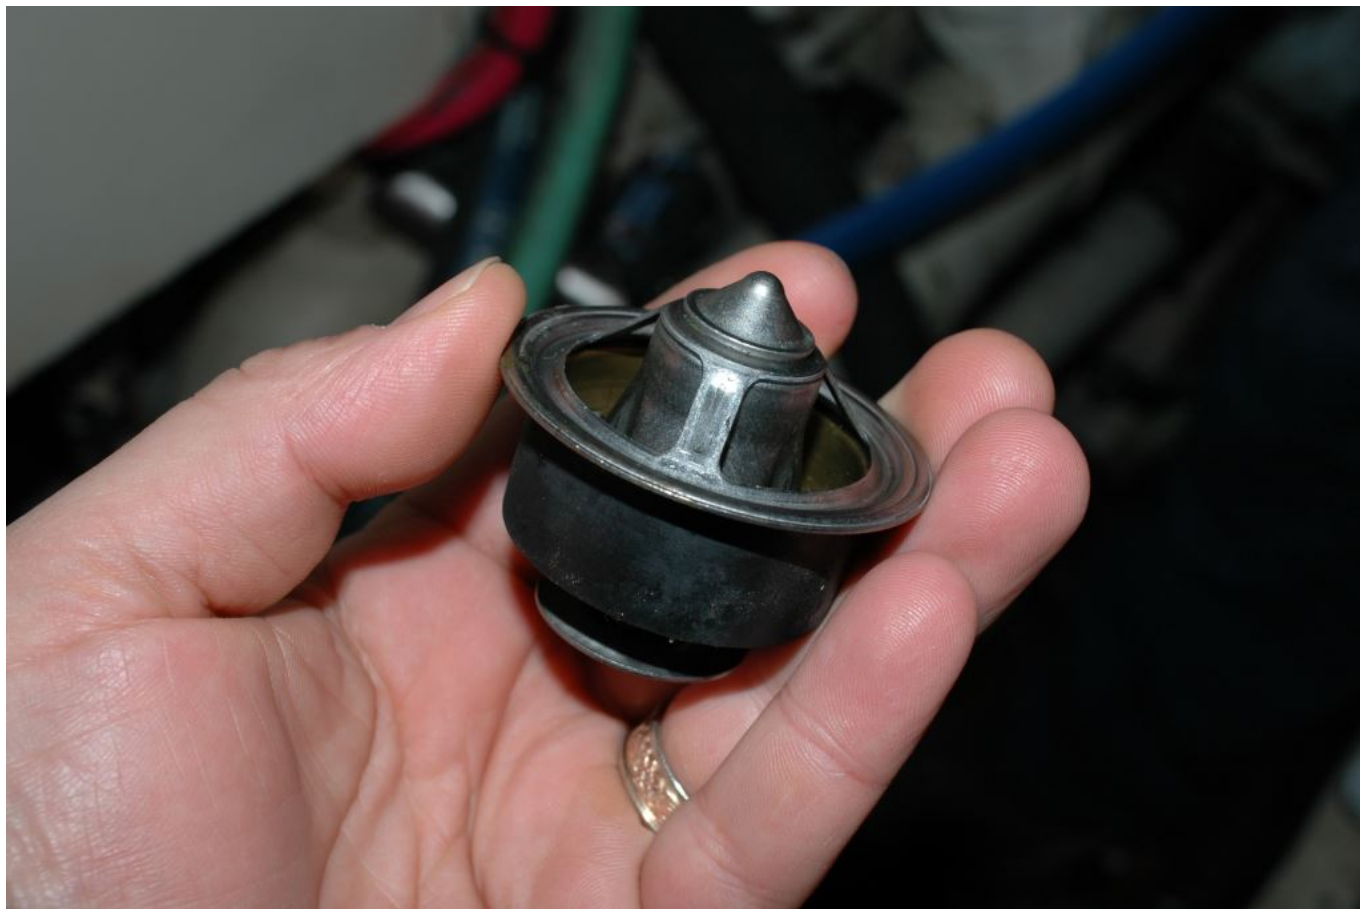
While typically very reliable, thermostats can fail to open fully, which can lead to overheating. These should be replaced when coolant is renewed, every two or three years.

If all of these turn out to be overheat dead ends, you can move on to the thermostat. While these rarely fail, it does happen from time to time.
