# Troubleshooting Overheating Scenarios – Editorial: Blisters and Drying Bottoms

## Troubleshooting Scenarios                      Overheating

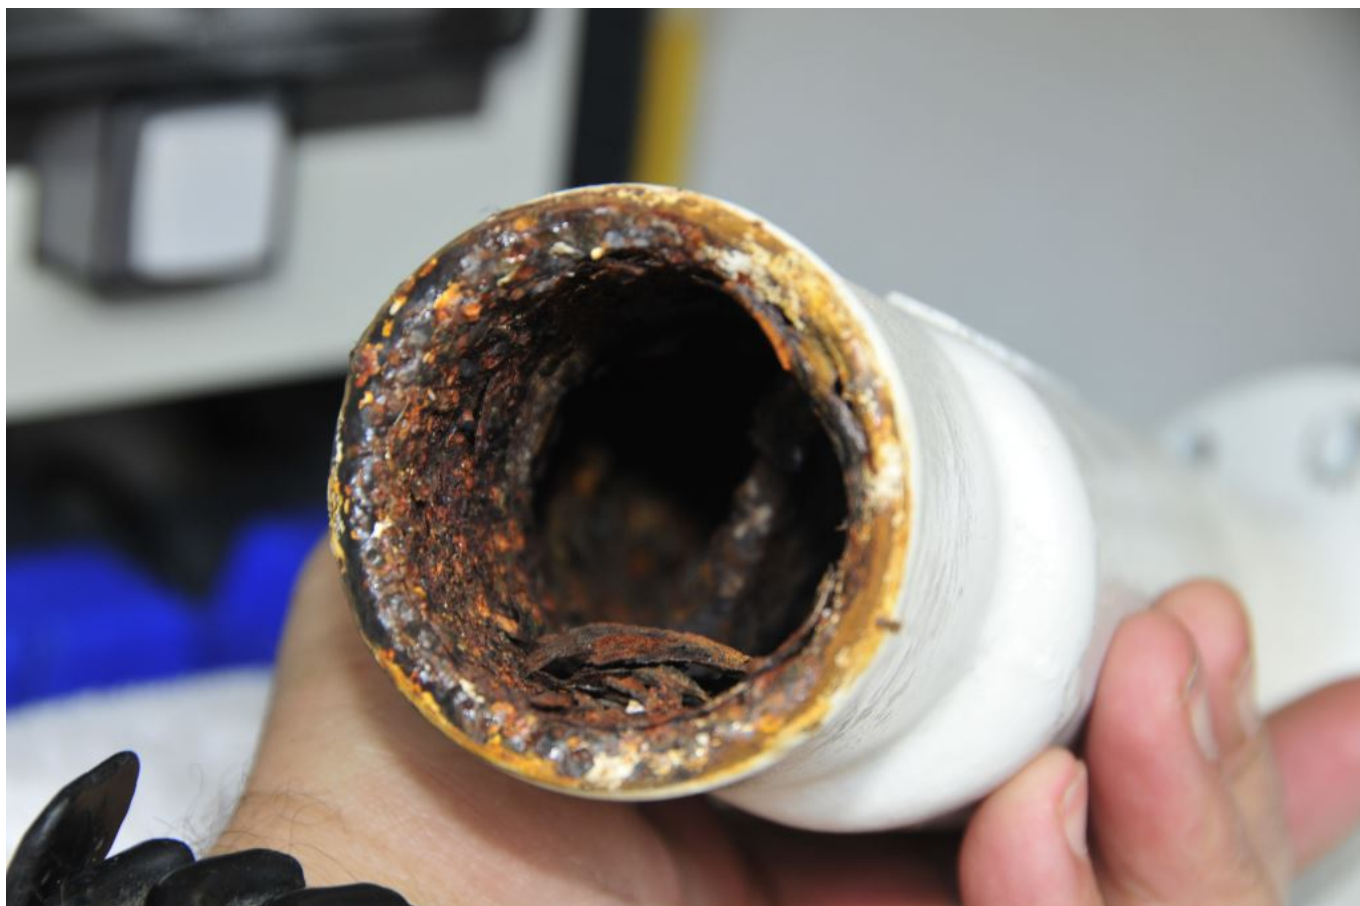
**Exhaust elbows, especially those made of cast iron, are prone to scaling, which impedes water flow, which in turn leads to overheating.**

Next, check the injected elbow. These are notorious for

becoming clogged with corrosion, acting like a bottle neck, a restriction slows down water flow through the entire raw water-cooling system. One test you can perform to determine of this is the culprit involves temperature differential; what is the difference between the temperature of the water entering the engine, i.e., seawater temperature, and that leaving the engine at the exhaust outlet? It comes as a surprise to many that the delta should not exceed about 20° Fahrenheit (11C). If it's greater, there's a possibility you are dealing with a restriction in the exhaust elbow, or water supply to the elbow. More on wet exhaust systems here.

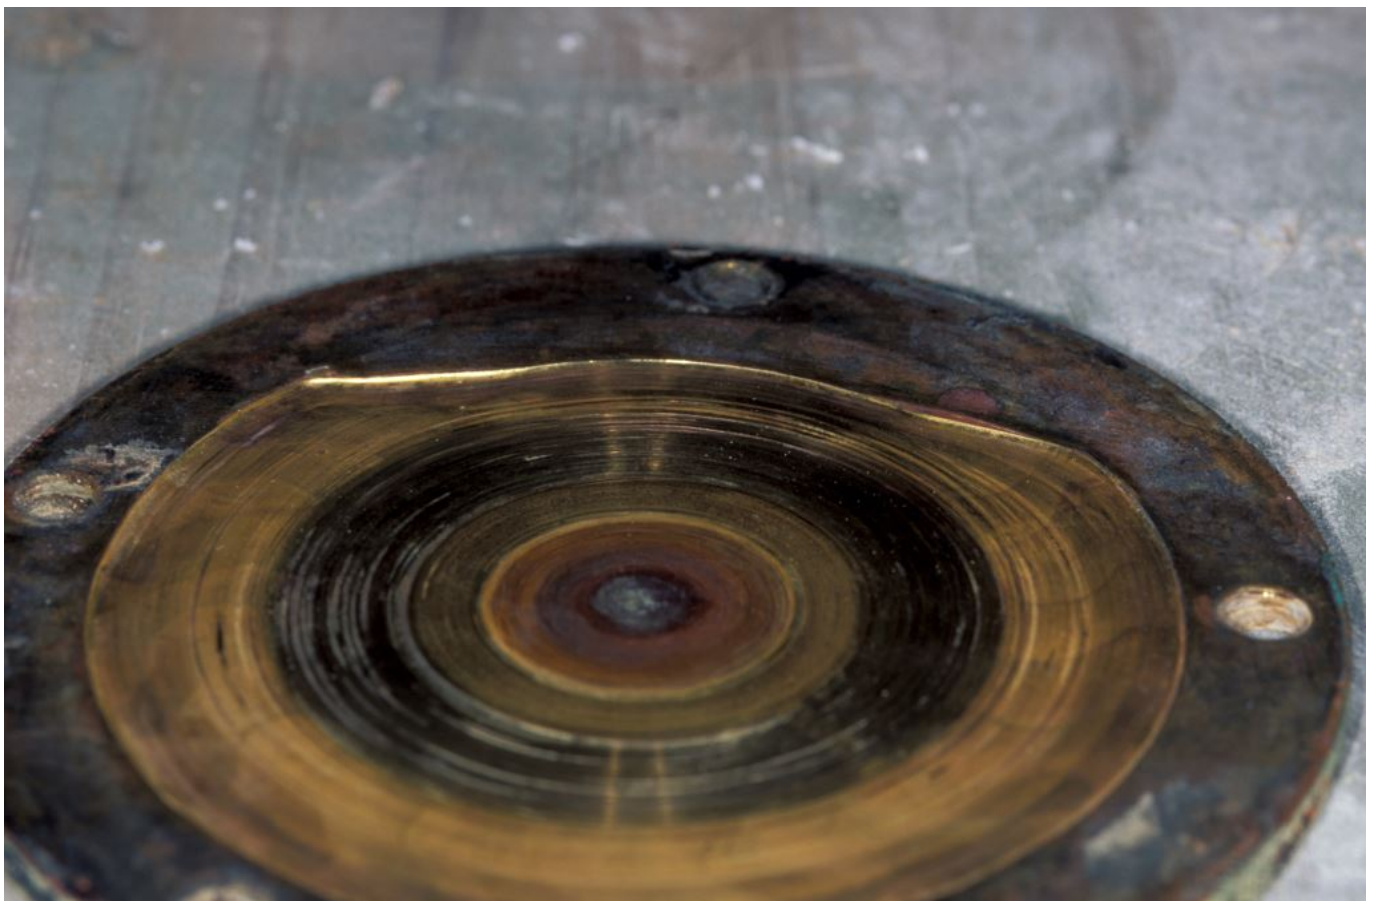
**If you can feel a ridge in your water pump's cover plate, it's time for it to be replaced.**

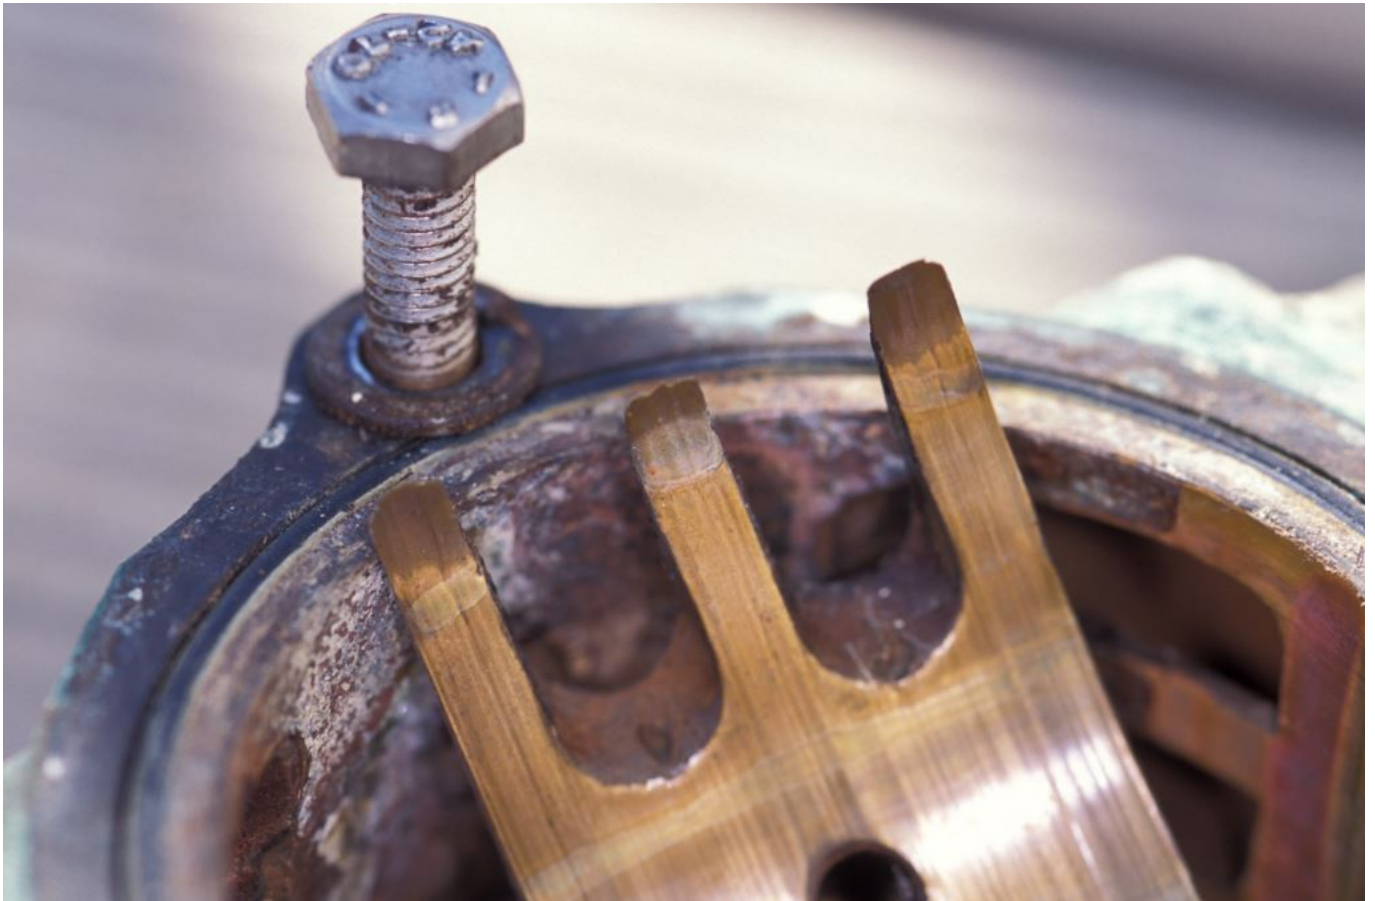
**It's often difficult to gauge wear on water pump parts until they are compared to new components.**

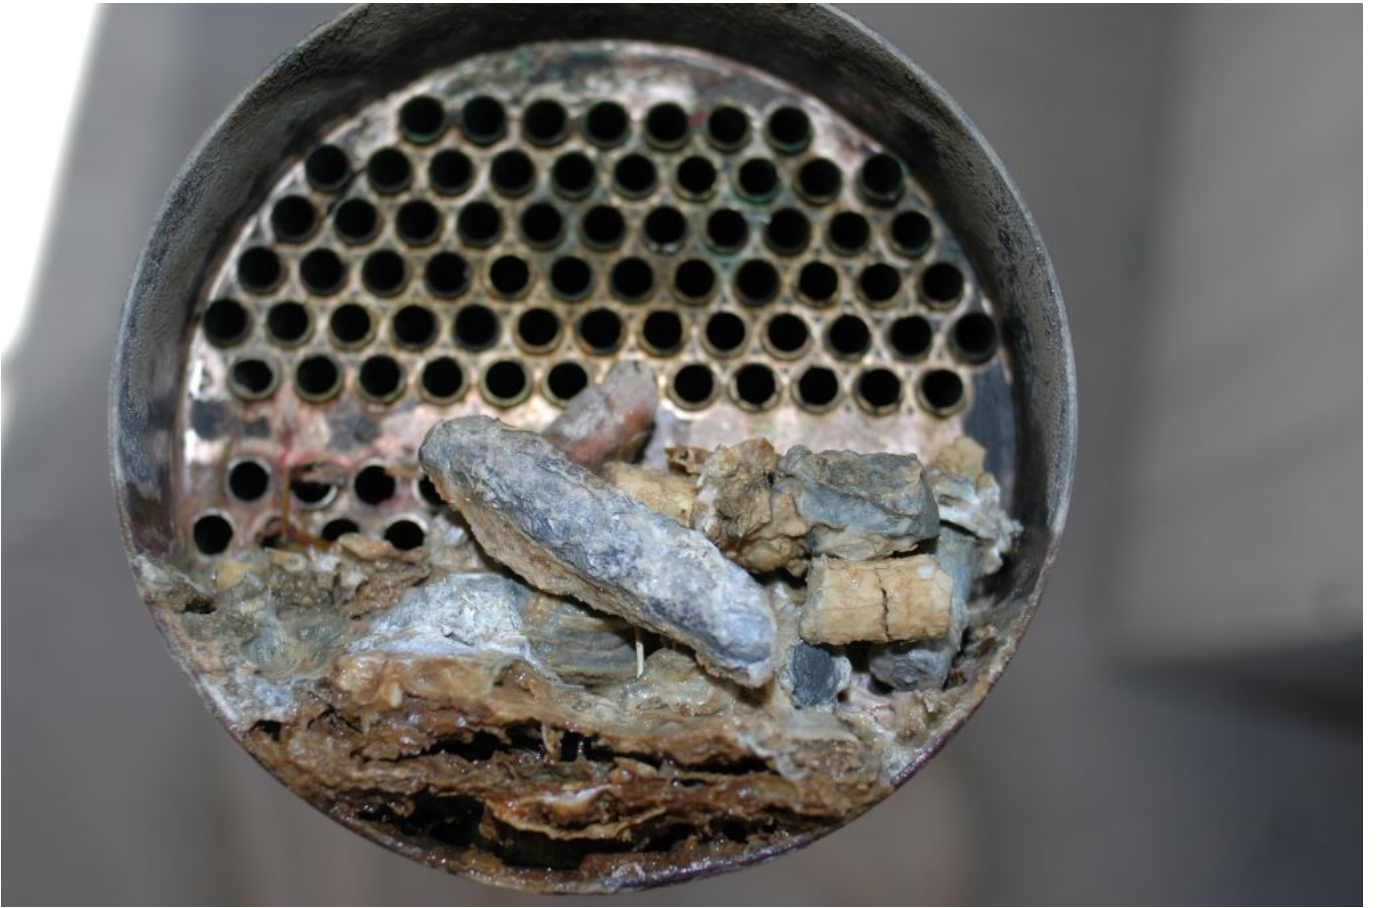
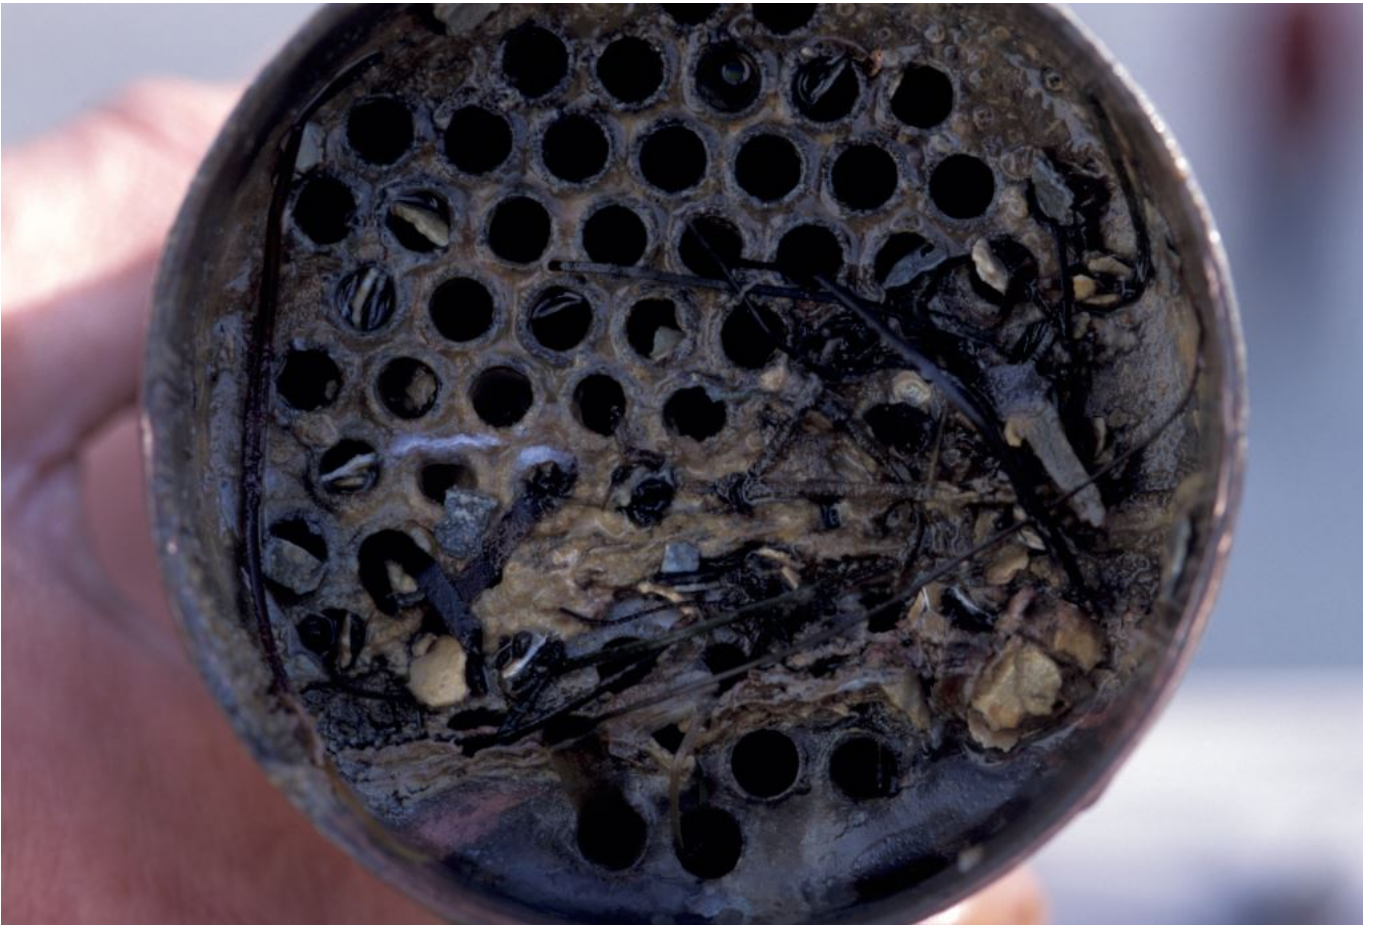
**Heat exchangers should be inspected for debris accumulation**

**about every two years, even if overheating isn't an issue;  
it's not unusual to find depleted anodes.**

Next, remove the end caps of the heat exchanger, and check for debris, depleted pencil anodes, as well as clogged or scaled tubes (the thinnest scale accumulation can have a dramatic effect on the ability of the heat exchanger to transfer heat). If scaled the heat exchanger will require flushing with a descaling solution.

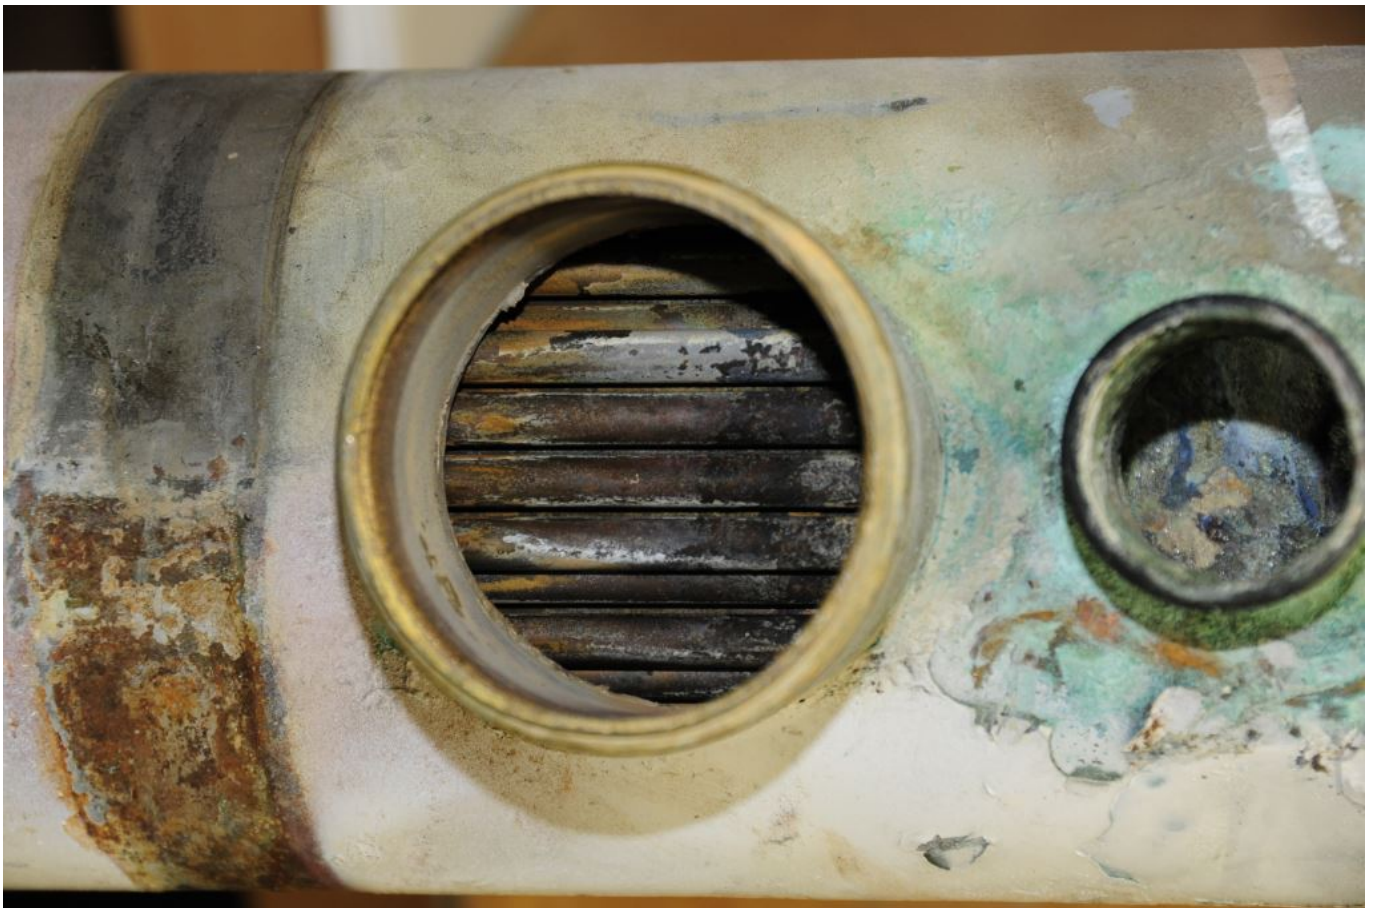
**In the event of an overheat, it's possible for an undetectable film to develop on the coolant side of the heat exchanger, which in turn will lead to poor heat transfer and overheating.**

Finally, if your engine does suffer a serious overheat, it's a good idea to replace the coolant and flush/descale the closed (coolant) side of the cooling system. Overheating can permanently degrade the coolant, while leaving an insulating film on the coolant side of the heat exchanger's tubes.

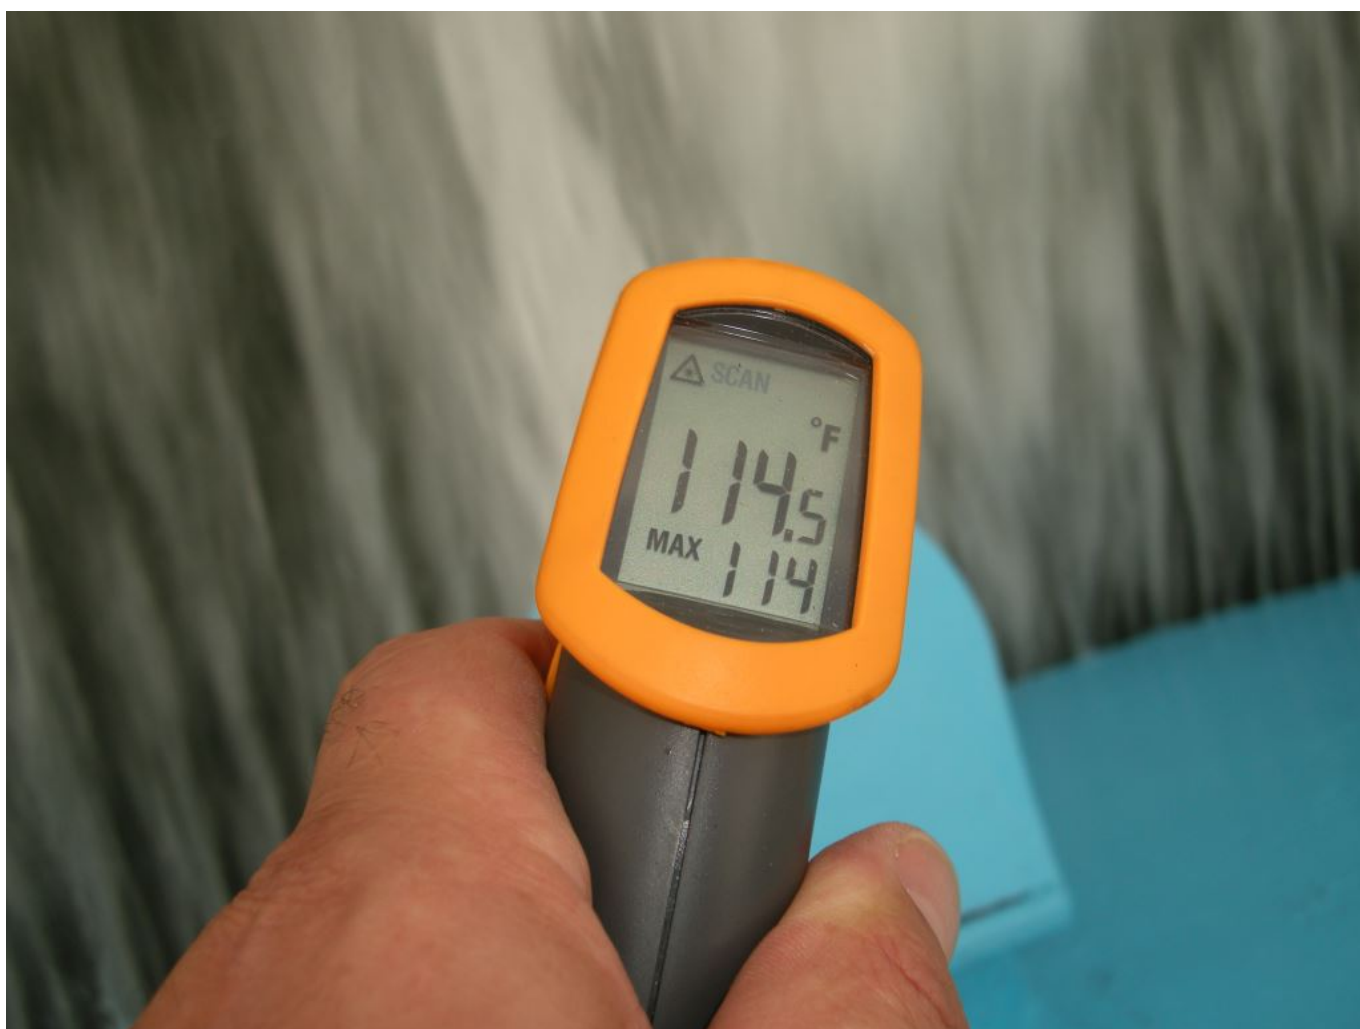
**There should be no more than about a 20° Fahrenheit (11°C) differential between the temperature of water entering, and the temperature of water leaving your engine. More than that is an indication of cooling system problems.**

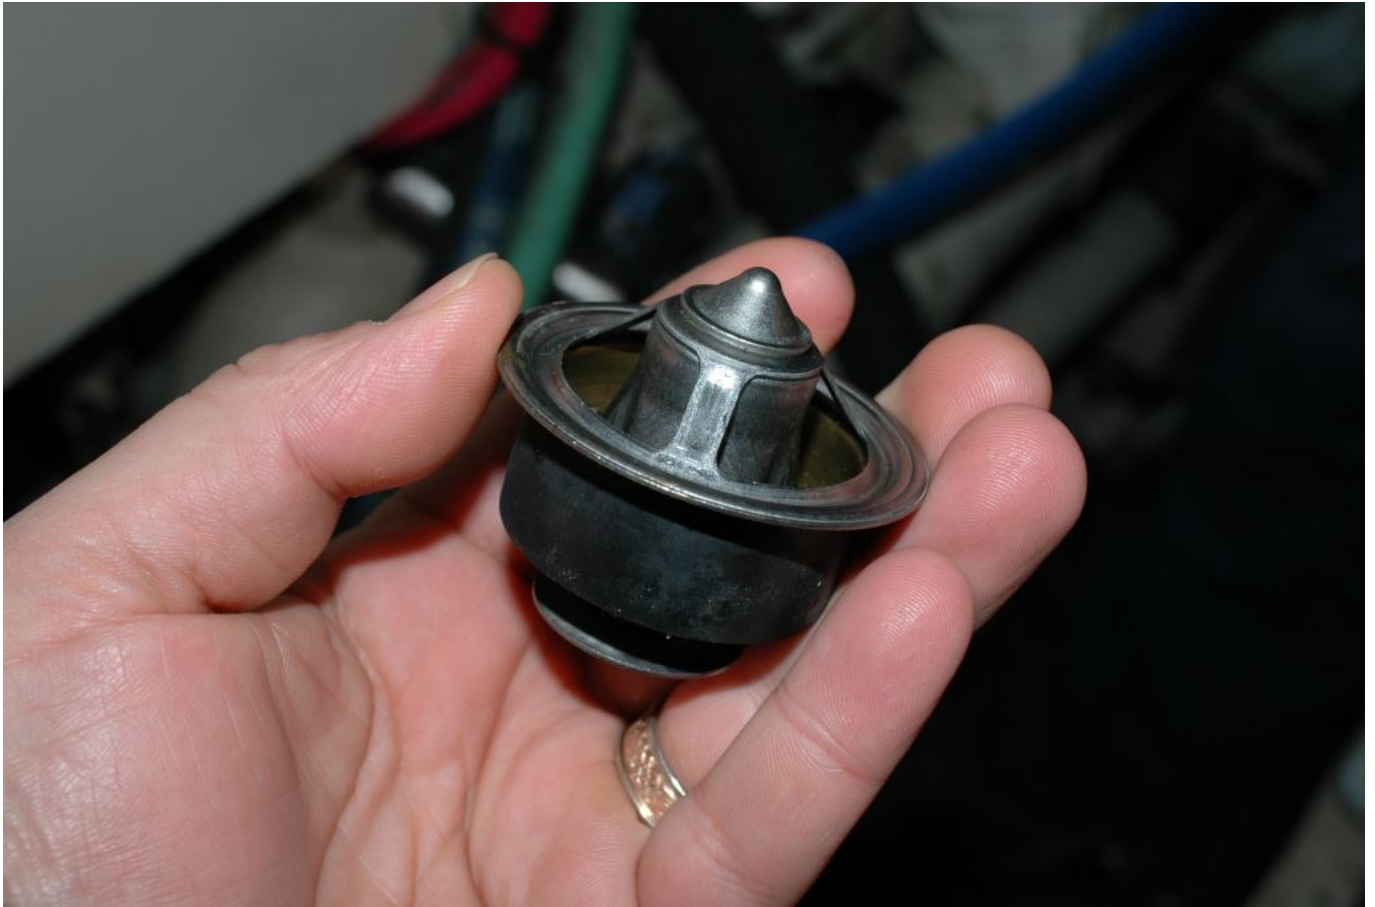
**While typically very reliable, thermostats can fail to open fully, which can lead to overheating. These should be replaced when coolant is renewed, every two or three years.**

If all of these turn out to be overheat dead ends, you can move on to the thermostat. While these rarely fail, it does happen from time to time.
