CRIMES AGAINST METAL

Understanding corrosion is the first step toward preventing it.

STORY AND PHOTOGRAPHY BY STEVE D'ANTONIO

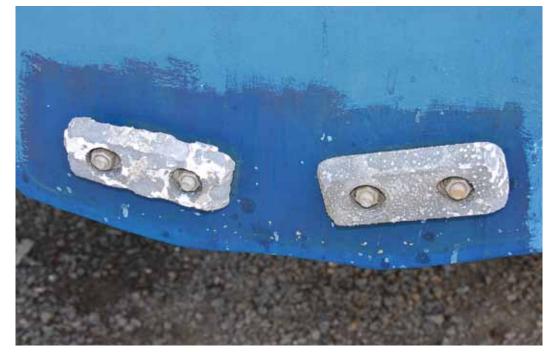
Anodes should decay at roughly the same rate, especially those that are the same size and collocated, when one remains near pristine it's usually a sign of a poor bonding system connection.

Recently, while inspecting a vessel as it rested on blocks in a local boatvard, I noticed a sharp disparity in the consumption rate of the two transom anodes. One had been consumed by

roughly 50 percent, a rate that I would consider consistent with the vessel's season afloat; the other, however, remained in a near-virgin condition. I'd seen this phenomenon before and knew something was amiss. Hold this thought, I'll return to that story later.

The aforementioned uneven anode consumption case is often indicative of a problem in the vessel's bonding system or the installation of the anodes themselves. Or, it may be a function of the anodes themselves. Simply put, some are made of higher-quality alloy and some are designed to be more effective than others. In this case, the problem turned out to be poor contact between the anode and the mounting stud. This scenario is exceptionally common and its symptoms, uneven or no consumption of anodes, should not be ignored.

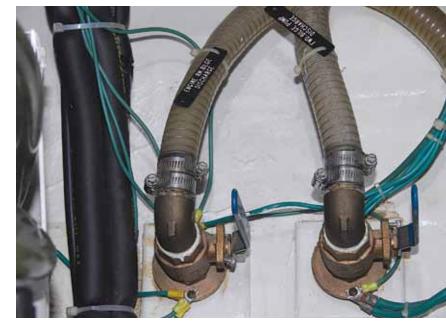
Left: Underwater hardware should bond in such a way as to avoid using the fittings as the current path. The fittings in this image are incorrectly wired. Right: Galvanic isolators are an inexpensive means of preventing shore-ground wire-induced corrosion. Units should be fail-safe and comply with the latest ABYC standards.

If a bonding strip is not used, and components are wired one to the other, avoid making connections through hardware. That is, if two bonding wires-"in" and "out" connectionsare connected to a single component, a seacock or strainer for instance, install the wire's ring terminals on the same fastener and stud rather than separately. This will prevent the bonding system's low voltage and current from relying on the potentially and comparatively high resistance of the hardware component as a conductive medium. Or worse, should one connection fail completely, everything downstream is disconnected from the bonding system à la the oldfashioned Christmas light scenario.

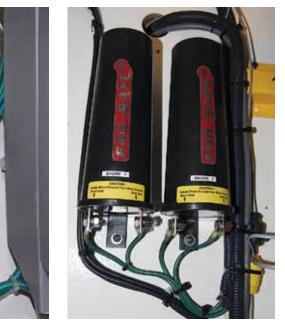
Using tapping screws, screwed into wood or fiberalass virtually quarantees a poor connection; it's also a violation of ABYC auidelines.

Bonding connections must offer a low resistance electrical path, which means they must be tight and free of corrosion.

The way that bonding is achieved with the bonding strip is critically important. In no case should selftapping, sheet-metal, or wood screws be used. If machine screws are used, the strip must be thick enough to be tapped and allow a minimum of four threads of engagement. Otherwise, through bolts and nuts may be used to connect a wire's ring terminal to the strip, which should have a minimum

thickness of 1/32 of an inch and minimum width of 1/2-inch. If wiring ring terminals are connected to a bonding strip using self-tapping screws, which pass through the strip and into fiberglass, or worse, wood, then you can be assured of a poor connection. In almost every case, when I inspect vessels whose bonding systems are wired in this manner, I find universally loose connections. Such connections do not comply with ABYC guidelines.

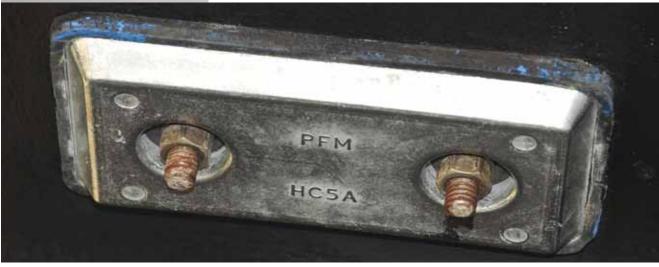
Left: Studs used to support anodes must be installed in such a way as to avoid relying on the anode to maintain tension.

Below: Aluminum anodes, like the one shown here, offer a variety of advantages, including increased amp hour capacity and functionality in fresh, salt and brackish water.

free of any scale or marine growth. The stud should remain captive to the hull regardless of whether an anode is installed or not. When installed, the anode should stand off the hull; there should be a gap between the back of the anode and the hull.

If necessary, remove the anodes and clean the hardware using a stainless steel or bronze. Make certain the fasteners used to hold anodes in place are secure and complete. Ensure that lock washers and washers, if necessary, are used and be certain they are installed in the correct order. The lock washer should always rest directly under the nut.

Hull anodes that are attached to studs of this sort should rely on an embedded contact plate that will maintain contact with the mounting stud as the anode's active material corrodes away. If the anode has no such plate, contact with the stud is often quickly lost as the anode begins to erode. In some cases the anode may loosen or even fall off. Once it's loose, it's no longer working. For anodes installed over other hardware, such as rudders, propeller shafts, and trim tabs, make certain the surface has been thoroughly cleaned before installing a new anode.

Aluminum anodes, on the other hand, have several advantages. They are well suited for use in seawater as well as brackish and fresh water. Thus, if you intend to transit these water types, then aluminum anodes make the most sense for that reason alone. Where I live, on the lower Chesapeake Bay, the salinity of the countless creeks, inlets, and harbors can be affected by rainfall, and as such, one week they may be salt, while the following they may be brackish or even fresh. Thus, especially in cases such as this, it's desirable to use an anode that will work in both fresh and salt water.

longer than zinc anodes of the same weight and they are impervious to the calcareous coating phenomenon. Their relative energy capacity is, at 1108Ah per lb., significantly greater than zinc, with a voltage of minus 1100 millivolts, more negative than zinc's minus 1050 millivolts. If you opt for aluminum anodes, ideally the change should be universal, for all anodes used within the same bonding system. It's not harmful to mix aluminum and zinc anodes, however, the former will "protect" the latter, which serves no purpose. Surprisingly, aluminum anodes are often no more costly than their zinc brethren, offering a free lunch of sorts.

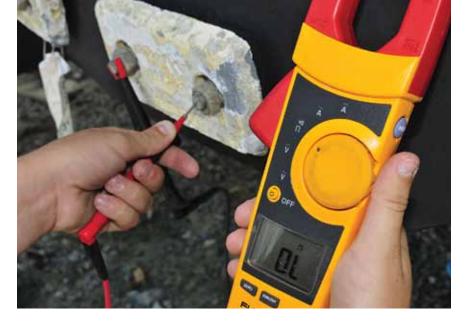
Top: Bonding system integrity should be checked periodically, especially if anodes are not being consumed or if they are being consumed unevenly. Above: When anodes are working properly, they should not become encrusted with marine growth.

In suspect installations on a boat that's hauled out use an ohmmeter to check the soundness of the bonding system by connecting one lead to the anode and the other to a bonded underwater metal, a through-hull fitting, strut, or rudder for instance (you may need to make extra long leads to perform this test). Remember, the resistance between any two bonded underwater metals and between any metals and an anode should not exceed one ohm. If it does, then the hull anode is either not making good contact with its mounting
